WHAT IS A REPORTABLE ACCIDENT?

JODEL D153 MASCARET FUEL FILTER BLOCKAGE

PIETENPOL AIR CAMPER OLD FUEL/NEW AIRCRAFT

GALVANIC CORROSION

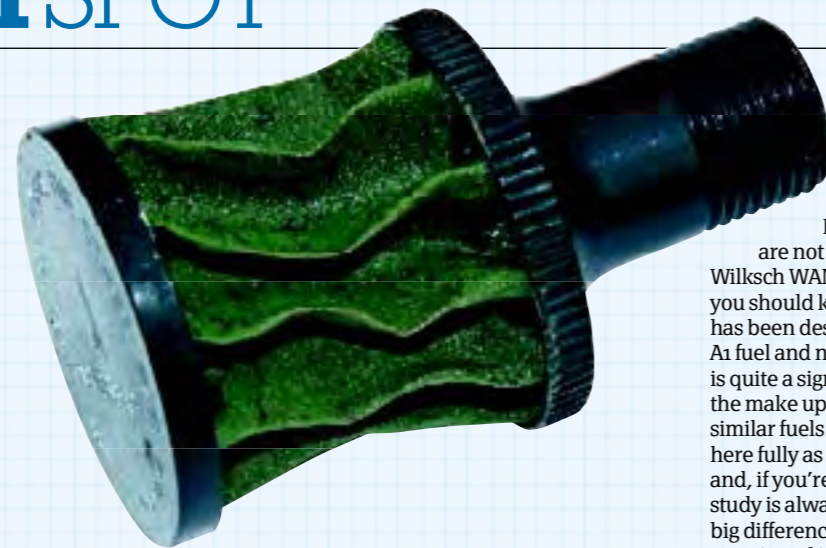
This is the filter element as discovered by Peter after his emergency land at Sywell. Peter noticed that the fuel pressure was quickly dropping and got back on the ground as soon as he was able. You can see that the sides of the filter itself have been sucked together because the pours of the element have been blocked by a greenish-brown mush.

I checked the fuel drains on the two tanks and the gascolator. All were spotless. I pulled the gascolator filter (Andair) and found a thick coating of greenish-black deposit on the gauze. The pleats of the element were squashed to a sharp crease (see photo above).

When Peter arrived home he started researching what may have happened to the fuel to cause this sudden fuel blockage. He could rule out low temperature waxing – what on earth could the 'greenish-black' deposits be? Peter continues:

Searching the internet revealed that petroleum oils contain asphaltenes. They are a huge range of different polycyclic aromatic hydrocarbons with a relative molecular mass (RMM) from 800 to 6,000 compared with a normal fuel molecule, say decane with an RMM of 142. They occur in distilled fuels in small, unquoted amounts. They are better known for causing blockages in crude oil pipelines.

Depending on the particular chemical composition of the fuel, and its temperature, the asphaltene molecules can agglomerate to form colloidal-sized particles called micelles, whose formation is promoted by the presence of water in the

fuel and increased temperatures (above 60°C is quoted). The formation is also favoured by a reduced concentration of aromatic hydrocarbons (benzene and similar).

Colloidal particles so formed can be 20 to 30µ diameter. The gascolator filter is a 70µ stainless mesh coated with pte.

I informed Wilksch Airmotive and four French pilots that I know who have diesel-powered aircraft. The aircraft was drained, flushed and a new gascolator filter fitted. It has since been fuelled exclusively with Jet-A1.

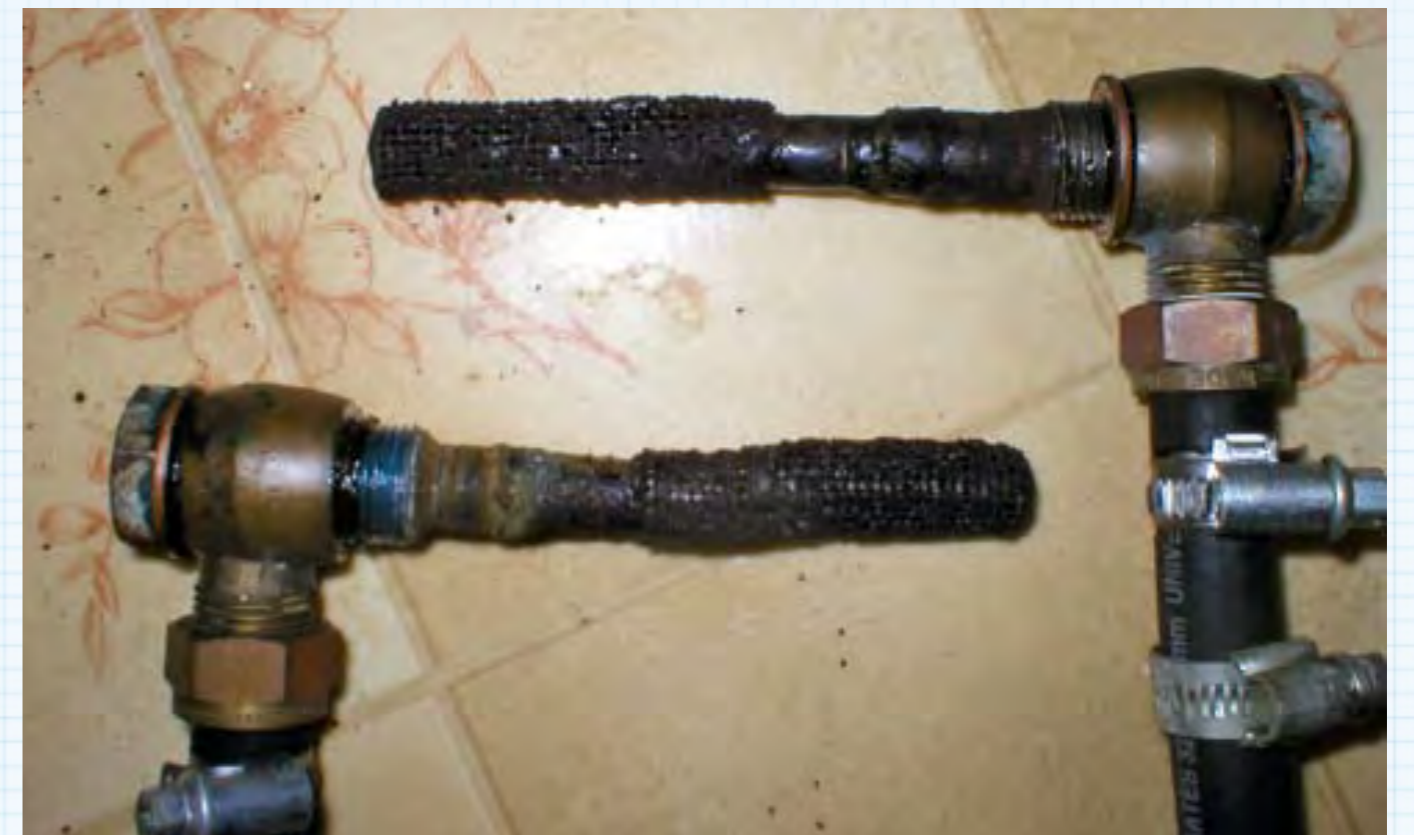
Who would have thought that, after only ten years of standing in a hangar, fuel would have more or less written off the fuel tank outlet filters in Keith's Pietenpol? (Photo: Keith Hodge)

I'm not all that surprised, take a look at the pictures sent in by Keith who, in his letter, explained that: *'In view of the long storage time (and the fact that the tank filler neck seemed corroded) I decided that it would be prudent to have a good look in the tank and at the fuel system in general. I had missed the corrosion on the filler neck because, during the top up, I had removed the filler cap and fitted a large funnel which prevented the rust from being seen.'*

I am glad that Keith is doing a complete overhaul of the fuel system, it's probably time! What amazes me is that the engine actually started with n-year-old fuel... they don't make it like that any more.

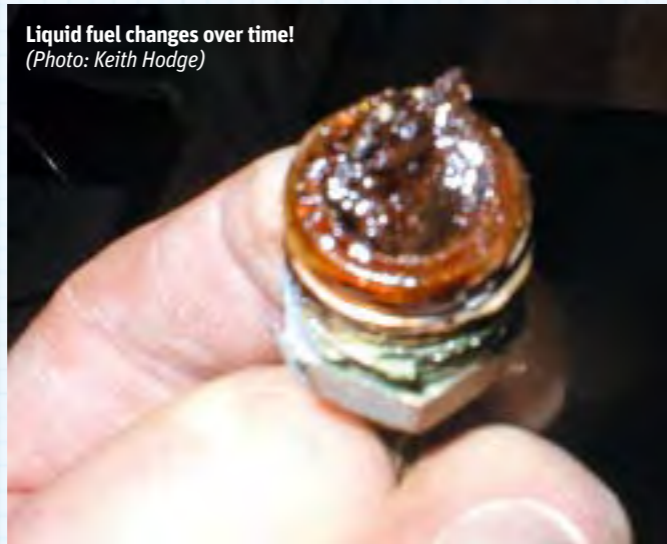
Liquid fuel changes over time!
(Photo: Keith Hodge)

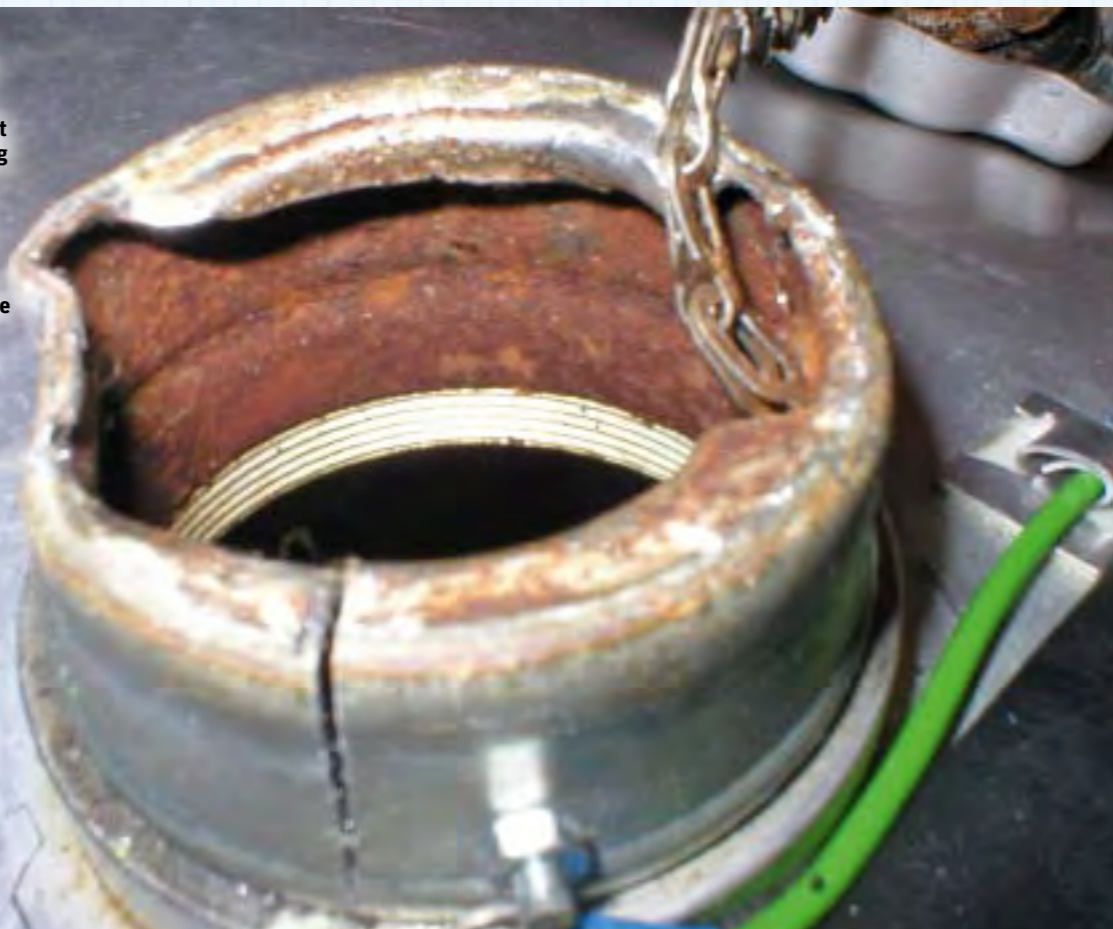
I think that it's fair to say that if you were to open this fuel cap on an aeroplane you might think twice about flying it. Not that the owner had any intension of getting airborne... his aircraft hasn't been completed yet, the corrosion that glued the cap to the tank is the result of many years standing about in his hangar. (Photo: Keith Hodge)

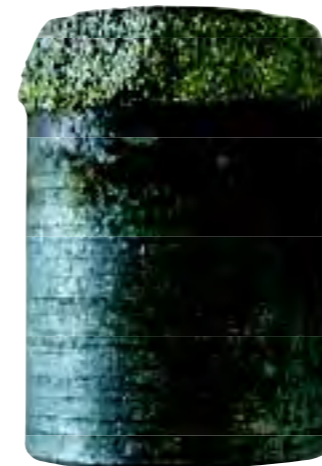
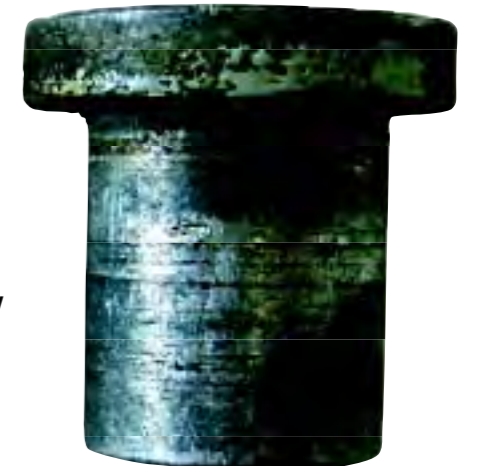
Many thanks to Gary Cotterell for sending in this great example of the effects of galvanic corrosion and its strange, often unpredictable, consequences. These aluminium propeller drive lugs both come from the same propeller hub, one has failed and the other, working just next door, hasn't. The material used for these lugs has been changed to a stainless steel by the manufacturers, not because aluminium alloy is not strong enough, but because it sits too far away from the steel in which it is fitted in the Galvanic Series. As a Current is created the aluminium is sacrificed in the same way as the zinc casing of a common torch battery is. (Photo: Malcolm McBride)

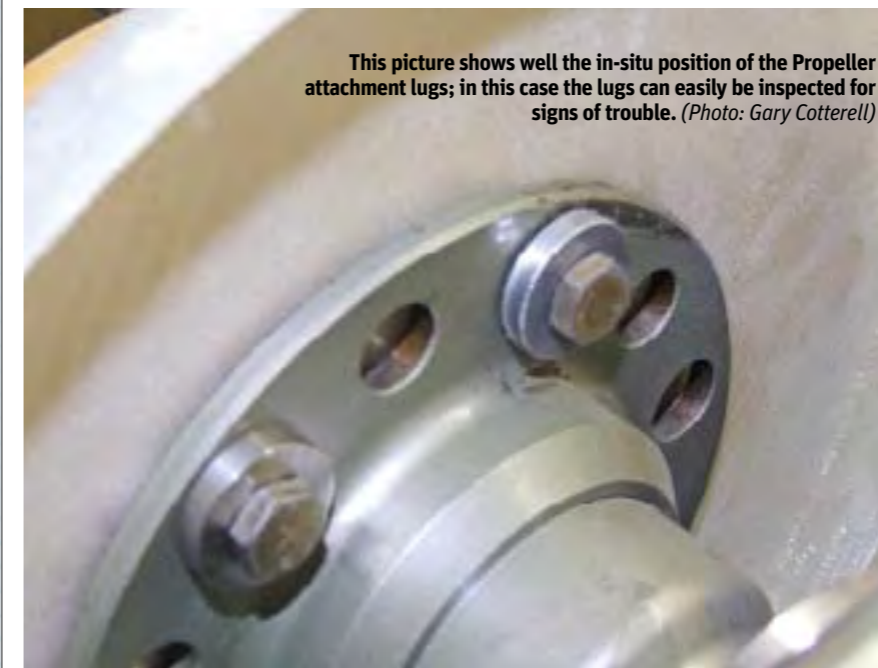
This picture shows well the in-situ position of the Propeller attachment lugs; in this case the lugs can easily be inspected for signs of trouble. (Photo: Gary Cotterell)
