With Malcolm McBride
Airworthiness Engineer

OF CORBETT, MOTHS, PUMPS, FIRE & EXHAUSTS

The latest LAA Engineering topics and investigations

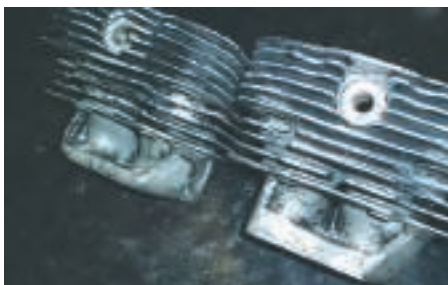
(Above) Aborting a take-off because of a rough-running engine was exactly the right thing to do, as LAA'er Malcolm Paul recently discovered. At the beginning of the take-off roll in his Gipsy Moth, the engine sounded rough, but he put this down to a fouled sparking plug, thinking "It'll probably clear". As it turned out, the engine had lost a cylinder because a valve push rod had come adrift. This picture shows a pair of early Gipsy cylinder heads with an additional rocker platform support flange welded in, a rather sensible modification according to Gipsy engine specialist Mike Vaisey. (Photo: Vintech)

They stopped the engine to investigate, making sure that the plug leads were still secure, etc, and then Paul pointed out that one of the valve push rods had come adrift. Closer investigation revealed that the rocker pedestal had cracked, allowing the push rod to disengage from its rocker. No valve operation equals no cylinder operation, over 25 per cent loss of 'oomph' and a gruff engine! Malcolm reflected that, if the failure had occurred thirty seconds or so later, he'd have been climbing out over the Solent at very low level.

On the engineering side, cracks in the cylinder head pedestals or the cylinder heads themselves, and failed rocker bolts aren't unknown in any of the Gipsy series of engines, although there tends to be more of a problem with the earlier marks.

As knowledge was gained, reinforcing gussets were added to the cylinder heads and there are now quite a few different designs of head to counter this problem. Malcolm submitted his head to Vintage Engine Technology, who repaired it and added gussets to the three other heads for good measure. If you run an early series Gipsy engine it's worth considering submitting the heads for a similar modification the next time you pull them for overhaul. I've experienced

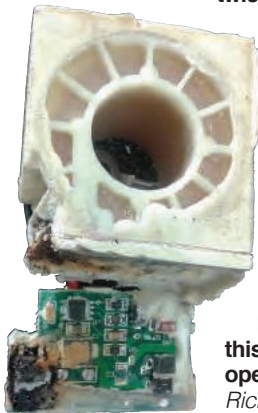
(Below) Regular readers will remember this picture of the damaged internals from a Facet-type fuel pump from last month's LA. You'll recall that the electronics overheated, which melted a small amount of the potting compound, probably some kind of polyurethane. That produced enough smoke and toxic effluent to completely fill the cockpit of Richard Parker's Van's RV-6.

We did try to find out what had caused this failure, the only clue lay in the fact that the pump was consuming nearly twice the amps it

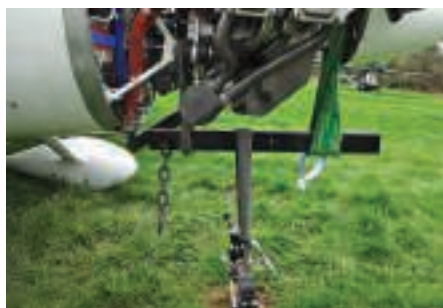
(Above & above right) These two pictures show the details of mechanics of the limit load test (6g). Note the Whiffletree mechanism, which is a clever way of getting the load acting in the right place. *(Photo: Tim Dews)*

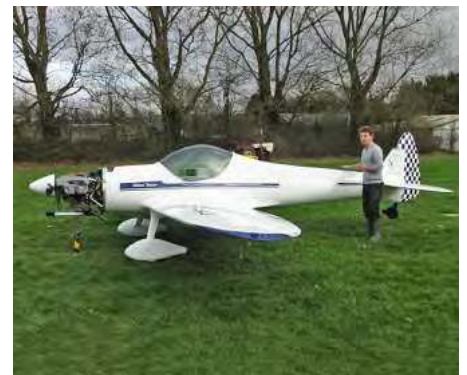
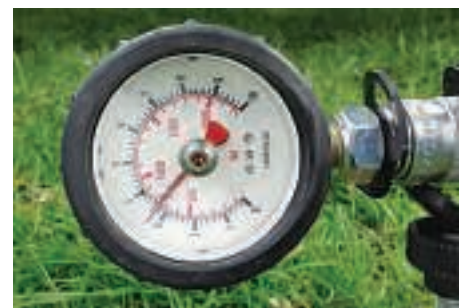
At first, Tim thought that there had been a fuel leak, perhaps from a pipe connection, though when he checked the system out later, it became clear the carburettor float valve had jammed itself open for some reason and the excess fuel was simply draining out into base of the lower cowl.

Naturally, Tim removed the engine and replaced all the connecting pipe and wirework, including the ignition harness. He felt that the spark which had set the whole thing alight probably emanated from the alternator which, as you may know, is a rather 'open' affair, situated at the back of the Jabiru engine.

(Left) LAA Inspector and composite specialist, Tim Dews, sent this picture showing soot and debris in the engine compartment of his lovely Twister.

As you can see, Tim's aircraft suffered an engine fire on start-up. Naturally, after the fire was extinguished, there was quite a bit of damage to ancillary equipment (wires, pipes and suchlike) but our real concern was to establish whether the engine-supporting composite structure had been compromised. *(Photo: Tim Dews)*

Tim says he's going to check whether the float valve is actually doing its job before starting the engine, perhaps by leaving the fuel pump on during the walk-round check. I think, again perhaps in a more general sense, it's worth remembering that fires need fuel, and of course oxygen, to continue burning.

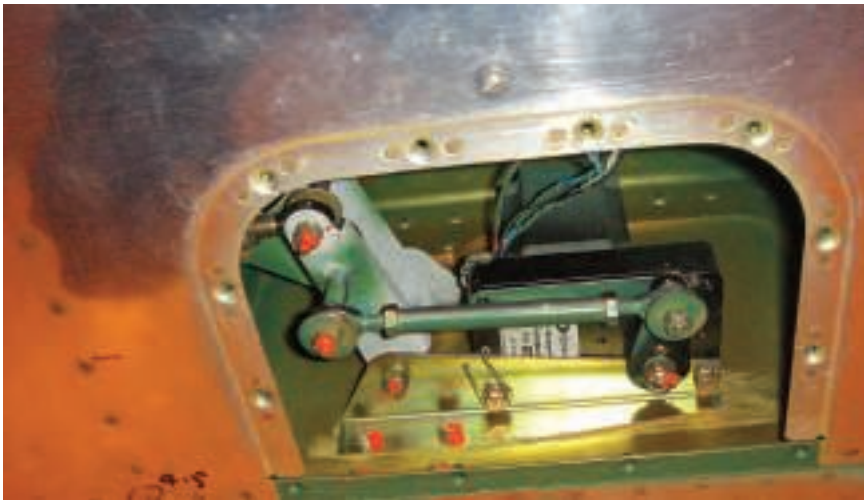
(Above) LAA'er Andrew Collett operates his Van's RV-10 aircraft from Turweston Aerodrome, so we often see him about the place. The other day, he asked me to look at a picture of the insides of his Dynon autopilot roll servo, which had started to become rather jerky in its operation. The above picture shows the roll servo as it sits in the wing. You can see that the servo is mechanically connected, direct to the aileron bellcrank so it's essential that the device remains in tip-top condition – no jamming allowed.

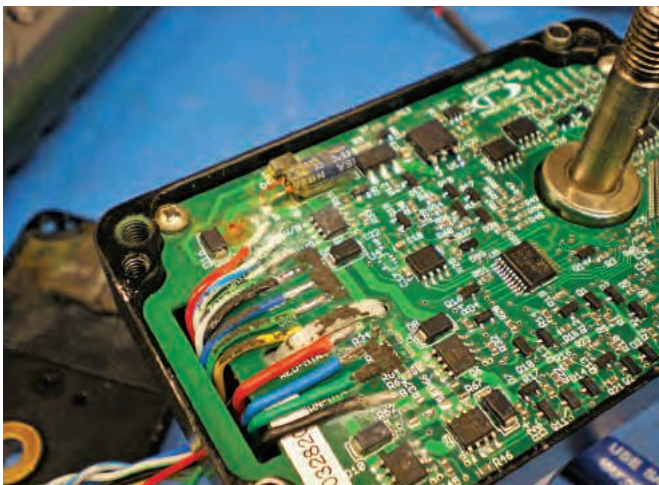
(Left) When Andrew opened up the Dynon roll servo's cover plate, he was rather alarmed to find that the board was covered in some kind of contamination – it rather looked like watery soil had got inside.

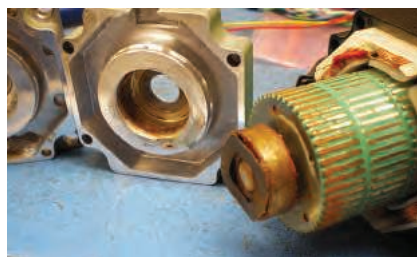
(Right) Andrew further stripped the servo down and, as you can see, the unit's motor and associated bearings have been damaged by ingested water. Andrew sent the pictures to Dynon HQ and they came back saying that this unit wasn't repairable. (Photos: Andrew Collett)

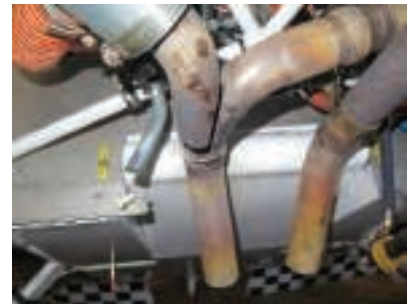
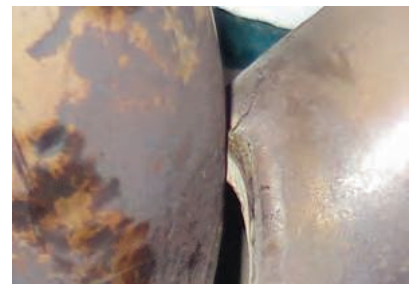
Here are a couple of photos showing a very recent area of failure on the exhaust of a Lycoming O-360-powered Van's RV-8. The exhaust failed shortly after take-off and, quite rightly, the pilot elected to land as soon as possible.

As you can see, the exhaust has principally failed at the long junction of the two down pipes but also near the connection with the rear (no 4) cylinder.

There's been some debate about the actual sequence of events. My best guess is that this exhaust failed at the top of the junction between the two pipes. Notice the small crack, which is clearer in the second, close-up photo, that's emanating from the weld.

However, two things do jump out straight away. The first is that the cup and ball fitting (top right in the first photo) was completely seized, preventing any relative movement between the pipes. Secondly, that the failures are predominantly along weld lines. Initially, there appears to be no evidence of fatigue in the fracture faces, though we'll need to look more closely to be sure of that.

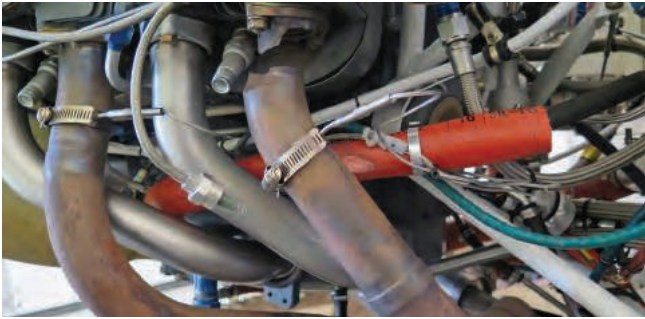
(Above) This photo shows a complete separation of the exhaust pipe from this Lycoming O-360 engine. I believe this failure was caused because of the loss of support supplied when the connecting weld failed further down the system.

Notice the EGT probe will now not be in the major exhaust gas stream. The loss of EGT information was this pilot's first indication that there was a developing engine problem.

We're looking into the origin of this system and will take a much closer look at the pipe's construction, particularly the quality of the welding. If you recognise this type of exhaust assembly, or have any experiences similar to this failure, please let us know by emailing engineering@laa.uk.com

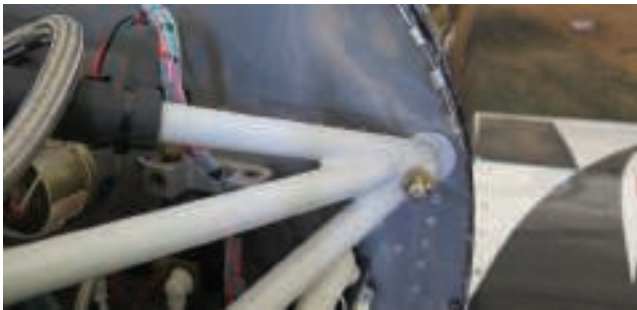
(Above) When the pilot noticed that the EGT was rapidly dropping, and the engine note appeared different, he elected to conduct an immediate precautionary landing.

Unfortunately, the landing was conducted into a low sun and one wheel left the runway, into the rough ground running alongside, and the aircraft tipped on its nose, though from all accounts quite gently. The owner thought that the damage would be limited to the wheel spat and, naturally the propeller. Sadly, as you can see from this photo, the firewall has been creased, which will mean a more difficult repair.

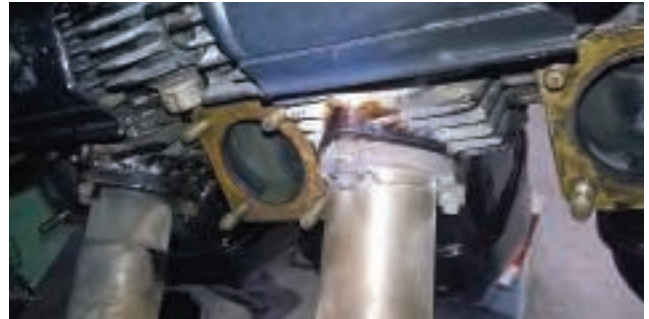
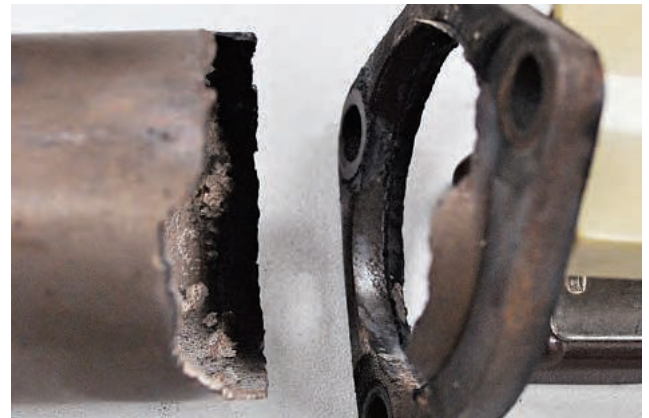
Initially, the job was to remove the intake manifold and carburettor from this Gipsy 10 engine, fitted to a DHC-1 Chipmunk which was in the hangar for a service.

However, LAA Inspector Alan Turney didn't like the look of the staining around the exhaust pipe to cylinder joint, so he removed that as well. The second photo shows why this was a good idea - "Honest, Guvnor, it came off in me 'ands."

Clearly, this pipe has been held in place by inertia for quite some time and the problem should have been picked up on a pre-flight inspection. Apart from the loss of power experienced when an exhaust fails like this, there's a greatly increased risk of an in-flight fire, particularly as a flexible fuel pipe passes very close to the rear cylinder exhaust outlet.
