SUFFERING A DEFINITE DISCOMBOBULATION OF THE SPIRIT...

The latest LAA Engineering topics and investigations

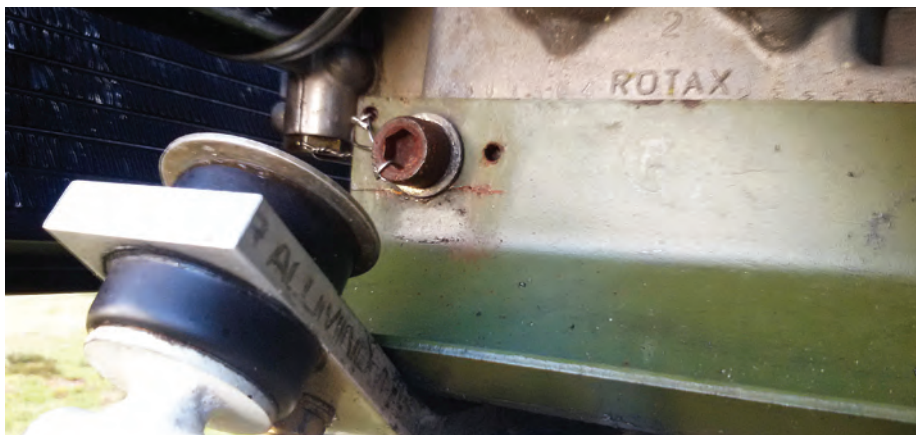
(Above) Last month's *Safety Spot* talked about Rotax 9 series engine-mounting bolts coming loose and failing through fatigue. That item generated a big response and it seems that this has long been a design issue. However, my take on this is that no design is perfect and there's much compromise in a lightweight aircraft structure, which is why close (and timely) regular inspections are so important. Here's a good example of a materials failure in a different kind of engine mounting. This 912 ULS is fitted to a Zenair 701 and, yes, both sides were cracked (below the the cap-headed bolt). Judging by the amount of corrosion around the crack, it had been there for a while. (Photo: Sandy Hutton)

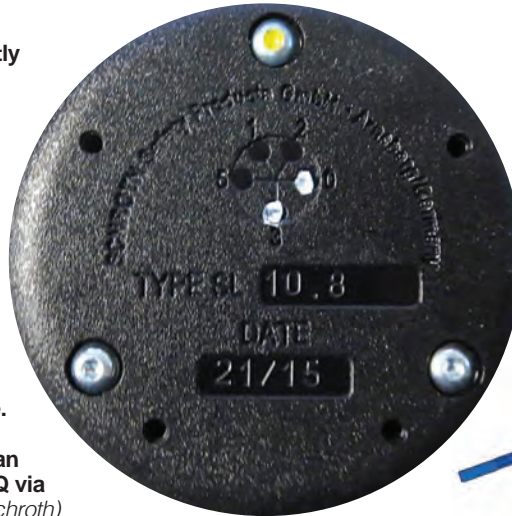
(Right) LAA Engineering has recently published an Airworthiness Alert, giving access to an important SIL from the manufacturers of the Schroth Harness. We've written to all Tiger Moth and Bulldog owners under an LAA-administered Permit to Fly, advising that, for the time being, it isn't a good idea to fly aerobatics if you've a harness affected by the SIL. You can check if a harness is affected by the SIL by looking at the 'Type SL' and 'Date' on the rear of the buckle. There may be other types using a Schroth system so if you know of an example please email us at LAA HQ via engineering@laa.uk.com (Photo: Schroth)

(Below) The problem with some of these Schroth harnesses appears to be that the latching mechanism can unlatch when it's under a consistent but varying load. Though the nature of the issue hasn't, at least at the time of writing, been fully disclosed, we're working closely with de Havilland Support Ltd, who hold the Type Responsibility Agreement (TRA) for the Bulldogs and the DH-82s. (Photo: Schroth)

At the time of writing, we aren't sure of the exact problem that's led to the issuance of this SIL, in which Schroth explain that: *It has been noted that in some cases it is possible that an individual latch of the restraint system could be unfastened from the buckle without prior activation of the release mechanism.*

Investigation has shown that this effect is caused by certain patterns of load changes that typically occur during acrobatic flying, in combination with very tightly attached

belts. Such operating conditions may result in unusually high abrasive wear of the retaining pins and/or latches which, in turn, creates the conditions for the inadvertent release of an individual latch.

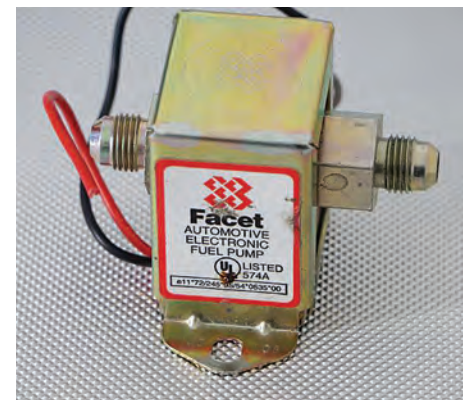
(Above) A consistent fuel pressure in an aircraft's fuel system has always been important, perhaps more so today for those using motor fuels which have a higher vapour pressure, to avoid the dreaded vapour lock. Many of you will recognise this relatively low-output Facet fuel pump – they were supplied as standard for Van's aircraft in the 1990s. These simple electrical piston pumps were designed to offer a back-up, just in case the engine-driven pump fails, and current advice suggests that these back-ups should be switched on during operations below 1,000ft. (Photo: Richard Parker)

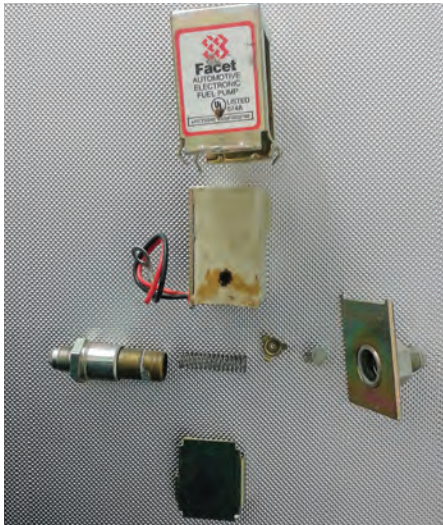
(Above) When aircraft electrical engineer and LAA'er Richard Parker switched on the electrical stand-by fuel pump fitted to his Van's RV-6, as part of his pre-take-off actions, he was surprised to find that he could soon no longer see anything, as the cockpit had filled with a "black, acrid smoke". Needless to say, he shut the aircraft down straight away and exited as quickly as possible. The reason for the smoke was tracked down to the expanded foam 'potting' compound getting too hot because of a PCB failure. This picture shows the bare bones of his failed pump and, as you can see, the shuttle piston, which contains a non-return-valve (NRV), is forced against a spring by an electro-magnet, while the inevitable electronic timing system is 'potted' in foam (at centre in the picture). (Photo: Richard

Richard explained to us that the amount of smoke produced by the burning PCP components and the scorched foam appeared completely disproportionate to the volume of smoke evidenced. I wrote to the manufacturers of the pump asking them whether they had any idea what may have gone wrong but, as of writing, they haven't responded.

Richard pointed out that, during an earlier test, his pump was drawing 3.2 amps, which he thought rather a lot for such a low-power device. He's now received his new pump, which draws just over 1 amp. He came to the conclusion is that the old pump was in some way defective.

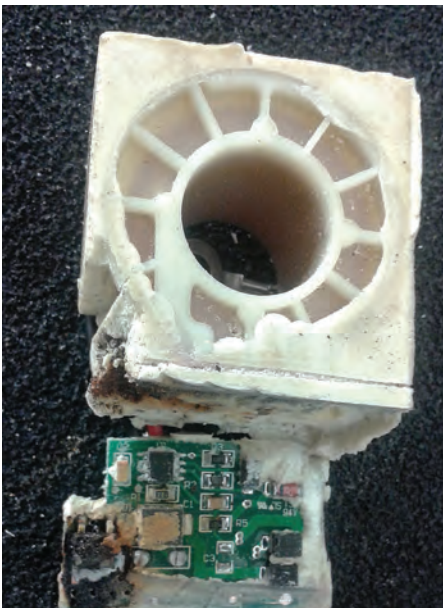
(Below) It's clear that the source of the heat which caused the fuel pump to change its role to a 'smoke generator' lay in the failure of the electronic timing mechanism. We're waiting to hear back from the manufacturers of the pump but aren't holding our breath for a response. During previous tests this pump had a running current of about 3.2 amps, while the identical replacement pump, supplied by Facet, draws only 1.2 amps so it may be that this failed pump has been living with a problem for some time.

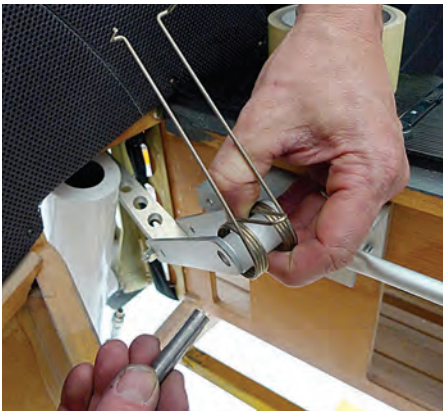
(Above) In 2010 Alpi introduced a spring bias to the over-centre mechanical undercarriage lock on all P300 aircraft. Alpi issued a Bulletin (SB 2010-02) to let owners without springs know that they springs were retrofitable – in fact, the company recommended their fitment. LAA Engineering has issued an Airworthiness Leaflet requiring all P300 aircraft to be fitted with these bias springs at (or before) their next undercarriage retraction check. *(Photo: Alpi Aircraft)*

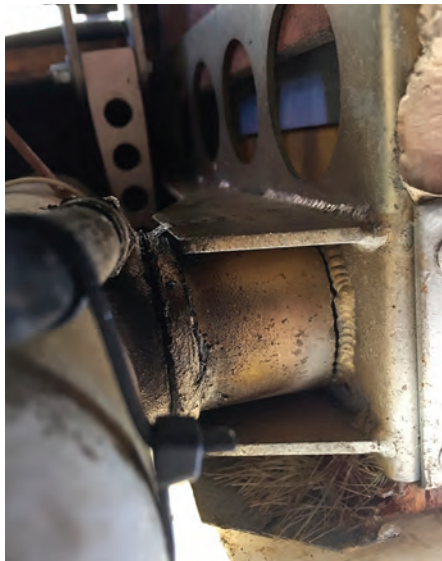
(Above) Putting aside pilot error, there are two primary reasons why retractable undercarriages fail on small sports aircraft. The first is a mechanical failure somewhere in the leg, or its associated supporting structure, while the second is that the system becomes out of adjustment. The out-of-adjustment issue is discussed in the main feature – this picture is an example of a mechanical failure. A failure like this can be because of repeated overload – for example, operations off very rough airstrips or the result of a single heavy landing. In either case, the way to avoid a complete failure is to spot the first signs – in other words, regular inspections. This crack, travelling quietly round the weld, spotted by an inspector during a post-heavy landing check, is a good case in point. If the aircraft had continued operating, the leg would have failed completely, a much more expensive repair exercise. *(Photo: Gary Masters)*

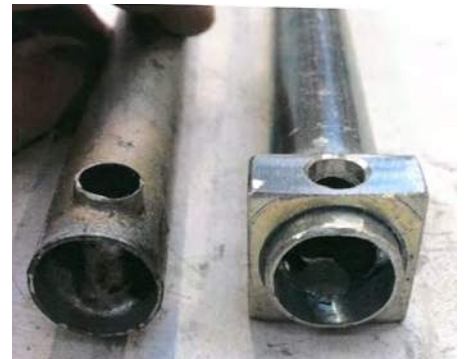
(Above) Correct adjustment of the length of the screw jack on the Alpi Pioneer operating rod is essential to ensure that the over-centre strut goes fully over-centre when the undercarriage is lowered. One problem is the adjustment of this rod has been rather too coarse. The length of the rod is changed by removing the attaching bolt and rotating the shaft through 180°, one way or another. This picture shows the original design, on the left, and the later improvement. Notice that the minimum adjustment is now afforded by turning the shaft through 90°, halving the length of the increase or decrease. *(Photo: Toby Wilcox)*

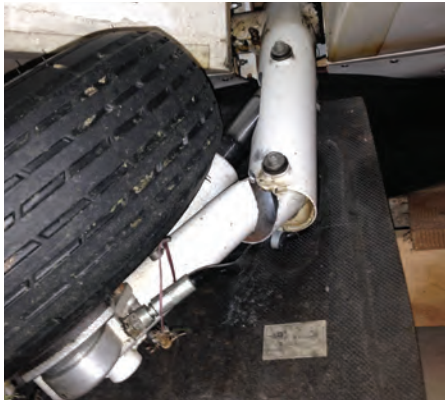
(Above) This picture shows the P300's undercarriage in its 'jammed' position. The pilot, LAA'er Roger Andrews, wrote up the tale for the February edition of *LA*. At the time of writing the story, Roger was convinced he'd hit an obstacle – perhaps just a big undulation in the ground – during the take-off run. However, further investigation has revealed other issues with this leg which may have contributed to the failure. *(Photo: Roger Andrews)*

As you can see from the pictures and accompanying text, there's some question over the reason for this undercarriage leg failure. Certainly, when it was inspected closely, the leg contained a pre-existing crack, which probably didn't help with the survival of the leg when it hit the bump. However, the big lesson here is that the undercarriage green lights were incorrectly wired, in so far as a failure in the gear motor circuit meant that undercarriage indication would also be lost.

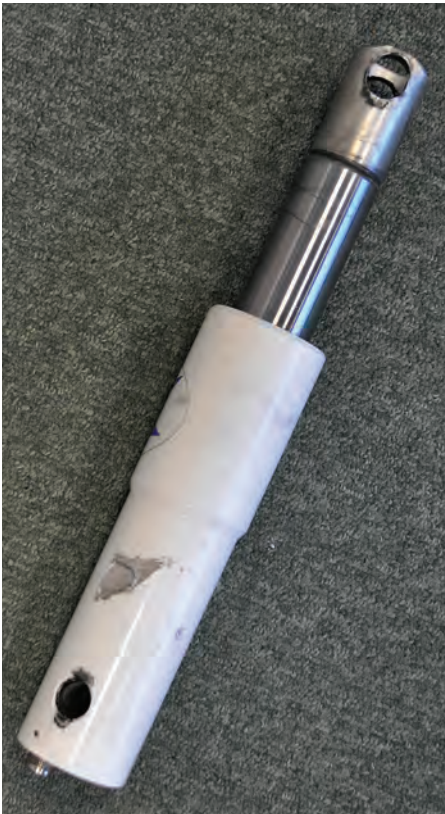
(Above) We showed this shock strut, from the P300 which suffered undercarriage impact damage during take-off, to Alpi Aviation's Corrado Rousillon. He immediately exclaimed that the reason for the wheel jamming – if it did – was that the head of the bolt attaching the brake disc had wound itself out and contacted the side of the shock-strut! Take a look at the tell-tale marks in the picture and you'll see what Corrado means. We may never know whether this undercarriage failed because of a structure failure of some sort or ground impact – perhaps it was a combination of both. *(Photo: Malcolm McBride)*

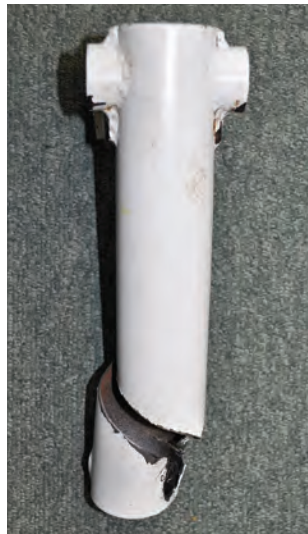
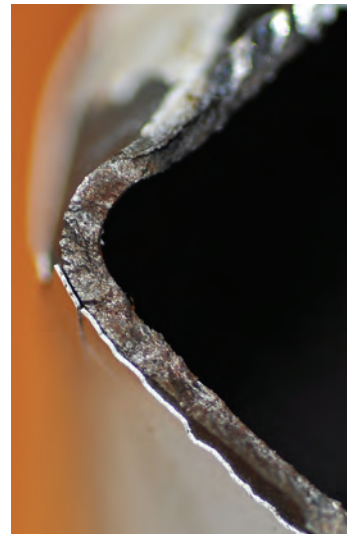
(Left) We stripped the undercarriage leg of the P300 which suffered a main undercarriage leg failure (shown far left). During a close check of the fracture face, we found that the leg appears to have been failed for some time, as can be seen by the embedded corrosion (shown in close-up, at right). *(Photo: Malcolm McBride)*

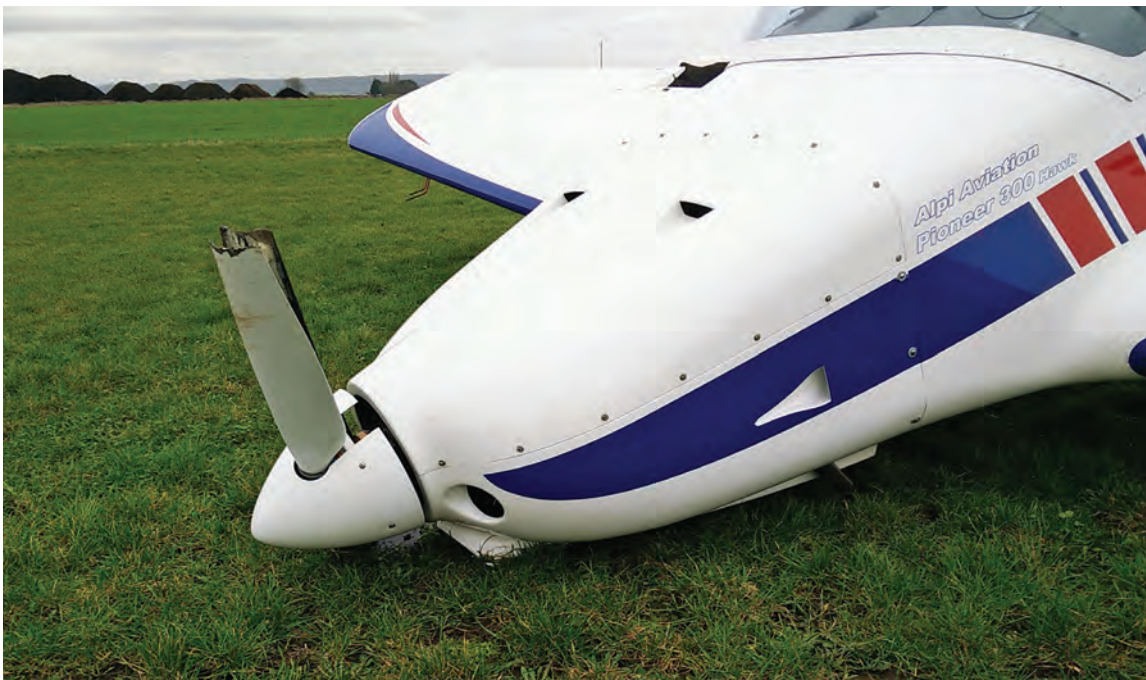
(Left) Even though I spent quite a few years looking into the reasons why an aircraft incident or accident occurs, and I should be quite used to pictures like this, my shoulders still drop when confronted with this type of sad spectacle. After all, it'll be a very expensive business to get this aircraft airworthy again. It's clear that the nose undercarriage suffered a sudden failure and that the propeller was rotating when it hit the ground. (Photo: Andrew Dayani)

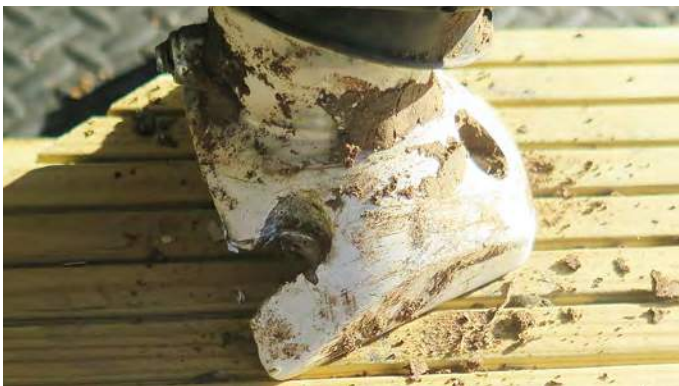
(Above) This picture shows the nose undercarriage leg's connection with the nosewheel fork assembly. Close inspection revealed that the two front bolts have been torn out of their attaching threads because of pure overload which, in turn, allowed the fork to rotate rearwards, ripping the rear bolts through the attachment. This is the first time we've seen a failure of this kind in the UK from the Pioneer fleet. However, overload failures like this do normally suggest a high nosewheel impact, perhaps by inadvertent 'wheelbarrowing'. (Photo: Al Greensmith)

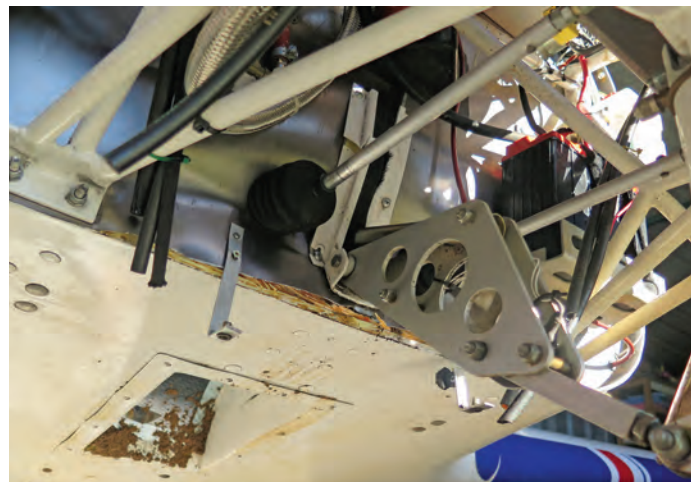
(Above) This picture of the firewall of the P300 which suffered a sudden nosewheel failure shows clearly that the over-centre system (shown centre-right) was intact at the moment of failure. Note that the firewall has been pushed rearwards due to the force applied when the leg failed. (Photo: Al Greensmith)
