With Malcolm McBride  
Airworthiness Engineer

# SUFFERING A DEFINITE DISCOMBOBULATION OF THE SPIRIT...

## The latest LAA Engineering topics and investigations

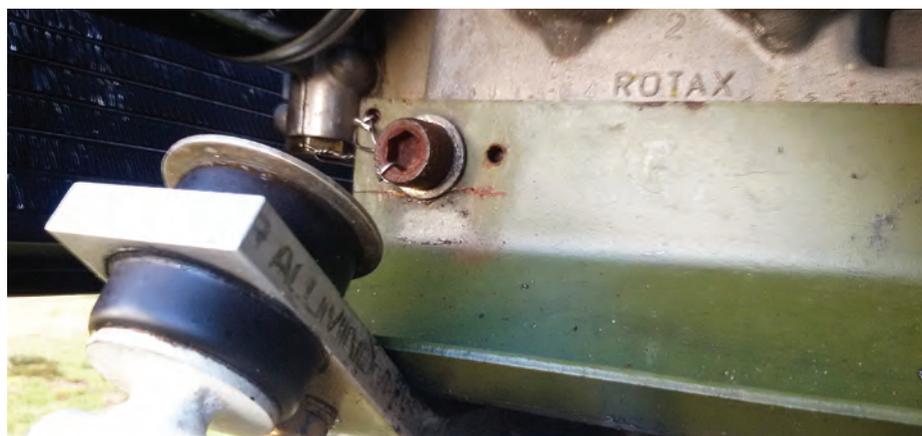
(Above) Last month's *Safety Spot* talked about Rotax 9 series engine-mounting bolts coming loose and failing through fatigue. That item generated a big response and it seems that this has long been a design issue. However, my take on this is that no design is perfect and there's much compromise in a lightweight aircraft structure, which is why close (and timely) regular inspections are so important. Here's a good example of a materials failure in a different kind of engine mounting. This 912 ULS is fitted to a Zenair 701 and, yes, both sides were cracked (below the the cap-headed bolt). Judging by the amount of corrosion around the crack, it had been there for a while. (Photo: Sandy Hutton)

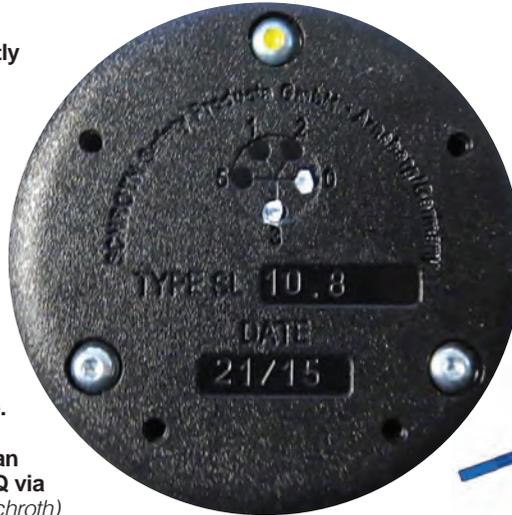
(Right) LAA Engineering has recently published an Airworthiness Alert, giving access to an important SIL from the manufacturers of the Schroth Harness. We've written to all Tiger Moth and Bulldog owners under an LAA-administered Permit to Fly, advising that, for the time being, it isn't a good idea to fly aerobatics if you've a harness affected by the SIL. You can check if a harness is affected by the SIL by looking at the 'Type SL' and 'Date' on the rear of the buckle. There may be other types using a Schroth system so if you know of an example please email us at LAA HQ via [engineering@laa.uk.com](mailto:engineering@laa.uk.com) (Photo: Schroth)

(Below) The problem with some of these Schroth harnesses appears to be that the latching mechanism can unlatch when it's under a consistent but varying load. Though the nature of the issue hasn't, at least at the time of writing, been fully disclosed, we're working closely with de Havilland Support Ltd, who hold the Type Responsibility Agreement (TRA) for the Bulldogs and the DH-82s. (Photo: Schroth)

At the time of writing, we aren't sure of the exact problem that's led to the issuance of this SIL, in which Schroth explain that: *It has been noted that in some cases it is possible that an individual latch of the restraint system could be unfastened from the buckle without prior activation of the release mechanism.*

*Investigation has shown that this effect is caused by certain patterns of load changes that typically occur during acrobatic flying, in combination with very tightly attached*

*belts. Such operating conditions may result in unusually high abrasive wear of the retaining pins and/or latches which, in turn, creates the conditions for the inadvertent release of an individual latch.*

LAA Engineering, as I explained earlier, has placed an Airworthiness Alert on our website which, as well as describing the situation, provides a link to Schroth's SIL. We've also written to all Tiger Moth and Bulldog owners, advising them of the problem, suggesting they take Schroth's advice and not perform aerobatics if their aircraft is fitted with a harness model which may be affected.

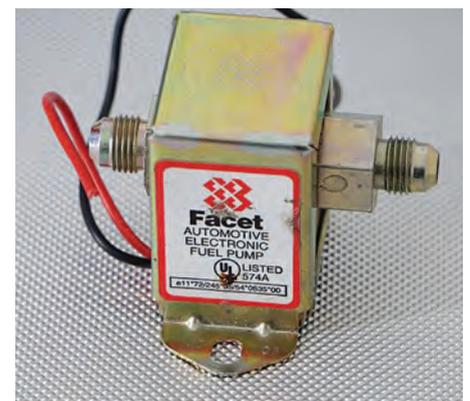
(Above) A consistent fuel pressure in an aircraft's fuel system has always been important, perhaps more so today for those using motor fuels which have a higher vapour pressure, to avoid the dreaded vapour lock. Many of you will recognise this relatively low-output Facet fuel pump – they were supplied as standard for Van's aircraft in the 1990s. These simple electrical piston pumps were designed to offer a back-up, just in case the engine-driven pump fails, and current advice suggests that these back-ups should be switched on during operations below 1,000ft. (Photo: Richard Parker)

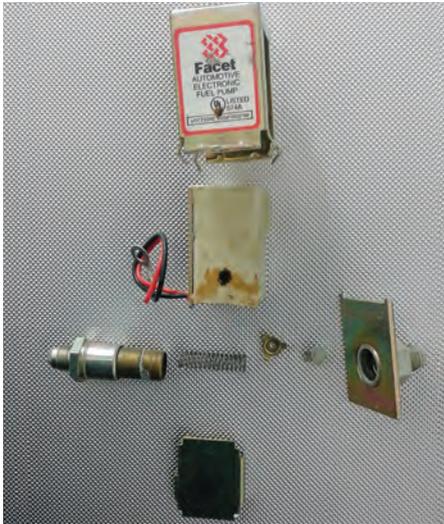
(Above) When aircraft electrical engineer and LAA'er Richard Parker switched on the electrical stand-by fuel pump fitted to his Van's RV-6, as part of his pre-take-off actions, he was surprised to find that he could soon no longer see anything, as the cockpit had filled with a "black, acrid smoke". Needless to say, he shut the aircraft down straight away and exited as quickly as possible. The reason for the smoke was tracked down to the expanded foam 'potting' compound getting too hot because of a PCB failure. This picture shows the bare bones of his failed pump and, as you can see, the shuttle piston, which contains a non-return-valve (NRV), is forced against a spring by an electro-magnet, while the inevitable electronic timing system is 'potted' in foam (at centre in the picture). (Photo: Richard

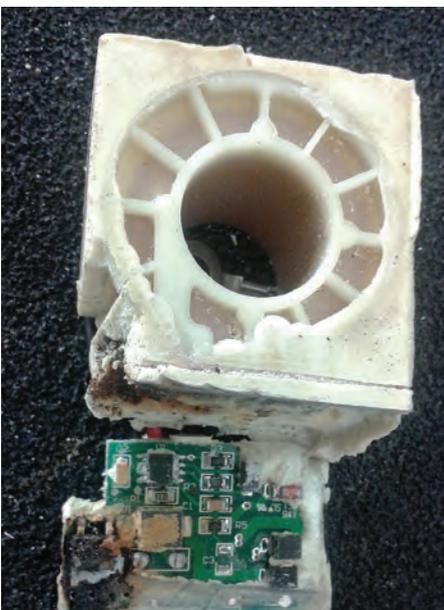
(Below) It's clear that the source of the heat which caused the fuel pump to change its role to a 'smoke generator' lay in the failure of the electronic timing mechanism. We're waiting to hear back from the manufacturers of the pump but aren't holding our breath for a response. During previous tests this pump had a running current of about 3.2 amps, while the identical replacement pump, supplied by Facet, draws only 1.2 amps so it may be that this failed pump has been living with a problem for some time.

Richard pointed out that, during an earlier test, his pump was drawing 3.2 amps, which he thought rather a lot for such a low-power device. He's now received his new pump, which draws just over 1 amp. He came to the conclusion is that the old pump was in some way defective.

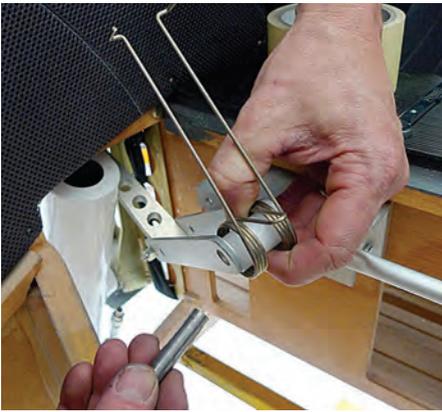
(Above) In 2010 Alpi introduced a spring bias to the over-centre mechanical undercarriage lock on all P300 aircraft. Alpi issued a Bulletin (SB 2010-02) to let owners without springs know that they springs were retrofitable – in fact, the company recommended their fitment. LAA Engineering has issued an Airworthiness Leaflet requiring all P300 aircraft to be fitted with these bias springs at (or before) their next undercarriage retraction check. (Photo: Alpi Aircraft)

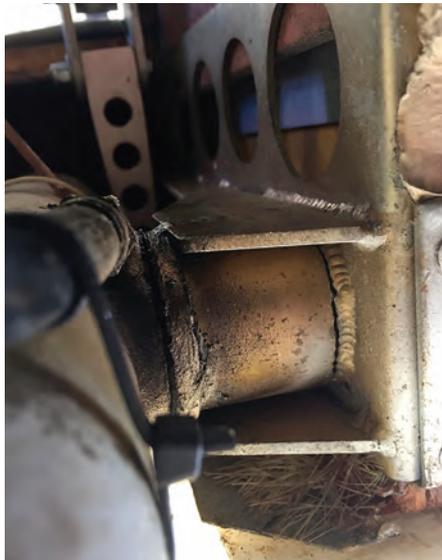
(Above) Putting aside pilot error, there are two primary reasons why retractable undercarriages fail on small sports aircraft. The first is a mechanical failure somewhere in the leg, or its associated supporting structure, while the second is that the system becomes out of adjustment. The out-of-adjustment issue is discussed in the main feature – this picture is an example of a mechanical failure. A failure like this can be because of repeated overload – for example, operations off very rough airstrips or the result of a single heavy landing. In either case, the way to avoid a complete failure is to spot the first signs – in other words, regular inspections. This crack, travelling quietly round the weld, spotted by an inspector during a post-heavy landing check, is a good case in point. If the aircraft had continued operating, the leg would have failed completely, a much more expensive repair exercise. (Photo: Gary Masters)

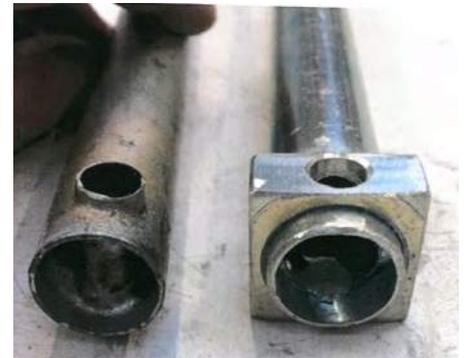
(Above) Correct adjustment of the length of the screw jack on the Alpi Pioneer operating rod is essential to ensure that the over-centre strut goes fully over-centre when the undercarriage is lowered. One problem is the adjustment of this rod has been rather too coarse. The length of the rod is changed by removing the attaching bolt and rotating the shaft through 180°, one way or another. This picture shows the original design, on the left, and the later improvement. Notice that the minimum adjustment is now afforded by turning the shaft through 90°, halving the length of the increase or decrease. (Photo: Toby Wilcox)

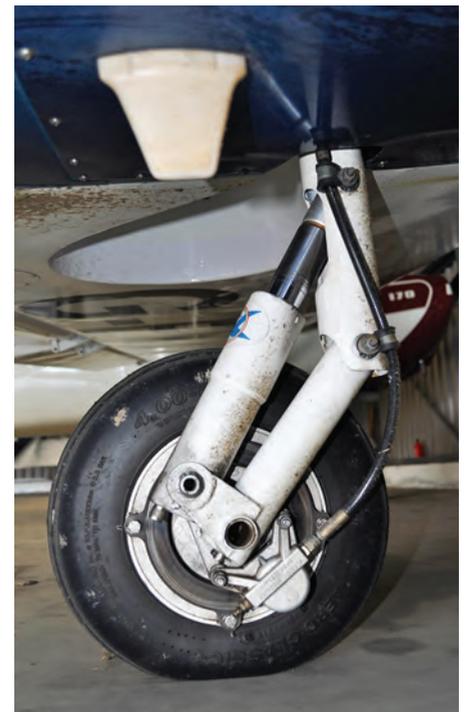
(Above) Here we show the general arrangement of the Pioneer P300 main undercarriage. This type of drag-link suspension is effective for absorbing impact loads applied roughly perpendicular to the lower swinging arm, but less so for those applied directly upwards. The geometry of this type of arrangement means it's especially important that the shock absorber is functioning correctly and not over-pressured. When we tested this leg, we found that shock-absorption wasn't that good during a drop test but was good with a fore and aft-loading case. Note the position of the brake disk attachment bolts, as discussed in the main feature. (Photo: Malcolm McBride)

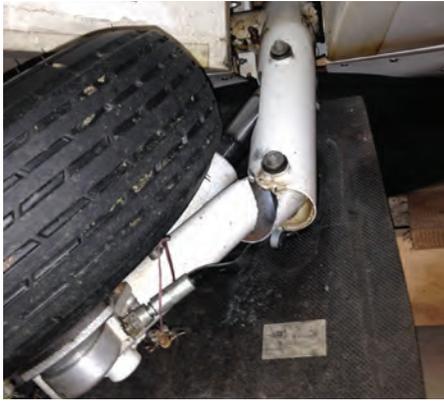
*(Above)* This picture shows the P300's undercarriage in its 'jammed' position. The pilot, LAA'er Roger Andrews, wrote up the tale for the February edition of *LA*. At the time of writing the story, Roger was convinced he'd hit an obstacle – perhaps just a big undulation in the ground – during the take-off run. However, further investigation has revealed other issues with this leg which may have contributed to the failure. *(Photo: Roger Andrews)*

On this occasion they reported that the starboard leg was abnormal. The leg was extended but the wheel was offset by 45°. The port leg was also reported to be extended.

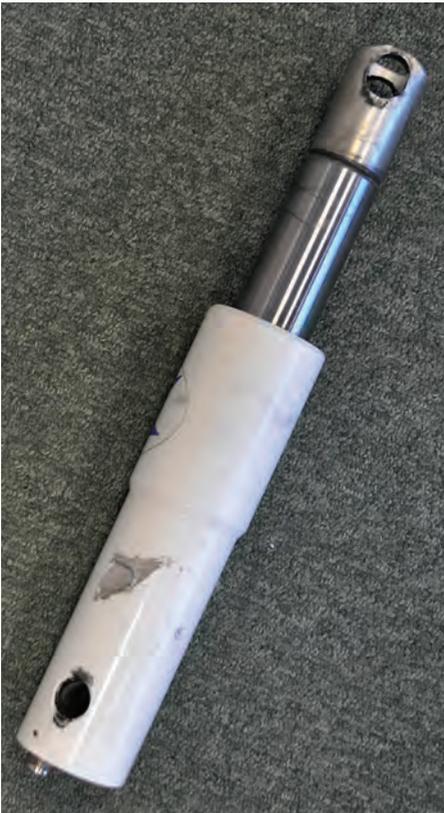
*(Above)* We showed this shock strut, from the P300 which suffered undercarriage impact damage during take-off, to Alpi Aviation's Corrado Rousillon. He immediately exclaimed that the reason for the wheel jamming – if it did – was that the head of the bolt attaching the brake disc had wound itself out and contacted the side of the shock-strut! Take a look at the tell-tale marks in the picture and you'll see what Corrado means. We may never know whether this undercarriage failed because of a structure failure of some sort or ground impact – perhaps it was a combination of both. *(Photo: Malcolm McBride)*

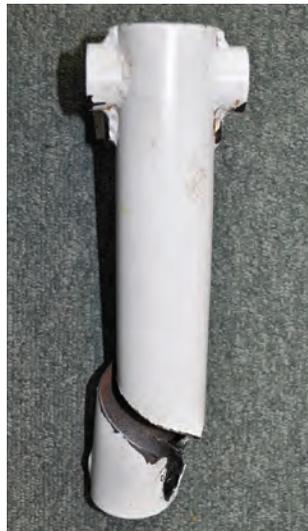
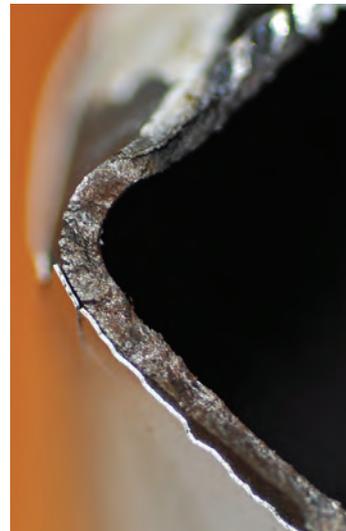
As you can see from the pictures and accompanying text, there's some question over the reason for this undercarriage leg failure. Certainly, when it was inspected closely, the leg contained a pre-existing crack, which probably didn't help with the survival of the leg when it hit the bump. However, the big lesson here is that the undercarriage green lights were incorrectly wired, in so far as a failure in the gear motor circuit meant that undercarriage indication would also be lost.

*(Left)* We stripped the undercarriage leg of the P300 which suffered a main undercarriage leg failure (shown far left). During a close check of the fracture face, we found that the leg appears to have been failed for some time, as can be seen by the embedded corrosion (shown in close-up, at right). *(Photo: Malcolm McBride)*

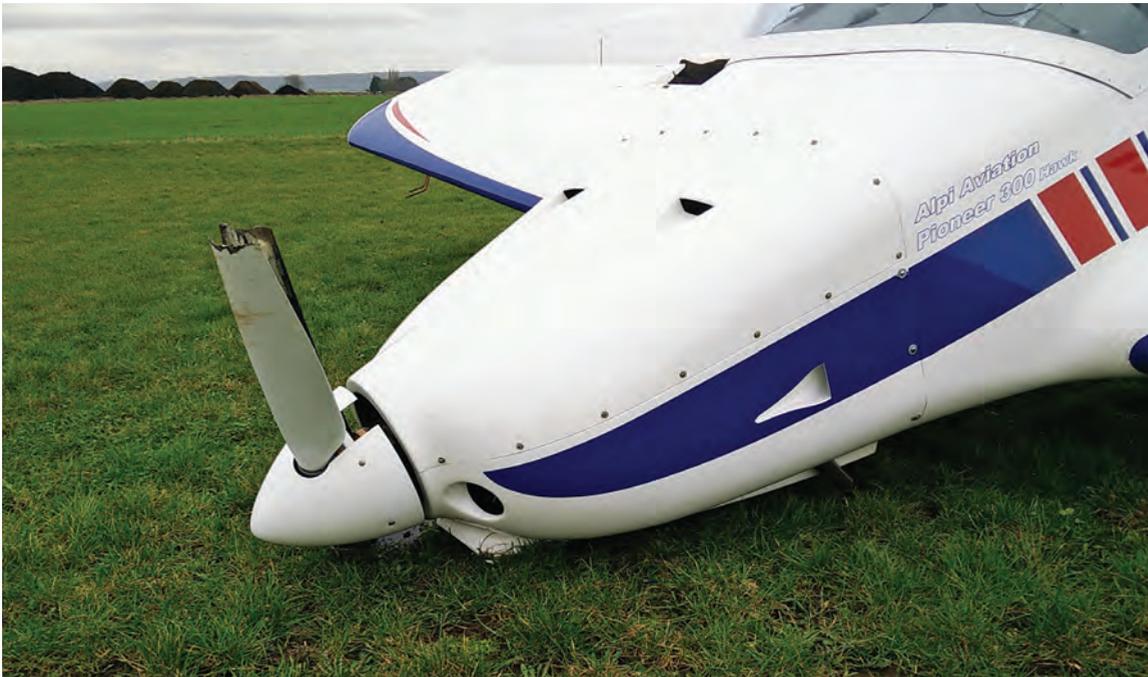
(Left) Even though I spent quite a few years looking into the reasons why an aircraft incident or accident occurs, and I should be quite used to pictures like this, my shoulders still drop when confronted with this type of sad spectacle. After all, it'll be a very expensive business to get this aircraft airworthy again. It's clear that the nose undercarriage suffered a sudden failure and that the propeller was rotating when it hit the ground. (Photo: Andrew Dayani)

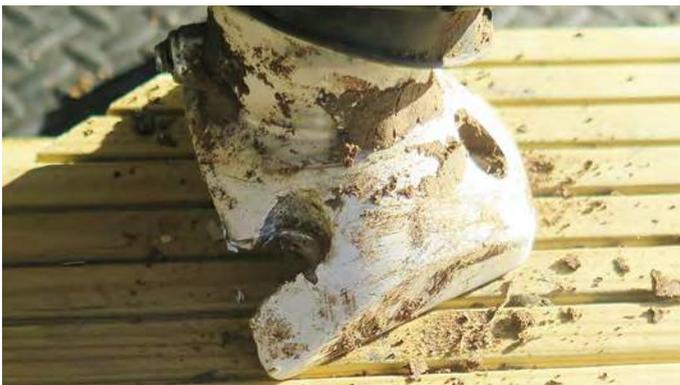
(Above) This picture shows the nose undercarriage leg's connection with the nosewheel fork assembly. Close inspection revealed that the two front bolts have been torn out of their attaching threads because of pure overload which, in turn, allowed the fork to rotate rearwards, ripping the rear bolts through the attachment. This is the first time we've seen a failure of this kind in the UK from the Pioneer fleet. However, overload failures like this do normally suggest a high nosewheel impact, perhaps by inadvertent 'wheelbarrowing'. (Photo: Al Greensmith)

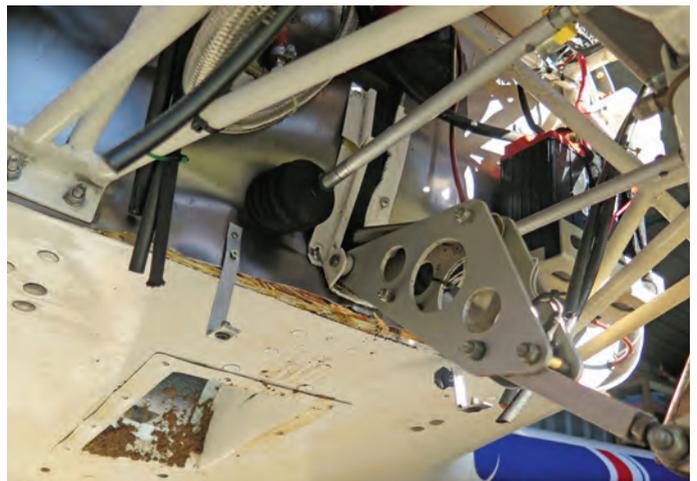
(Above) This picture of the firewall of the P300 which suffered a sudden nosewheel failure shows clearly that the over-centre system (shown centre-right) was intact at the moment of failure. Note that the firewall has been pushed rearwards due to the force applied when the leg failed. (Photo: Al Greensmith)
