Safety Spot
By Malcolm McBride

KNEE-JERK REACTIONS, TAILPIPES, JABIRU FLYWHEELS AND SEAT HARNESSSES

The latest LAA Engineering topics and investigations

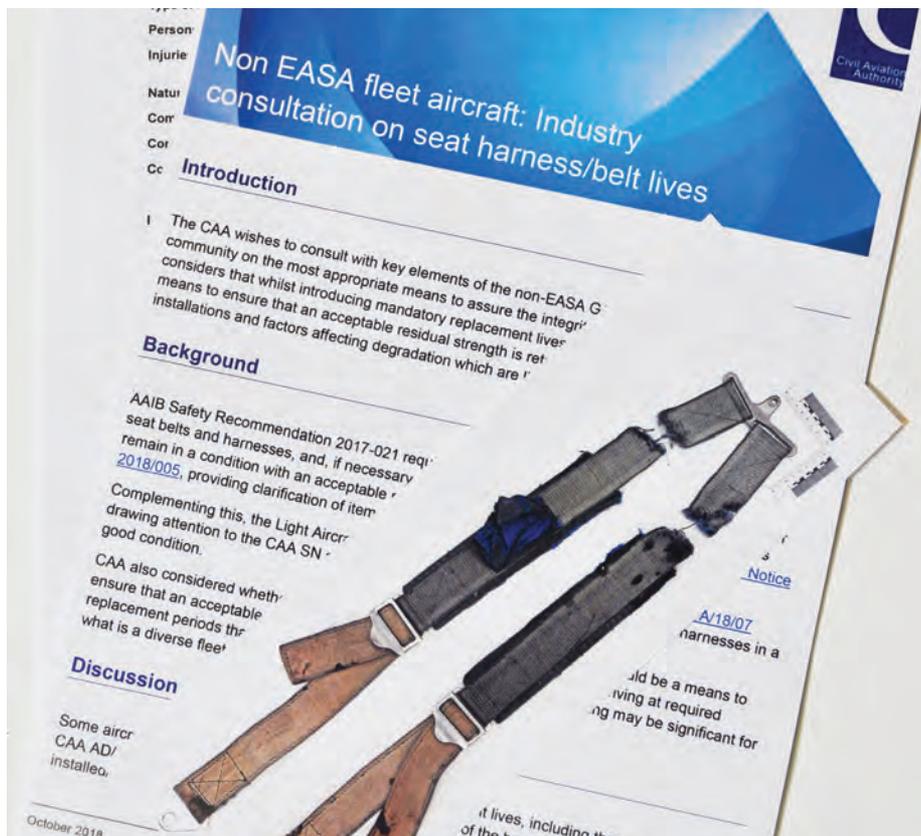
(Above) A very nasty accident in 2016 involving a Yak-52, where one pilot was killed and another seriously injured, has focussed attention on the ongoing condition of seat belts, particularly seat restraint systems in some of our older aircraft. The CAA has recently instigated an industry-wide consultation seeking suggestions about how operators can ensure that an acceptable in-service strength is retained throughout a belt's life to ensure that it won't fail prematurely when needed. Engineers from the LAA are working with engineers from the UK CAA and AAIB to assess the various suggestions made and formulate inspection advice to owners and inspectors of aircraft operating under an LAA administered Permit to Fly. If you have expertise in this area, please take the time to respond to this consultation exercise.

I have to say that the LAA's engineering team were very pleased to see that the CAA have adopted a very careful approach to the AAIB's Safety Recommendation (2017-021) to review the maintenance rules surrounding the continuing airworthiness requirements of seat-belts, issued as a result of a seat-belt failure during an accident with a Yak-52 in June 2016 (see above).

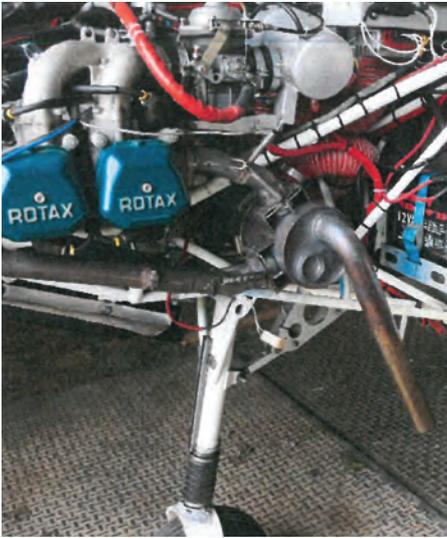
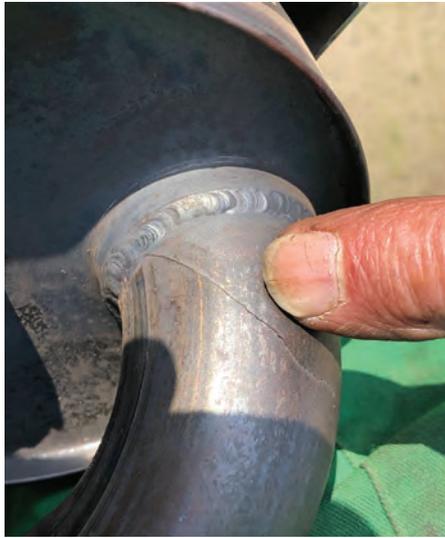
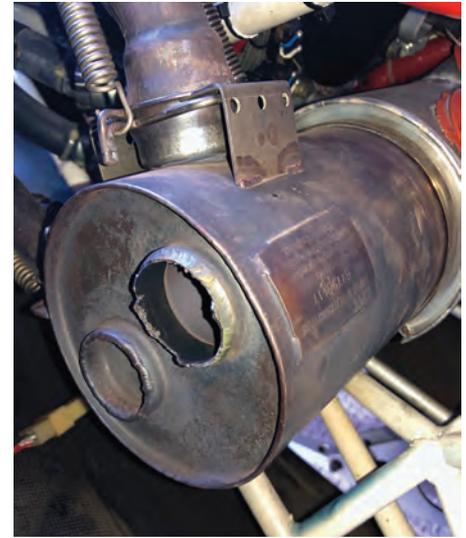
(Above) Earlier in the year two Pioneer 300 flyers suffered problems when the exhaust tailpipe detached from the silencer canister in-flight. You may remember that one of the aircraft ended up having to make an emergency landing after his cockpit filled with smoke. Aircraft exhaust systems operate in one of the harshest environments imaginable, so a close eye needs to be applied to spot minor problems before they grow into troublesome, perhaps dangerous, ones. This story features again because we've had another failure reported. The story started when the owner, Alan Robinson, noticed a crack developing in the tailpipe (see the picture above). He had this crack welded up and there didn't appear to be any other signs of distress in the connection between the tailpipe and the silencer's body. A short time later, whilst on the downwind leg to his strip, the tailpipe departed the aircraft. This picture of the installation with the cowling removed shows the exhaust's general fit. Notice two things from a design perspective: 1 the silencer canister is cantilevered back from the main body of the engine quite some distance, and 2 the very long tailpipe. Alan remarked, "We had a good track record of the last flight on our GPS, so we set off to find the missing tailpipe – we noticed straight away that the track followed a motorway – we never found the missing tailpipe but, thinking about the increased risk to road users, we won't be using the motorway as a ground feature to follow again." (Photo: Alan Robinson)

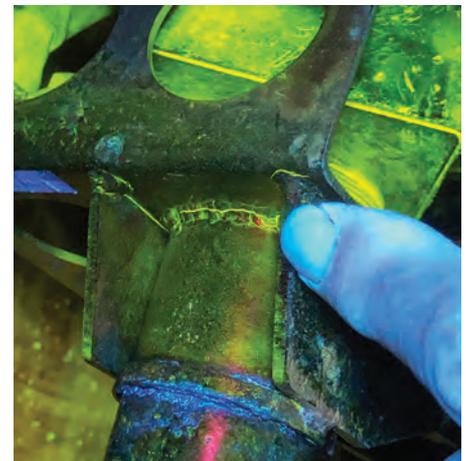
(Above) The November issue of *Safety Spot* included a story where Pioneer pilot Simon Swift had to conduct an emergency landing after his cockpit filled with smoke. Simon also described the very heavy loads imposed on the airframe after a 'difficult' take-off - essentially the aircraft hit a bump fairly early in the take-off roll, "which launched the half-flying aircraft into the air below stalling speed". So, effectively, the take-off became a heavy landing – more than one by all accounts! Naturally Simon, along with his inspector, Gary Masters (of 'Airmasters'), have been carrying out extensive heavy landing checks – the picture above shows a crack in the main undercarriage support frame (attached to the wooden main spar) – without a magnetic particle inspection (MPI) this crack through the main weld may not have been spotted. (Photo: Gary Masters)

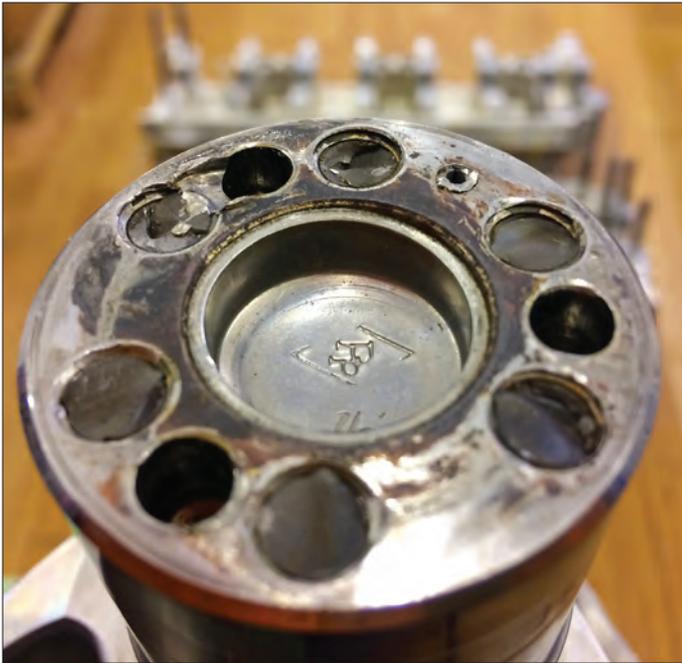
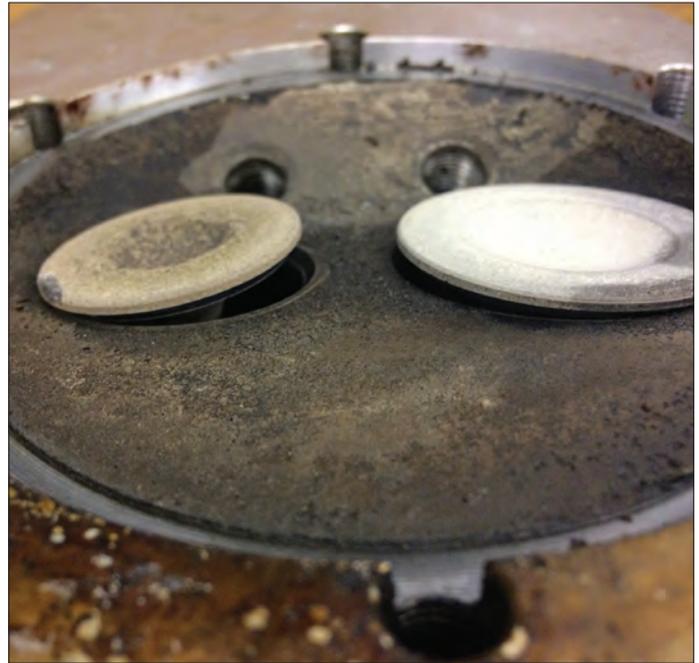
One issue that has bedeviled the Jabiru 2200 engine over the years has been the failure of the bolts attaching the flywheel to the back end of the crankshaft, and it's a recent flywheel failure on a Jabiru 3300A powered SportCruiser that's brought this engine failure mode back into sharp focus.

Naturally, if all the flywheel attachment bolts fail then the flywheel will fall off and the engine will stop. But actually, because the rear-mounted generator system (part of which supplies power to the ignition system) could be damaged by one single failed bolt head jamming between the generator's rotating parts, even the loss of one of the six attachments could end up with an engine stoppage and considerable mechanical damage. In the most recent failure case, probably because the camshaft gear jumped a couple of teeth during the flywheel's departure, the engine was completely wrecked.

(Above) From the very earliest days of the engine, it seems that Jabiru 2200 owners have been plagued with occasional failures of the bolts that secure the flywheel, so this is an issue that has a fairly interesting (from an engineering perspective) history. The two big reasons why we see material failure in a component are overload and fatigue; identifying which of these two predominate in a failure case is sometimes quite difficult. Initially, though the evidence from fracture faces in failed flywheel connection bolts showed that the failure resulted from fatigue, the engine designers decided that the core reason for this was understrength bolts so, in a rather stepwise manner, bolt sizes have steadily increased. The pictures above show damage to a Jabiru 3300 engine caused as the flywheel became detached after all the flywheel bolts failed sequentially. The picture on the left shows damage to the end of the crankshaft, the picture on the right shows valve stem damage caused when the mechanical timing of the engine was disturbed when the camshaft gear slipped as the flywheel departed. Every valve and pushrod was damaged due to the valves being struck by the pistons. (Photo: Kevin Hyam)

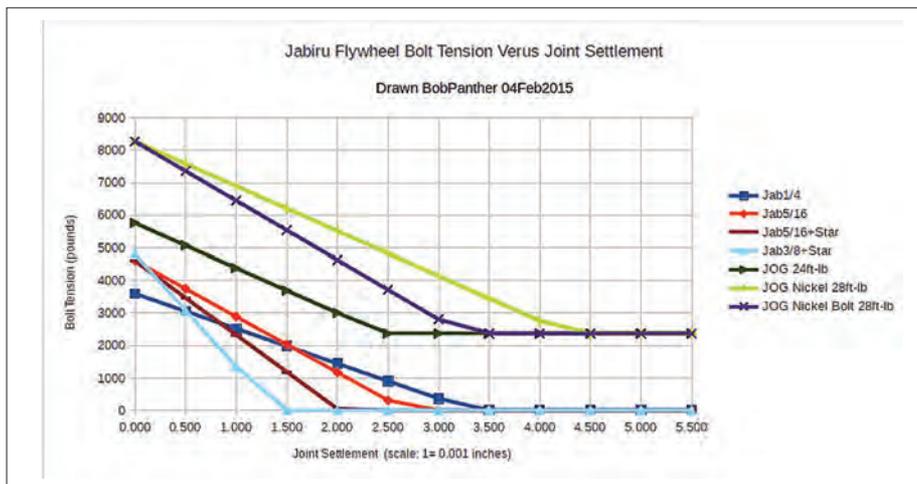
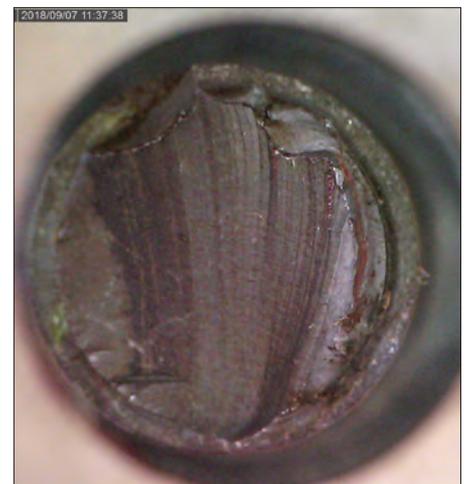
(Above) After a close study of the flywheel to crankshaft connection both in terms of initial design and by reviewing post-failure evidence, it became clear that the primary reason for the failure of the bolts was that tension was being lost over time due to settlage in the joint. The bolts, having effectively lost their clamping force, were now subject to local cyclic loading – the primary cause of fatigue. The graph on the left shows the loss of tension in various bolts against various levels of settlage. Interestingly, by upping the size of the bolts, less settlage is required to lose bolt tension, so instead of improving the attachments longevity, it actually makes matters worse. The picture on the right shows the fracture face of a failed bolt from the recent 3300 failure – as you will recognise, a fairly typical cyclic fatigue failure. (Photo: Bob Panther/Malcolm McBride)

However, it was learnt back in the 1920s that if a bolt is torqued up so that it is permanently stressed in tension to a level above that created by the alternating force, the bolt doesn't 'feel' an alternating stress, so fatigue doesn't happen. But if the bolt loses its torque-induced tension due to settlage in the joint, it will experience the alternating stress and quickly start to accumulate fatigue damage.

We think that in the case of the Jabiru flywheel bolts, it is the loss of clamping effect and pre-tension in the bolts due to joint

settlage which causes fatigue to become a factor in the life of this bolt.

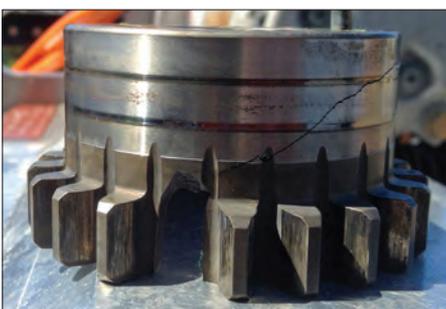
(Left) After chatting to engine overhaulers who specialise in keeping our fleet of Jabiru engines serviceable, another important point to note regarding re-assembly after overhaul came to the surface. The picture above shows a failed camshaft drive cog which, in-service, fits over the end of the crankshaft (between the crank and the flywheel). Note there's a tooth missing and, more importantly, the body of the gear is cracked. When the engineer checked the fit of this cog over the end of the crankshaft, he found that it was very tight indeed, even with the dimension-changing crack. This cog is held in place by the flywheel attachment bolts, so it's easy to imagine that if the cog wasn't seated absolutely correctly during engine assembly then, as time progressed, it would eventually settle into the fully seated position. This settlage would completely release any tension in the flywheel bolts. (Photo: Gary Cotterell)

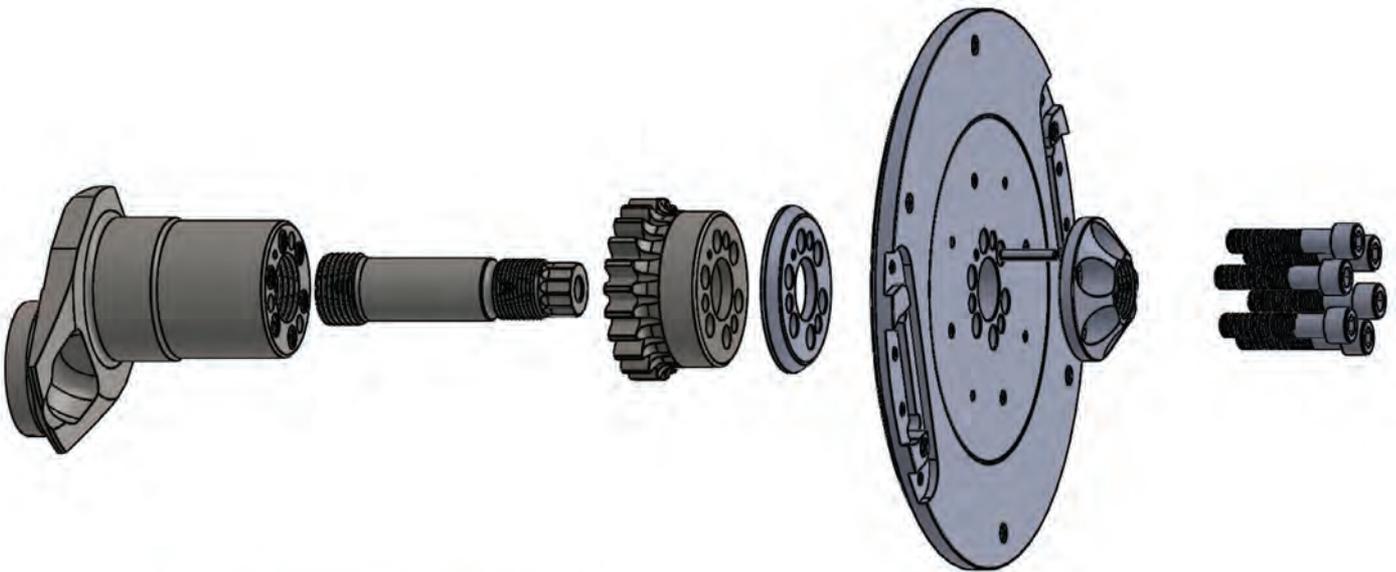
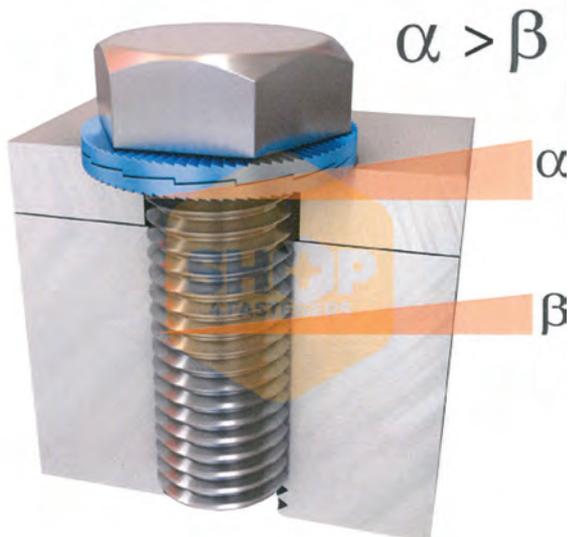
(Left and above) In the light of the most recent Jabiru 3300 engine failure, LAA Engineering, after a thorough review, has decided to issue an Airworthiness Information Leaflet (AIL) changing both the required inspection intervals and the approved methods of fixing.

Because of this most recent failure, the LAA has issued an Airworthiness Information Leaflet (AIL) reducing the inspection interval and the life in service of these bolts. In addition to this, we're ceasing to endorse Jabiru's Loctite approach to locking these bolts. In effect, we're mandating Jabiru's alternative method of using Nord-Lock washers which we consider much more effective in maintaining the clamping force in this joint and preventing the bolts fatiguing. Loctite is a great way of locking a bolted joint but, the only way to subsequently checking the torque on the bolt is to remove and replace the bolt – so it's not an appropriate way of locking this particular connection.

The sketch on the left shows one flywheel attachment method that has been recently approved – the developer of this attachment method, Kevin Hyam of CAMit Aero Engines UK Ltd., believes that its incorporation will completely solve the problem of flywheel detachment because the primary attachment is now through the differentially threaded centre flywheel clamp. As you can see, the flywheel bolts are still there but they only act to prevent the centre clamp nut from rotating and becoming loose.

Another solution, we believe equally effective, is the incorporation of NordLock X-series washers which both lock the bolt (thus removing the need for, and problems associated with, high-strength Loctite) and, because of their domed Belleville effect, retain clamping force after settlage.
