Safety Spot
By Malcolm McBride

PIONEER EXHAUST FAILURES, ARPLAST PROP THRUST LOSS & SINKING ROTAX FLOATS

The latest LAA Engineering topics and investigations

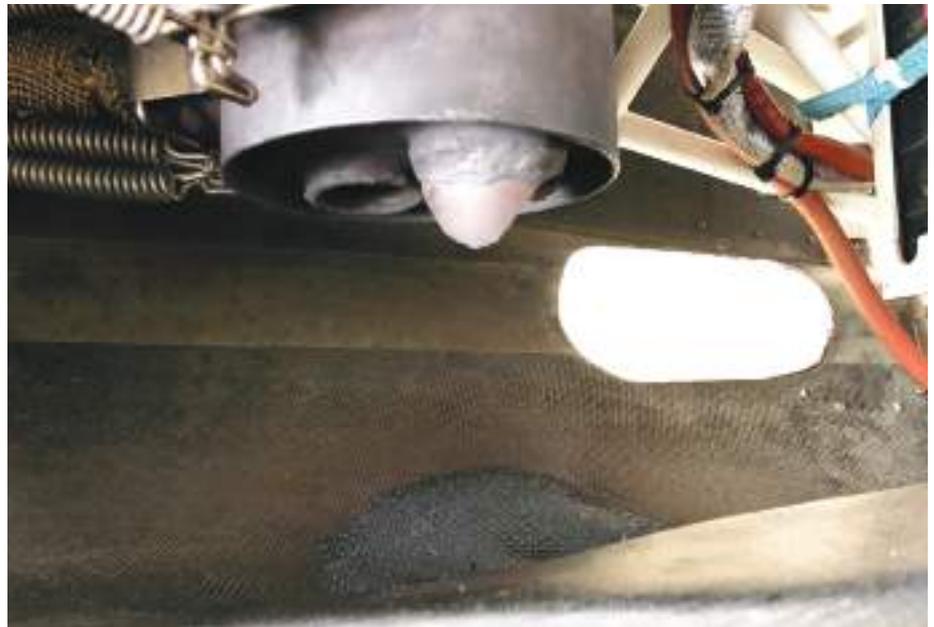
(Above) Pioneer 300 Pilot Simon Swift's return flight from Sandown, Isle of Wight, was cut short over the Solent when his cockpit suddenly filled with smoke. In fact, so much of it that he had trouble seeing out of the cockpit. After something of an unwanted adventure, which ended with a successful emergency landing at Popham, Simon removed the engine cowl and immediately saw the smoke's origin. As you can see, the tailpipe had become detached and very hot exhaust gasses were blowing onto the fibreglass lower engine cowl. The smoke generated was directed straight into the cockpit via the ventilation system. (Photo: Simon Swift)

'The cause of the problem was that the tailpipe on the silencer had broken off. The escaping hot gasses burnt a hole in the engine cowling and caused considerable damage to some of the components on the firewall.'

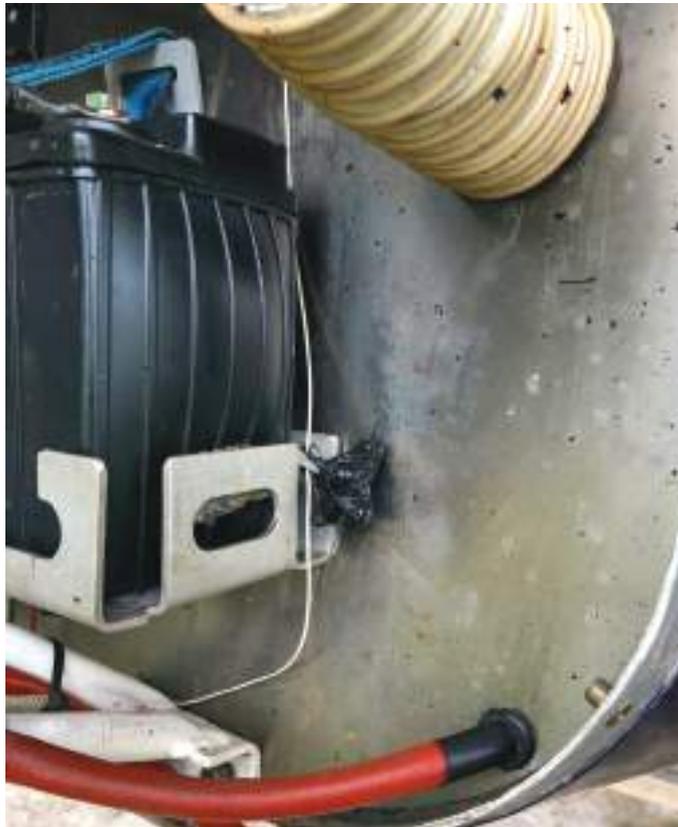
(Left) This photo shows the effect heat can have on a battery, see how its casing has been distorted. The scat hose connecting the cockpit air inlet from the duct in the lower cowl can also be seen (now disconnected) top centre. This event highlights why it's essential to check the engine, both visually and mechanically, in your daily cowls-off inspection. Don't be frightened to give the exhaust a bit of a yank, as this type of check will show you if all the expansion slip joints are working and, importantly in this case, whether a crack is growing somewhere in the assembly. (Photo: Simon Swift)

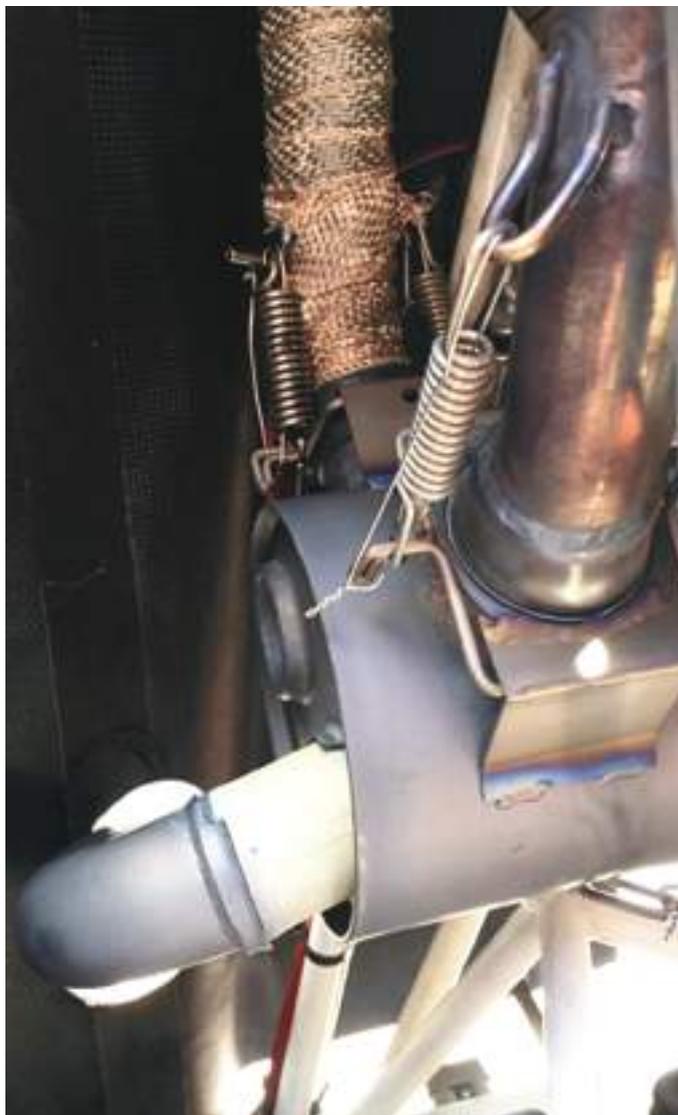
(Left) On the same day that Simon's cockpit filled with smoke because of a failed exhaust, another Pioneer 300 flyer, LAA'er Michael Foreman, had to cut short his planned flight to the Scilly Isles after he heard a distinct change in engine note during the climb out from Sleep. No smoke this time but, as you can see from the attached photo, again the tail pipe has detached completely from the expansion chamber. This time though, because the pipe itself remained in-situ, there was no further airframe damage. (Photo: Michael Foreman)

Interestingly, on the same day, another Pioneer 300 pilot, Michael Foreman, suffered a very similar exhaust failure – I hope it isn't catching, Michael explained that he's particularly annoyed at not spotting the problem before it turned into a failure, especially as he's in the habit of removing the engine cowl at the end of each day's flying, to check all's well. Cracks can be difficult to spot but putting a bit of muscle into the joint can often reveal relative movement in a part-broken component and, unless you're super-human, you won't break anything.

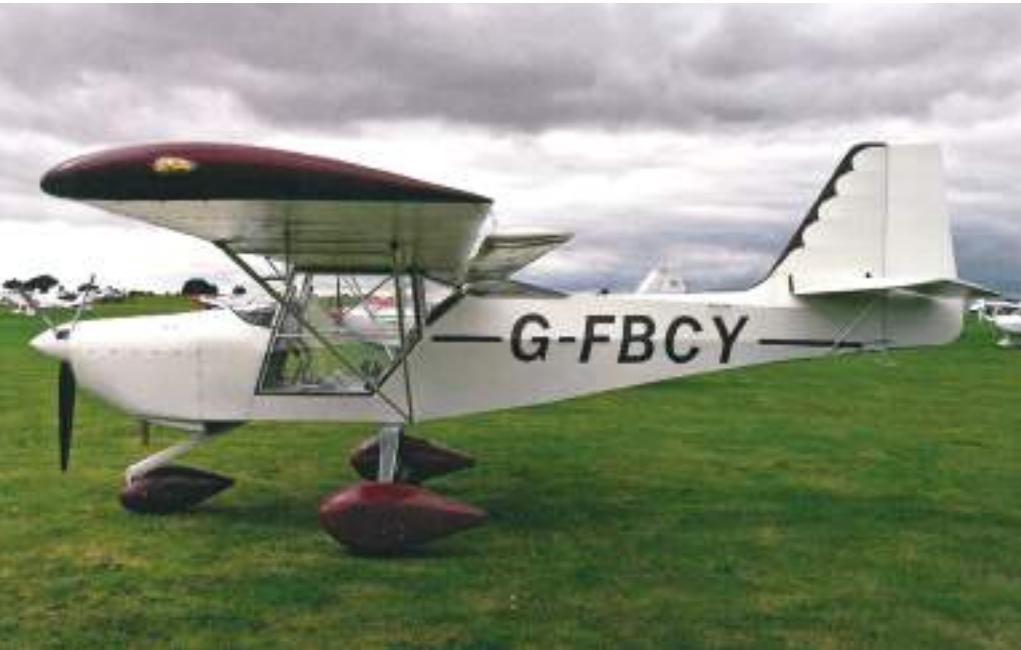
(Above) Alan Bray's nosewheel version of the Kitfox Mk 7, and very smart it looks too. This picture was taken before Alan suffered what can only be described as a 'thrust' failure during a normal departure from his local farm strip. The damage caused to the airframe during the emergency landing was limited to the nose area and, naturally, the undercarriage. However, the engine, a 100hp, four-stroke Rotax 912 ULS, which is normally limited to 5,800 rpm, was running above 7,000 rpm for some time and will doubtless need some considerable attention before it flies again. (Photo: Martin Uzell)

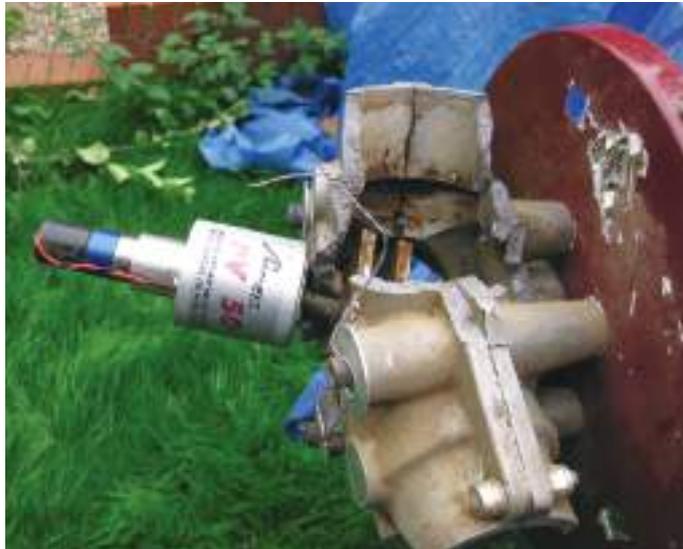
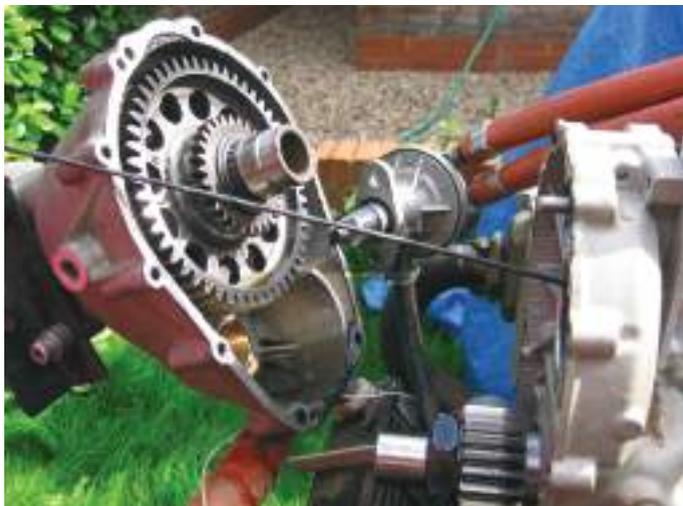
(Left & below) after the forced landing suffered by Alan's Kitfox Mk 7, initial investigations as to the cause of the loss of thrust suggested problems with the propeller pitch change mechanism or the gearbox. During LAA Engineering's visit, both these areas were inspected. These pictures show the damaged Arplast PV50 propeller hub – when found, the mechanism indicated that, at impact, the blades were in the fully coarse position, which isn't suggestive of an over-rev situation. Confusingly, although the most probable reason for the apparent loss of drive to the propeller was a drive-train failure, a local inspection of the recently overhauled gearbox didn't show any evidence of failure. (Photos: Malcolm McBride)

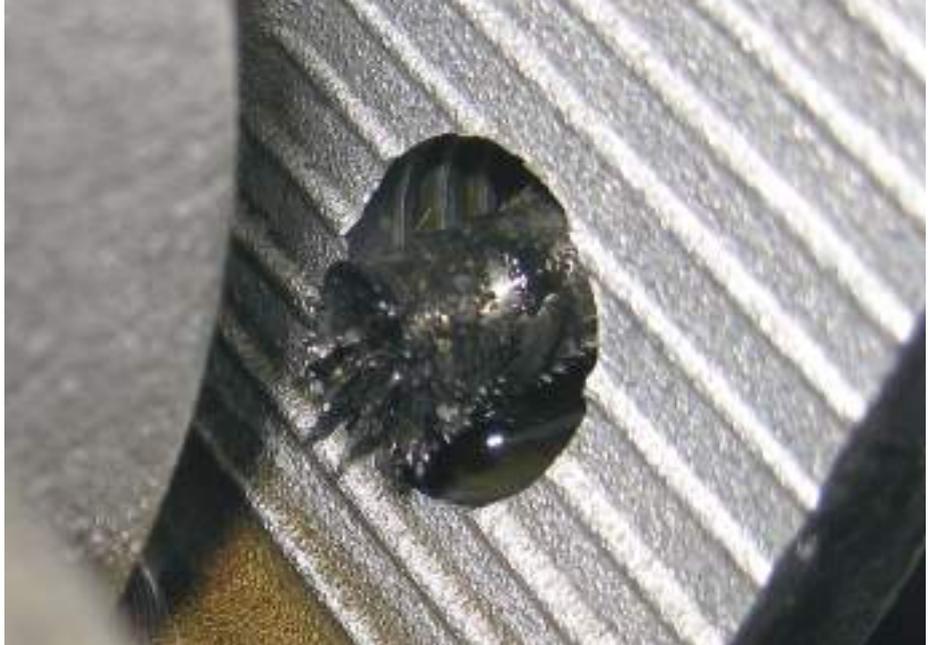
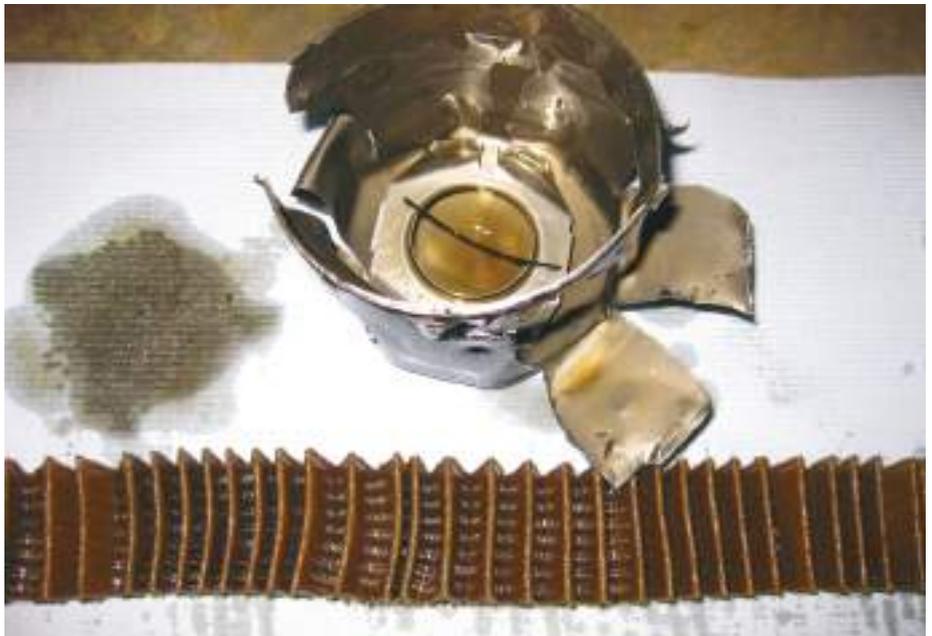
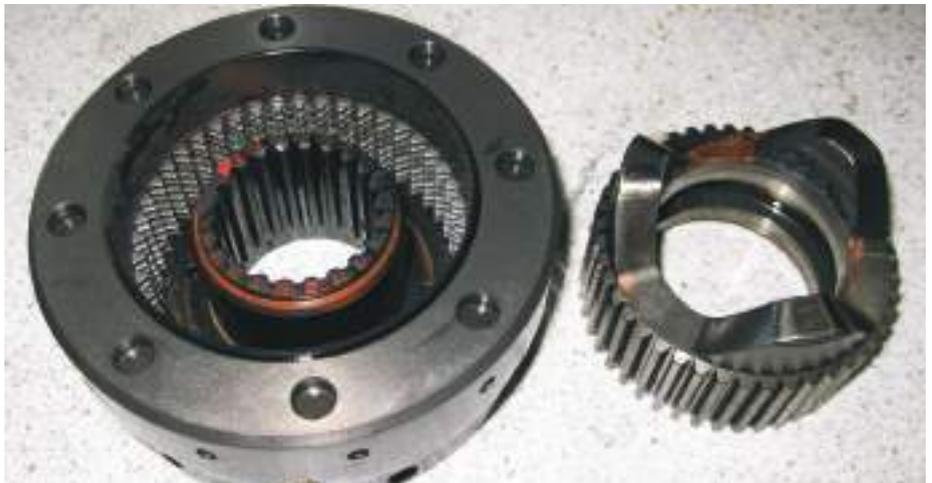
(Above, from top) After establishing that the reason for the loss of thrust wasn't, or at least didn't appear to be, a 'super-fine' propeller pitch issue, the drive-train in the gearbox became the prime suspect. Initial visual inspection didn't reveal any obvious issues and the gearbox appeared to be operating normally, so a closer look was necessary.

A study of the basic gearbox design suggested that there were only two points of failure which could lead to a loss of drive, namely a 'disconnect' of the crankshaft drive gear or the failure of the overload clutch assembly. A mechanical failure in an engine or gearbox usually leaves evidence in the oil and failure products normally collect in the oil filter or, in some engines, if ferrous, on a magnetic drain plug. These three pictures show these areas of interest – note the particles on the drain plug, which are deemed fairly typical in an essentially new assembly – both the oil filter element and the clutch assembly were normal. (Photo: Malcolm McBride)

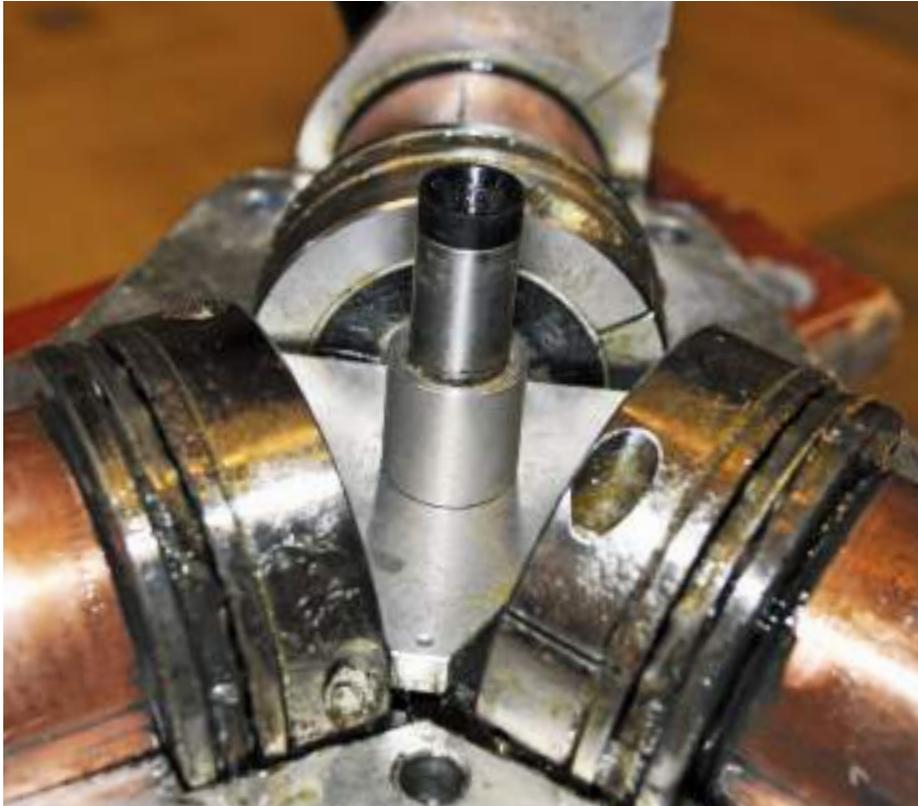
(Above) This picture shows part of the pitch change mechanism in the Arplast PV50 propeller – the front casting, which contains the drive motor, has been removed. The triangular carriage, seen at the centre, moves forwards and backwards (up and down) as a result of the force generated from the threaded, motor-driven, lead screw (removed here). A single peg in each of the blade roots sits in a slot in the carriage so, as it moves, the blades are forced to rotate, increasing or decreasing the relative blade angle to the airflow as they do so. *(Photo: Pete Jeffers)*

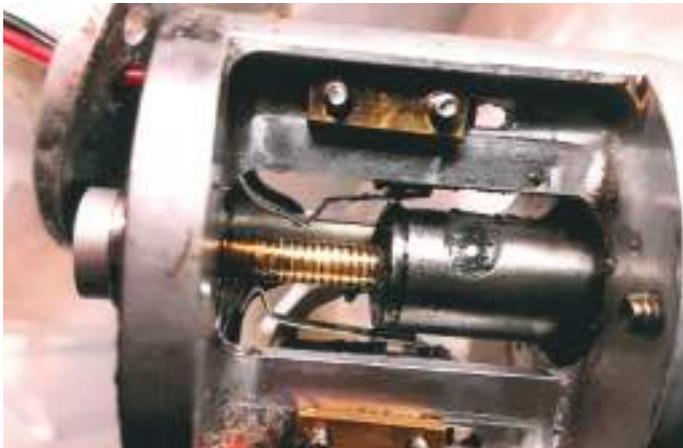
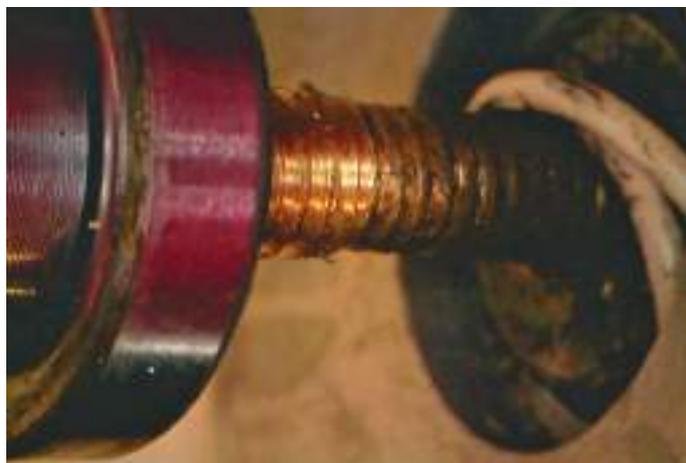
Then, what caused the lack of thrust? In this case, although it took a bit of working out, it was discovered that the lead screw in the prop pitch change mechanism had failed. >

(Left & below) The drive mechanism in the Arplast PV50 propeller shown more clearly. The first picture at left shows how the lead screw works – as it rotates it pulls or pushes the carriage forwards or backwards. You can see that the motor has been moved to the side so that the mechanism can be moved manually on the bench, also notice the range-limiting micro-switches. Although the screw thread, as seen in the photo above left, looked very worn, only when it was nearly fully withdrawn, as shown in the photo at left, did the damage to the thread and the failure of the mechanism, become totally obvious.

As it turned out, the gearbox checked out fine but, in a more detailed strip inspection, the lead screw was found to have failed, hence the propeller's natural tendency, as rpm rises and centrifugal effects predominate, to go to full fine (Centrifugal Turning Moment caused the overspeed). Selecting full coarse in the cockpit didn't make any difference to the propeller pitch but, once the engine had stopped developing power (failing due to excessive rpm) the natural tendency of these propellers to go to full coarse (Aerodynamic Turning Moment) at lower rpms took over.

What about the LAA's requirement for a fine-pitch stop? After an accident in 2008, involving a Europa, where a propeller pitch change drive failed and the resulting very fine pitch meant that the propeller lost most of its ability to produce thrust, the LAA already had a requirement that all in-flight variable-pitch propellers must be fitted with stops limiting the 'fineness' of the blade angle, whatever happens to the mechanism that moves it. In other words, even with a complete failure of the control mechanism, the aircraft will still remain flyable.

We're going to introduce a propeller TADS which will be available online and, most probably, we'll be writing to all PV50 owners letting them know about the fine-pitch stop requirements – there's some admin work here as we're going to have to do some research into where these props might be.

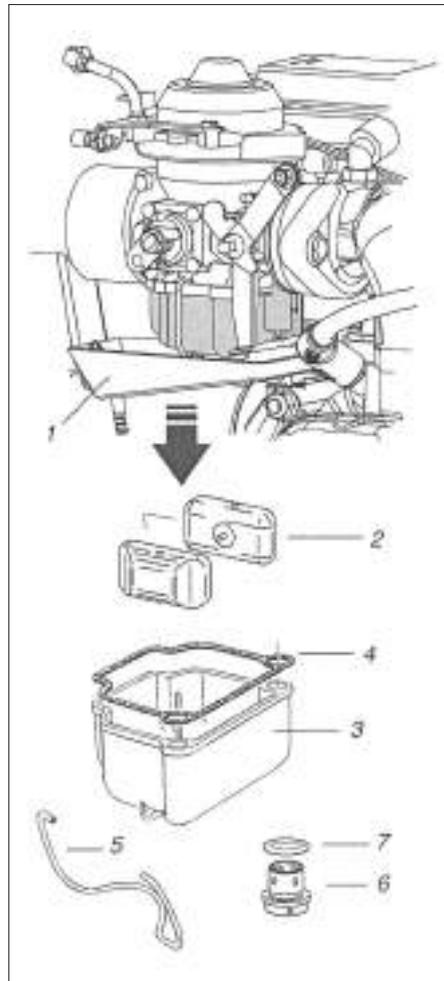
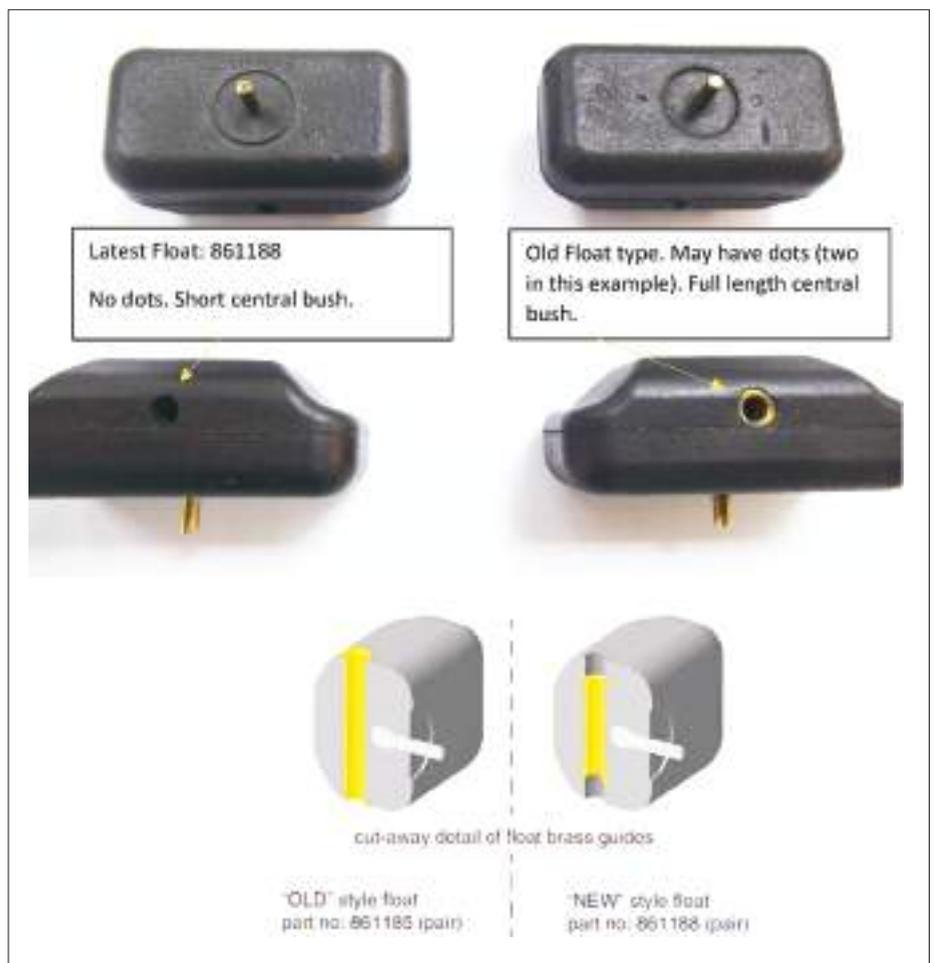
'The aircraft had operated for thirteen hours using Avagas 100LL before the incident. The cause of the power surging and failure to reach beyond 4,300 rpm (normal take-off rpm is 5,800) was the failure of the floats in the LH carburettor. They were overweight and not floating as required.'

(Left & below) We thought that the problems associated with 'sinking' floats had passed into history but a recent incident involving Cavalon gyroplane demonstrated that isn't the case. Although shrouded in mystery, anecdotes suggested that the reason for the excess of numbers of failures of this important part a few years ago, and the issuance of a number of *Service Bulletins* from the manufacturer, was due to a manufacturing defect in a batch of floats.

The defect showed itself as an increase in float weight because of fuel absorption in its foam core. The SBs produced along the way suggested hours-based checks were necessary, although field experience shows that the failures, when they occur, are random events. This is why LAA Engineering suggest that if Rotax operators notice any change in the behaviour of their engines, especially differences when idling or problems starting, they check their floats first. Most likely the richer mixture, essentially the first effect of a raised fuel level in the float chamber at low rpms, is likely to be causing the problem. *(Photos: Rotax Engines/CFS Aero)*

However, as I write these final few words, I've just received a worrying report that some Bristell owners have been suffering rough-running engine issues, which seem to be connected with their floats. Naturally, more research is needed but it might be wise, if you're operating one of the more complex Rotax carburetted engines, to change the floats to the latest type.

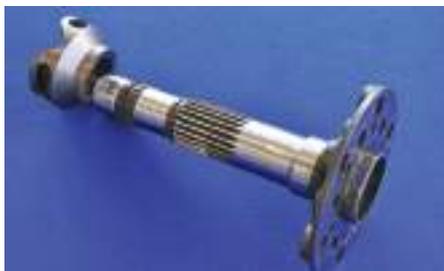
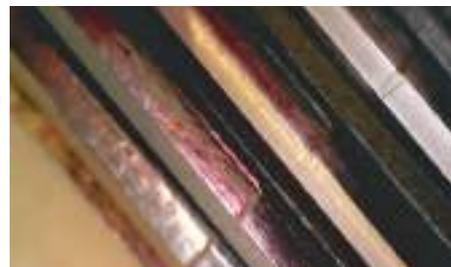
(Above & above right) Here we have a propeller shaft from a Rotax gearbox which suffered excessive and rapid wear shortly after being fitted during a gearbox overhaul. As you can see, this Rotax part is beautifully engineered and should last, if treated kindly, for over a thousand hours in service. Alongside the UK Rotax agents, CFS Aero, the LAA is looking at why this individual part has prematurely failed. Gearbox experts we've talked to are sure that this kind of damage is indicative of a tiny centring misalignment during manufacture. Rotax has replaced the part under their warranty scheme but this incident highlights the need for pilots to keep their engines out of the low rpm rough-running range whenever possible. (Photos: Malcolm McBride)

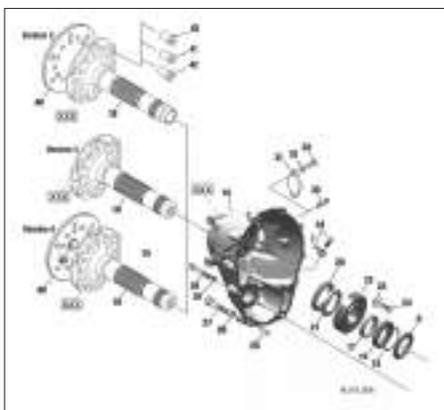
(Left) At the time of writing, we're waiting for a response from Rotax HQ about the reason for the premature failure of a member's propeller shaft, as detailed above, although it's interesting to note that the latest edition of the *Illustrated Parts Catalogue (IPC)* shows that the company has introduced an 'oiler' directed at the shaft into new gearboxes – see item 44 in this picture. (Image: Rotax Engines)

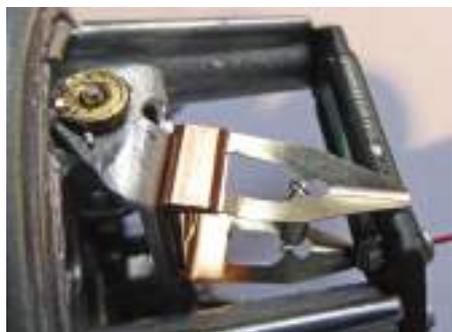
(Left) Although many mechanical devices can operate through quite large ranges of movement, normally some tend to do so within a very narrow spread. This narrow range of normal operation will naturally mean that any position-related wear will be focused into a small area. This picture, of the inside of an oil pressure sender unit which stopped working in service, illustrates the issue very clearly. Essentially, this device varies an output voltage by changing the position of the 'wiper' on the rheostat, effectively lengthening or shortening a long length of thin wire – seen at far right. This movement increases or decreases the electrical resistance in the circuit as a response to change in the oil pressure. In the cockpit, the pilot sees an oil pressure gauge but in reality it's a voltmeter! The picture shows that the engine from which this unit was removed operated with a fairly constant oil pressure, probably somewhere around 60 PSI or 9v! Although that's good for the engine, you can see the wear in the rheostat which went 'open circuit' (failure) after 500hr in service. (Photo: Pete Jeffers)
