# Safety Spot

## Tailplane corrosion, creating a TMS, importance of following the 'drill' and nosewheel damage

### Luscombe 8E – Tailplane Corrosion

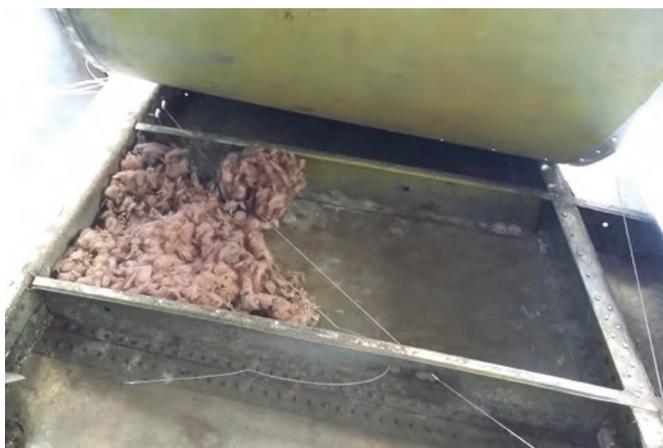
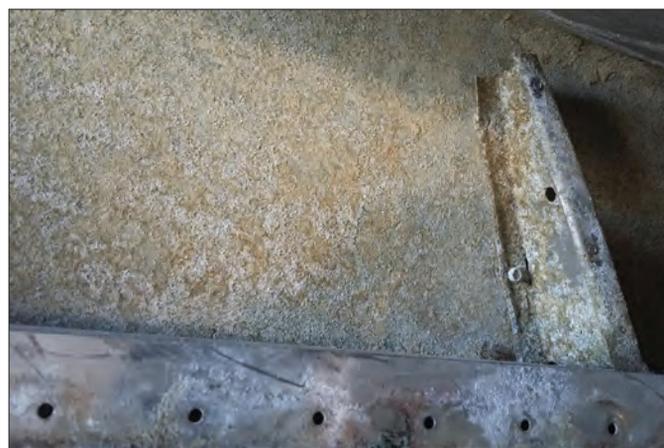
**Above** In 2018, Peter decided that it was time to carry out a deep maintenance check on the empennage of his aircraft so, because the inside of the tailplane, most especially of course the fuselage to tailplane forward and aft. attachment points, couldn't be inspected without lifting the aluminium skins, he decided to de-skin the assembly. The pictures above show a first glimpse of a structure built more than 70 years ago. Notice the mouse nest (left)! **Photo Peter Bentley**

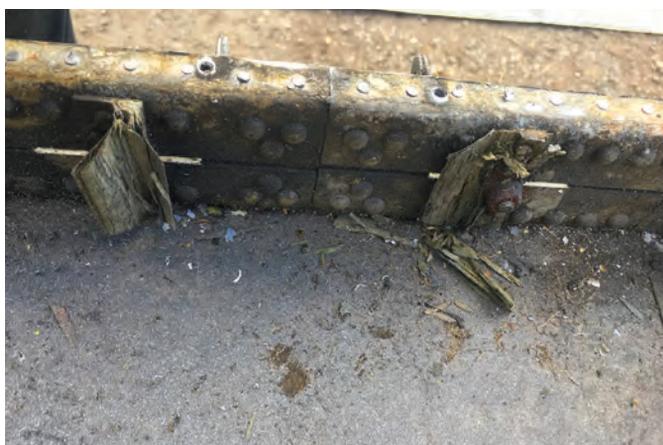
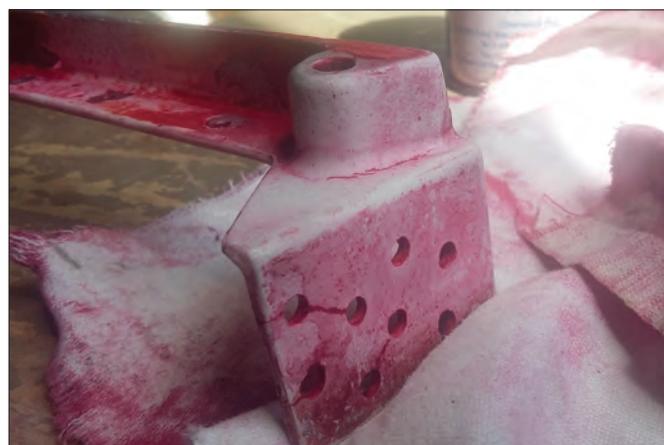
**Above** On the left are the Luscombe's rear attachment brackets hidden within the tailplane. As you can see, they have nearly corroded completely away. Picture right shows the forward attachment bracket which is riveted to the fuselage – this bracket looked OK from the corrosion standpoint, but when a non-destructive, dye-penetrant test was carried out cracking is visible in the forward lug receptacle and between the rivet attachment holes. **Photo: Peter Bentley**

usage, them, you and your beautiful flying machine's original manufacturers. You don't want to be flying around in an aircraft you don't trust. Peter feels quite lucky that the tailplane on his aircraft didn't fall off because the attachments had nearly corroded away, and he had no idea they were in such a terrible state before taking a closer and deeper look.

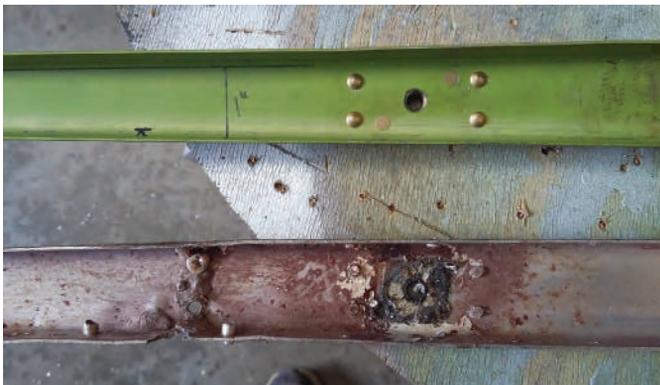
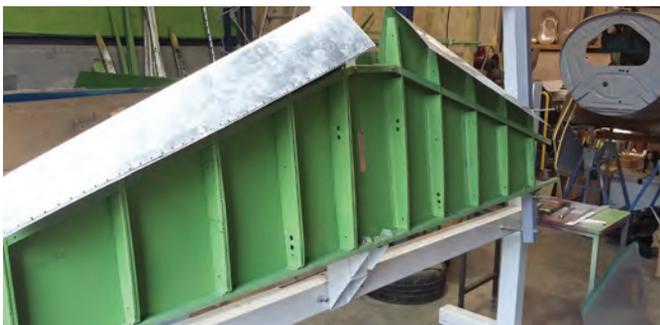
**Top and Above** Before/After. The picture (above) shows the tailplane during its refurbishment, note the substantial assembly jig – secure jiggling is essential in any situation where aircraft skins are going to be replaced. **Photo Peter Bentley**

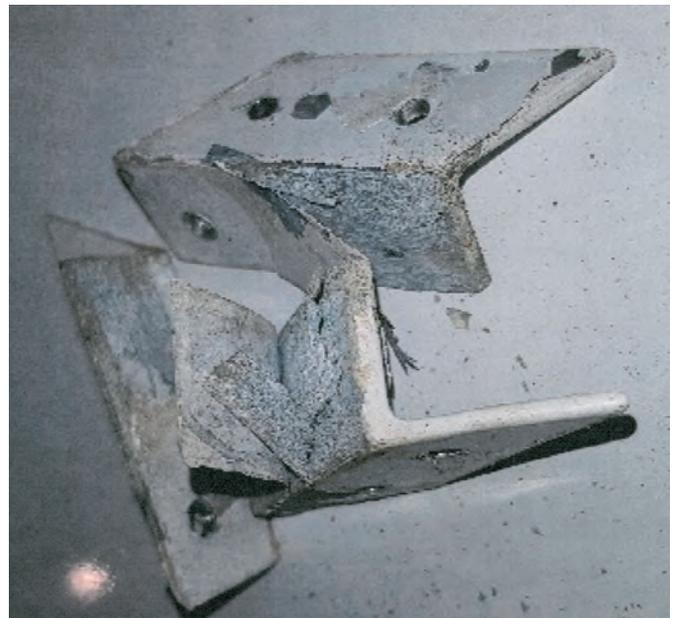
**Above:** To emphasise the fact that corrosion is not limited to the Luscombe aircraft – and that it's not just the Luscombe that contains areas in its structure which are difficult to inspect – here's a picture that arrived in LAA HQ a few weeks ago showing severe corrosion in some MCR-01 (Bambi) aileron attachment brackets. These brackets were only seen because the aircraft was involved in a minor (ish) incident where the aircraft overran the runway and the nose undercarriage was damaged. A subsequent deep inspection for other damage revealed the above. **Photo Nick Stone**

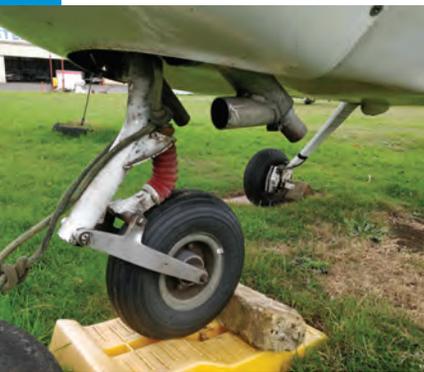
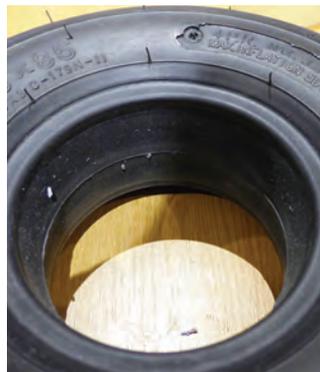
**Above** Occasionally landings don't go completely to plan, and quite often when this happens there will be damage to a nose undercarriage assembly. The picture on the left shows the result of one such event where the pilot entered what is sometimes described as a Pilot Induced Oscillation (PIO) during a rather rushed landing. Notice that the shock strut (see the red rubber doughnuts) has been significantly bent in overload. Undercarriages are designed to absorb energy so that airframes aren't damaged during landing, or when taxiing over undulating ground. Part of the undercarriage's suspension system includes the suspension afforded by the pneumatic wheel and tyre assembly – the picture on the right shows a pneumatic tyre that's been modified by infilling with a solid rubber compound. The aircraft involved was a Jabiru UL-D factory-built training aircraft and LAA Engineering has written to all UL-D owners operating under an LAA administered Permit, reminding them that changes like this can only be made after a modification application is made and granted.

When the aircraft was inspected it was discovered that the nosewheel tyre had been replaced with a rubber-filled solid tyre. Further inspection of this by the UK Jabiru agent, Dave Almey, revealed that there was almost no give in this type of tyre, and this lack of give would have undoubtedly changed the suspension characteristics of the nose undercarriage assembly.

I had never heard of a solid aircraft tyre before and, looking at the pictures the owner sent of it, I think that it would be a difficult thing to spot from an inspection point of view. The tyre is completely standard in every other respect (including the impressed information about maximum inflation pressures). Further enquiries, just for interest, revealed that these tyres are modified by a firm here in our neighbouring town of Brackley for use on mobility scooters. I chatted this tyre choice through with the owner who explained that he'd been suffering punctures very regularly and, on the advice of a flying instructor, he chose the solid tyre option.

It is essential that any changes like this are first discussed with your LAA inspector, who will be able to judge whether the proposed change would need some kind of official approval. In this case, it's not likely that the change would be approved as the aircraft would need to go through extensive drop-testing to ensure that the undercarriage, as a system, still worked as it should. Without the added suspension afforded by a pneumatic tyre it's unlikely that the nose undercarriage would survive such a test and would fail – as was seen in the field during this incident! Fair Winds. ■

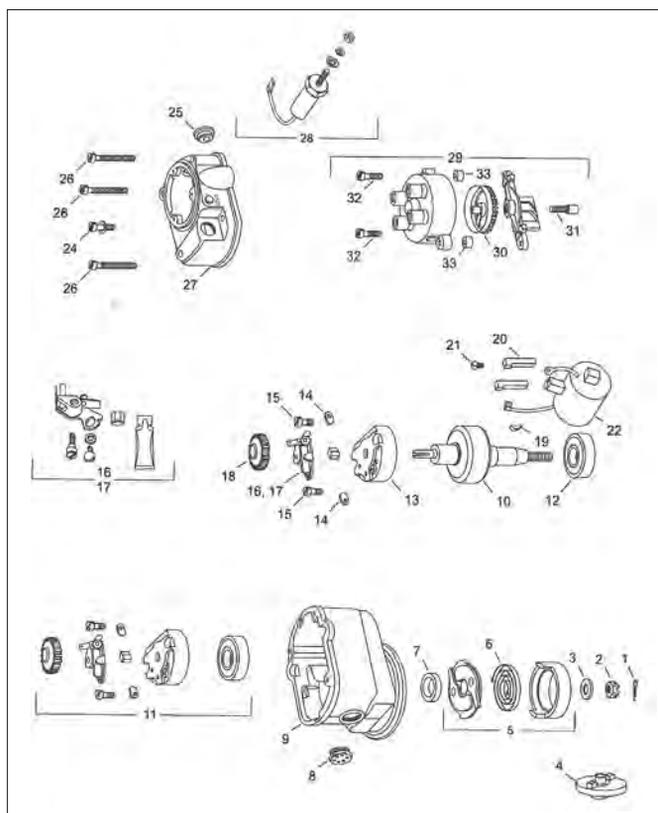
Right Slick magnetos are common in the GA fleet and only rarely cause trouble, although one issue that was once considered quite rare – slippage of the distributor gear's 'finger' electrode (item 30 in the exploded parts diagram) – appears to have become a more common failure mode. Champion Aerospace recently reissued a Service Bulletin (SB1-15A) suggesting that some magnetos designed for four-cylinder engines may suffer a decrease in service life because of this issue, they'll replace the potentially defective part free of charge. A recent LAA Airworthiness Alert gives full access to this document. First sign of a problem is most likely to be a rough running engine when operating on the defective magneto. Of course, the most common cause of a large mag. drop or single mag. rough running will be a fouled plug, so check the plugs first! **Photos Norvic Aero Engines/Champion Aerospace**
