## All Tail-Draggers with Tubular Steel Frames.

### Cracking & Corrosion at Aft Tail Post Welded Joint & Lower Longerons.

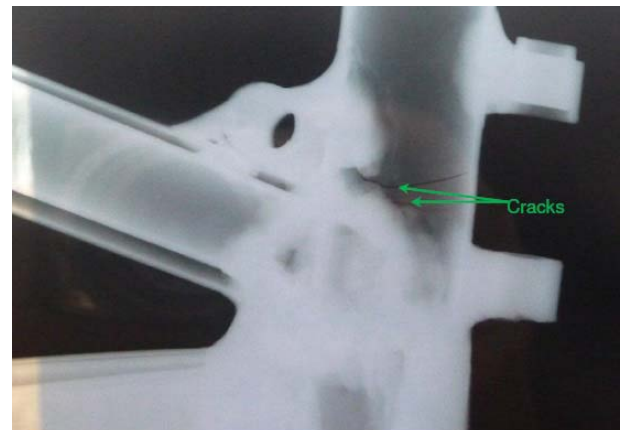
Fig. 1. X-Ray of cracked Fin Post

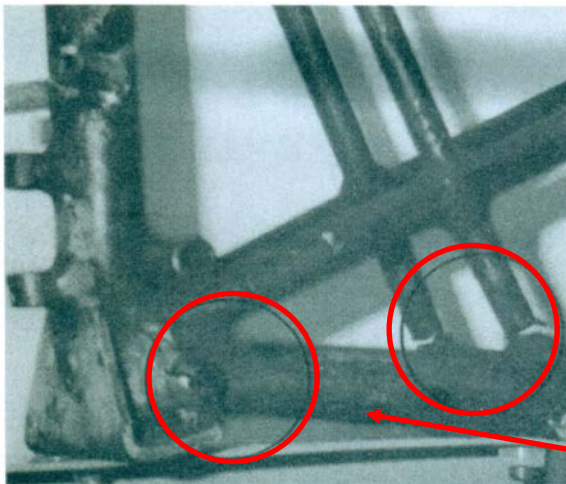
Fig. 3. Serious corrosion and cracking found in the rear fuselage structure of a Vagabond (PA-15)

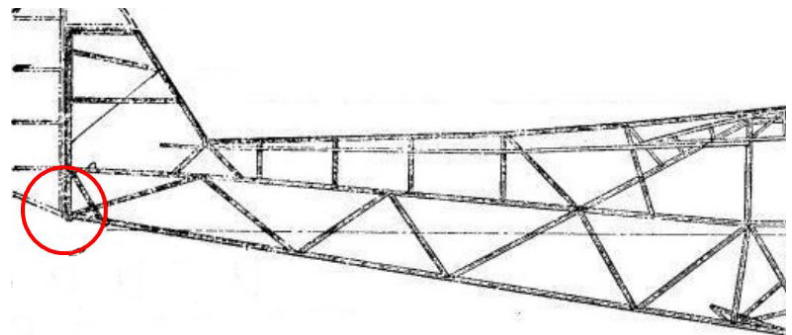
Fig. 2. General Arrangement showing area of concern.

NOTE: The lower Longeron is especially prone to corrosion
