LAA/AWA/21/09
5th November 2021

Eurofox Tricycle Undercarriage (3K version)

Fuselage Structure Under Seat Pan Weld Inspection

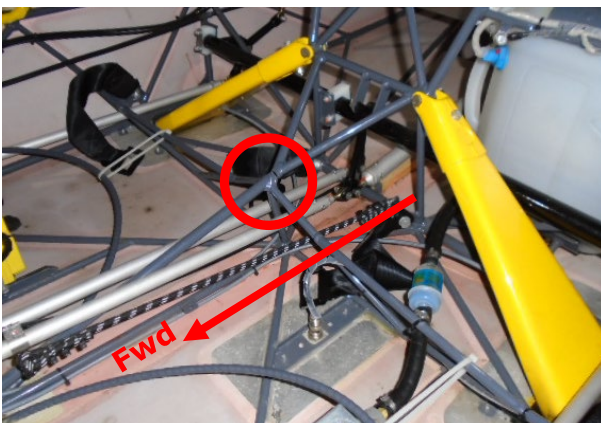
After an uneventful flight, the pilot of a Eurofox glider tug noticed an audible "rattle" on taxiing in. Upon inspection of the fuselage structure underneath the seat pan, it was discovered that a weld cluster had failed. When a force was applied to either gear leg, considerable deflection of the structure was observed. No hard landings had been reported. This aircraft had flown over 1000hrs and over 4000 landings.

At the time of issuing this alert, it has not been possible to ascertain a specific cause for this failure. However, if left unchecked, this could result in undercarriage collapse.

Location of failed weld cluster under seat pan.

Tricycle gear Eurofox owners are now required to inspect this weld cluster on their aircraft mandated by LAA Airworthiness Information Leaflet LAA/MOD/376/005 Issue 1.

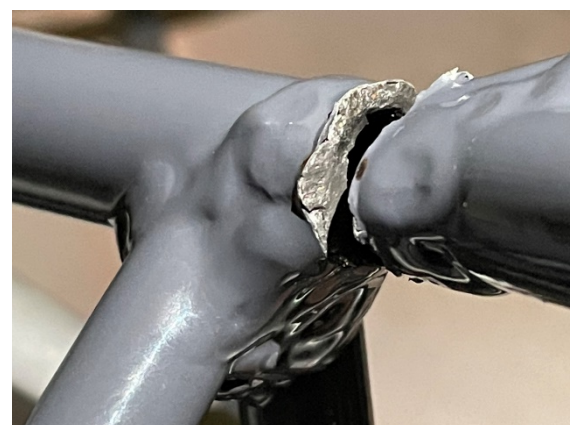
Fracture face of failed weld cluster found located under the seat pan. We have been unable to determine the failure mode due to the apparent burnishing of the fracture surface.
