LAA/AWA/20/05
27th March 2020

Ikarus C42 (All Models)

Technical Information Notice (TIN-04-2020)

OSB 33 Issue 1.0 Control Surface Corrosion and Cracking

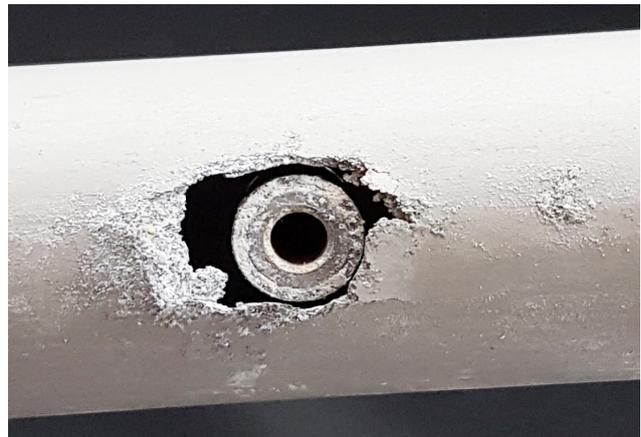
The publication of this TIN follows the discovery, during a C42's annual maintenance, of severe corrosion affecting the centre hinge eyebolt's attachment point (See Fig. 1).

Fig. 1 The above picture shows the failed eye-bolt attachment point in the leading-edge tube of the subject C.42. The reader will note that this tube has been failing for some considerable time, most likely as a result of dissimilar-metals (electrolytic) corrosion.

It is worrying that the 'beginnings' of this corrosion wasn't spotted during one of the aircraft's scheduled maintenance/inspection points, and a reminder that it is vital that deep (dismantlement) inspections are scheduled into the TMS at appropriate points ... especially where access is difficult.

On the C42, a number of hinge attachment points are hidden under the control surface's fabric covering. TLAC insists that, before the aircraft is next flown, a physical check of each hinge should be made by applying a force (about 10kg) to the trailing edge of each control surface against a fixed control stick (or rudder control), whilst monitoring each individual hinge for unusual movement.

TLAC suggest that a close visual inspection of the control surface attachment points should be made within the next ten hours flying time, though they do feel that where access is difficult, an endoscopic examination would be sufficient.

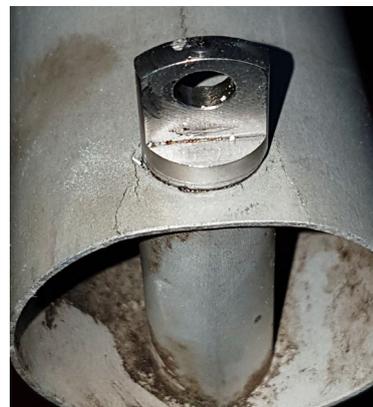
Fig. 2 This picture shows previously 'unspotted' cracking in the area of the eye-bolt; clearly this cracking is due to stress in the aluminum alloy tube over time. As you can see, this aileron hinge wasn't that far from failing completely – had it done so, flight control may have been lost.
