LAA/AWA/20/06
27th March 2020

Aerotechnik EV-97 Eurostar (All Marks)

Publication of Airworthiness Information Leaflet LAA/MOD/315/005 Issue 1 - Inspection of Fuel Filler Hose

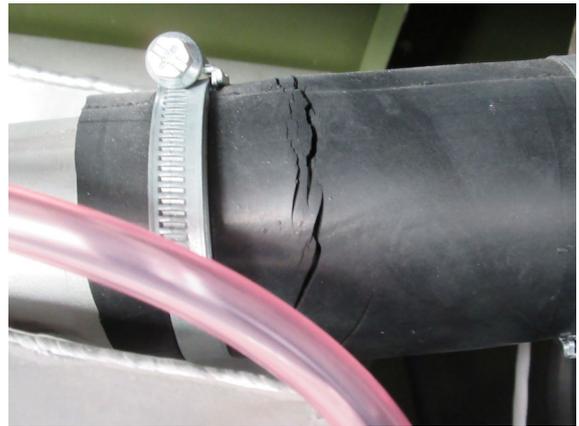
Fig. 1 This rubber fuel filler hose has failed such that fuel has leaked from the pipe. Naturally, this fuel has the very real potential of causing an in-flight cockpit fire. Note though, this pipe didn't degrade completely in one go, and that this splitting is likely to affect both the external and internal structure. Material degradation inside the pipe will mean that there's a huge risk of a fuel blockage (and therefore engine failure) due to 'breakaway' rubber debris collecting in the fuel system.

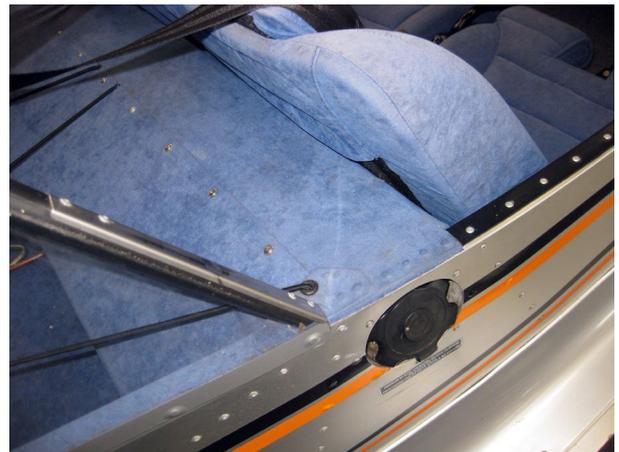
Fig. 2 This picture shows the external fuel filler cap and the baggage compartment in an EV-97 Eurostar Aircraft; it's a very neat arrangement. Note that there are about twenty screws holding this floor in place; possibly the reason why some owners have been reluctant to lift the panel annually. This new AIL requires the baggage compartment floor to be removed annually to inspect the fuel filler pipe.
