LAA/AWA/21/01  
13<sup>th</sup> January 2021

## Van's Aircraft RV-12

### Service Bulletin SB 00023-REV 1

#### Engine Mount Stand-off – Inspection/Replacement

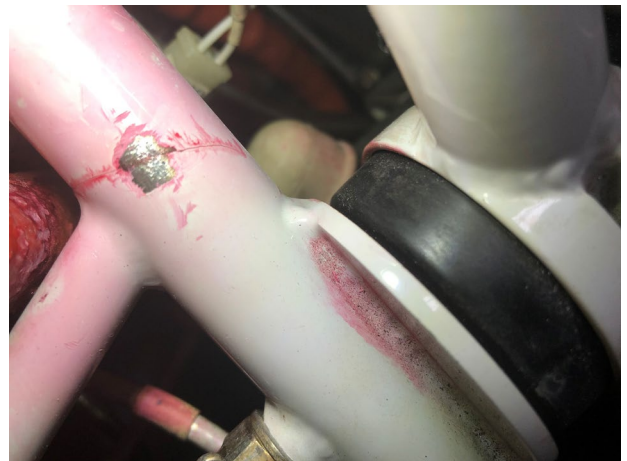
Following the receipt of a Van's Aircraft Service Bulletin (SB 023), suggesting that owners check the engine mount stand-off on their aircraft, the owner of an RV-12, operating under an LAA administered Permit to Fly, checked his aircraft and discovered cracking in the areas shown in the SB.

The SB explains that cracks had been discovered on two aircraft so far and, in their view, a primary cause of cracking is vibration due either to poor carburettor synchronisation or propeller balance issues.

This picture shows the circumferential crack found by the LAA administered RV-12 owner after receiving a copy of the Service Bulletin directly from Van's Aircraft. The pink staining is the residue following a dye-penetrant inspection.

That said, this part, WD-1221, has subsequently been strengthened and replacements carry a different part number (WD-01221-1). Kits shipped to owners after October 2020 are not affected, as they contain a strengthened version of the stand-off.

Investigations were made to see if a weld repair was viable for this part, but the complex nature of the repair was such that a repair wasn't a cost-effective option.

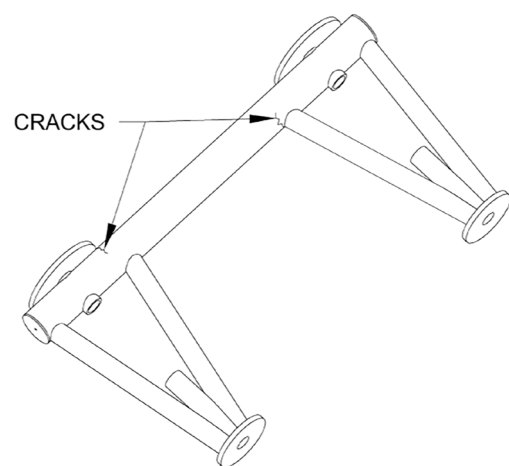
This sketch, extracted from the Van's Aircraft SB, shows where cracking has been seen in other examples of the type.
