LAA/AWA/21/02  
13<sup>th</sup> January 2021

## Rotax 912 and 914 (Series) Engines Service Bulletin SB-912-074/SB-914-056 Exchange of Floats

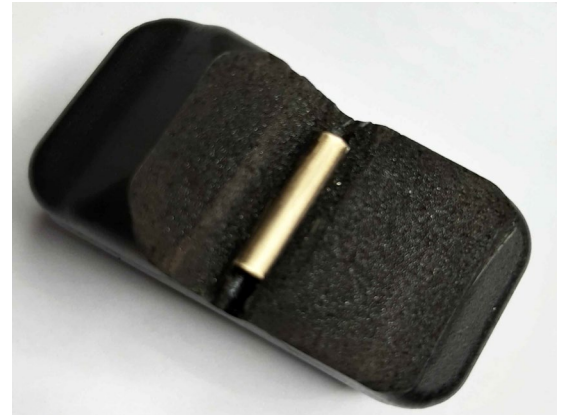
This picture shows the a cutaway of the newly designed Rotax float. Note the embedded metal tube. Engineers suspect that earlier designs, where this tube covered the complete width of the float, lay at the heart of the leakage issues occasionally suffered by engine operators.

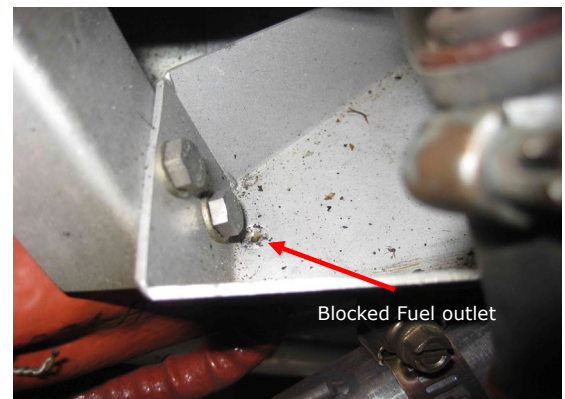
Though it may be true that a rough running engine at low RPM is not likely to have a major effect on flight safety, a carburettor with a partially sunk float will suffer a raised fuel level, and this, in turn, may lead to fuel leaks from the float bowl – potentially, a major fire hazard.

The picture above shows a drip tray, in place to steer leaked fuel away from a hot exhaust, with a drain outlet completely blocked by debris – fuel collected here for any reason, could easily lead to an engine fire.
