CZAW SportCruiser

Replacement of CZAW Nose Undercarriage Spindle Assemblies

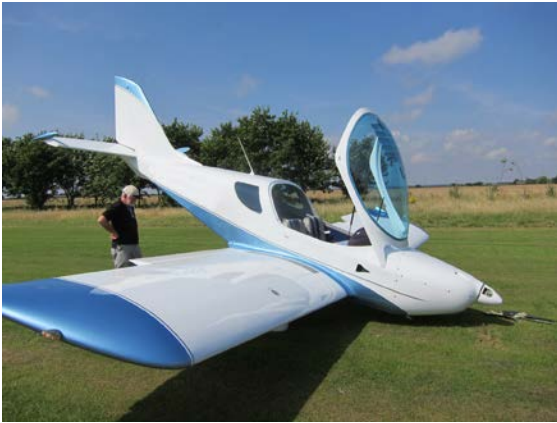
Fig. 1. This CZAW SportCruiser suffered a nose undercarriage Spindle assembly failure at low speed.

Following an accident that occurred to a CZAW SportCruiser in August 2012 where the nose undercarriage Spindle failed, LAA Engineering has withdrawn from use, with immediate effect, the CZAW undercarriage Spindle assemblies.

To affect this component withdrawal an Airworthiness Information Leaflet, superseding MOD/338/015, has been issued to all LAA SportCruiser owners. This Airworthiness Information Leaflet (MOD/338/017 issue 1) can be downloaded [here](#).

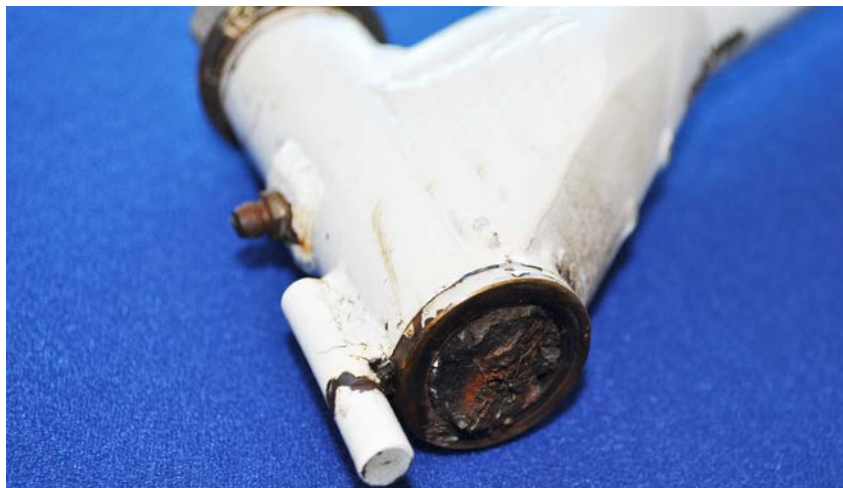
Shortly after this initial failure LAA Engineering published an Airworthiness Information Leaflet [MOD/338/015](#), requiring fleet checks. As a result of the information received from these fleet checks, and reports of further Spindle failures, it has been decided that these components are not fit for service.

Fig. 2. The broken CZAW Spindle

At the time of writing this Alert an alternate nose leg assembly is available to owners affected by this component withdrawal and two modification applications have been received by LAA Engineering which may offer alternative solutions. A letter updating owners of their options has been sent and a copy of this letter can be downloaded [here](#).
