LAA/AWA/14/05
21st March 2014

ALL DH 82 (Tiger Moth), DH82A (Tiger Moth) & DH82B (Queen Bee) Aircraft.

Emergency Airworthiness Directive Prohibiting Aerobatics Pending an Inspection of the Lower Fuselage Tie Rods.

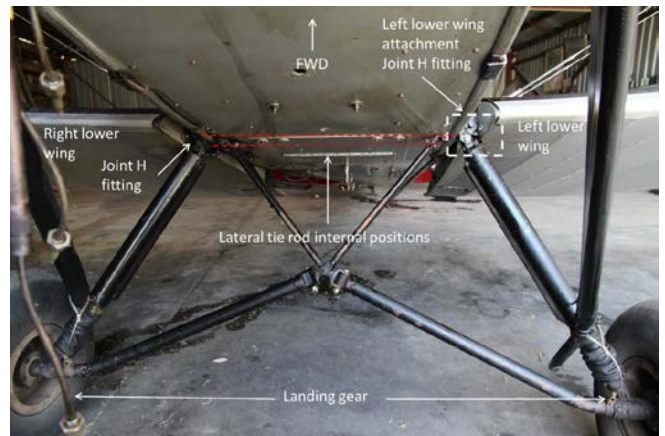
Fig. 1. View looking aft, showing the area of concern and position of Tie Rod.

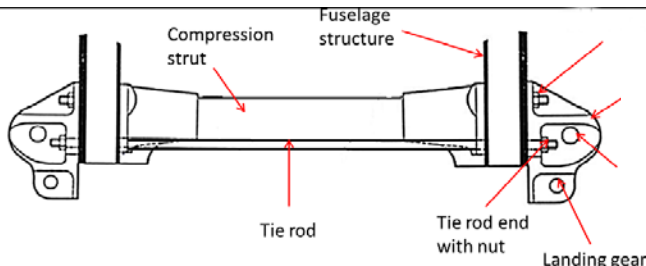
Fig. 2. Cutaway sketch showing the position of the Tie Rod.

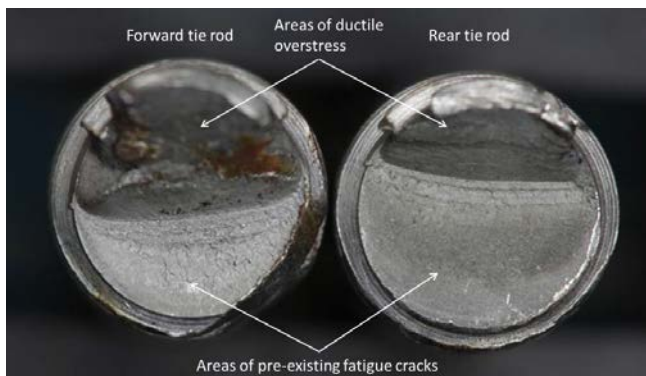
The actual cause of this catastrophic failure has yet to be determined but, early on in the investigation, it became clear that both fuselage tie rods had failed and that there was clear evidence of fatigue in the fracture faces.

Fig. 3. Fuselage Lateral Tie Rod Ends showing left side fracture faces.

The UK CAA have just issued an Emergency Airworthiness Directive (EAD) restricting DH82 types to non-aerobatic flight until the provenance of the Tie Rods fitted to the aircraft has been established. In any event, this check must be carried out within 10 flying hours.
