LAA/AWA/14/13  
12<sup>th</sup> November 2014

## Pietenpol Aircamper

### Undercarriage Rod End Bearings

#### Inspection/Replacement of Undercarriage Rod End Bearings

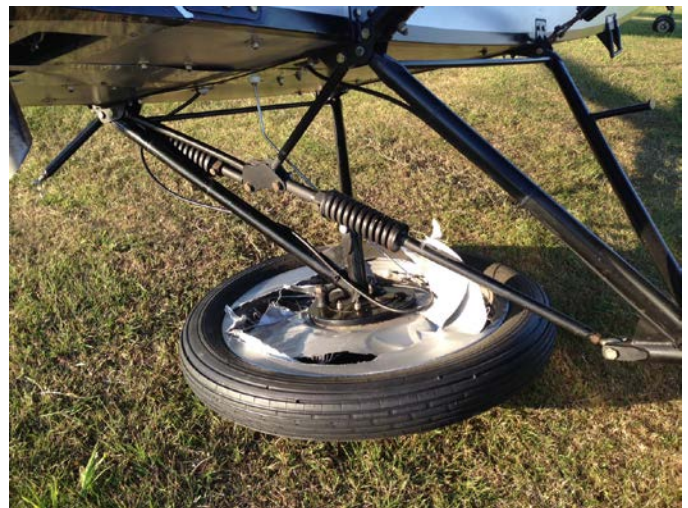
Fig. 1. In this example the starboard lower rod end has failed. The port rod end, which can be seen connecting the spring strut to the axle assembly, remains intact.

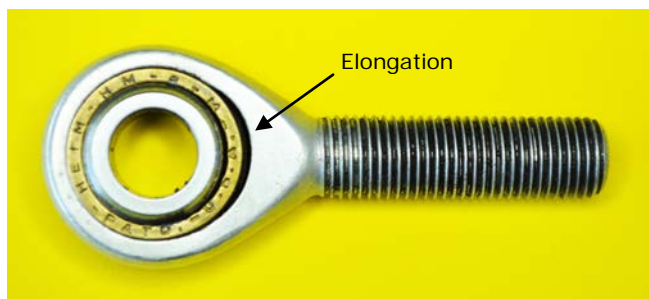
Fig. 2. Elongation can clearly be seen in this example of a lower rod end bearing recently removed from service. This elongation may have been caused by temporary overload or gradual 'creep'. The recent AIL requires owners to check these bearings fully after a heavy landing incident.

Because of these recent findings LAA Engineering has issued an Airworthiness Information Leaflet (AIL) (LAA/MOD/047/009 issue 1) requiring regular inspections of the rod end bearings fitted to Pietenpol Aircamper aircraft with Cub type undercarriages. This AIL also introduces a working life to this component. LAA/MOD/047/009 issue 1 can be downloaded [here](#).

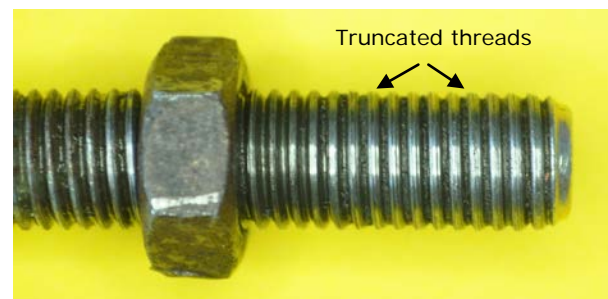
Fig. 3. In this example of a failed rod end bearing the wear in the attaching threads can be seen. The highly polished nature of the threads along with very reduced major diameter suggest in service movement.
