LAA/AWA/14/14
6th November 2014

Rotax 9 Series Engines

Sinking Carburettor Floats

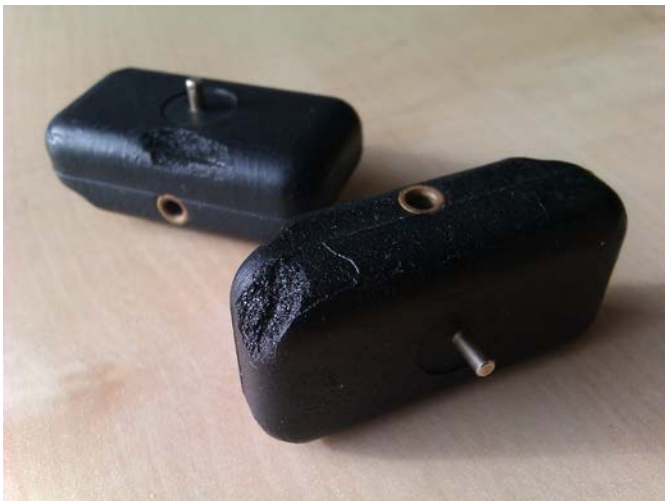
Fig. 2 The Tailored Maintenance Schedule (TMS) for your aircraft should include an inspection of the carburettor, this should be at least an 'Annual' check item. During this inspection it's certainly worth taking a close look at the floats: the first sign of problems of material failure in the example shown above was debris in the float bowl, although in this case the buoyancy of the floats wasn't noticeably affected.
