LAA/AWA/16/06  
28<sup>th</sup> October 2016

## Aerotechnik EV-97 Eurostar

### Visual Inspection of Main Spar Caps

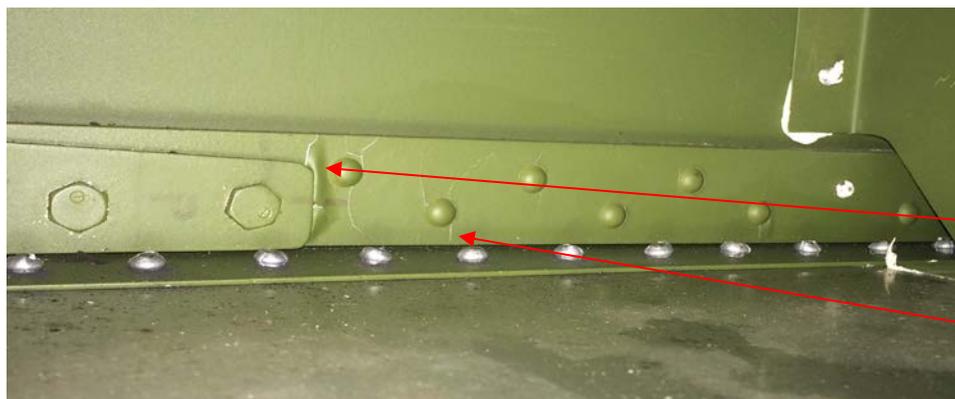
Fig. 1. EV-97 – Lower Spar Cap.

This example, from a 3500 flying time example, clearly shows a problem with the paint's attachment to the metal. Two issues are present and need further investigation.

1. Blistering between the steel attachment fitting and the Spar Cap.
2. Cracking in the paint finish which emanates from the Spar Cap attachment rivets.

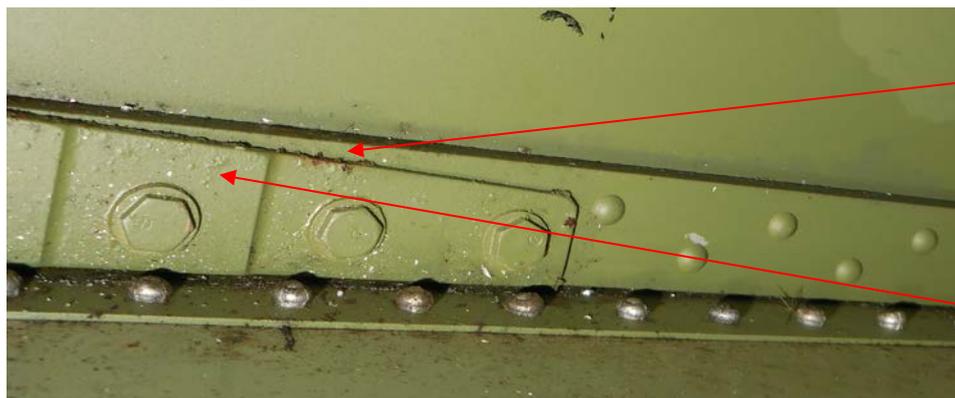
Fig. 2. EV-97 – Lower Spar Cap II.

This example, from a low hour example (< 350 hrs.), shows worrying signs of corrosion. Take note of:

1. What appears to be rust on the surface of the steel bracket and the Spar Cap.
2. Uneven paint finish, indicative of underlying corrosion.
