LAA/AWA/16/07
4th November 2016

EuroFOX Tail Wheel Aircraft

Replacement of Undercarriage Guide Bracket Bolts

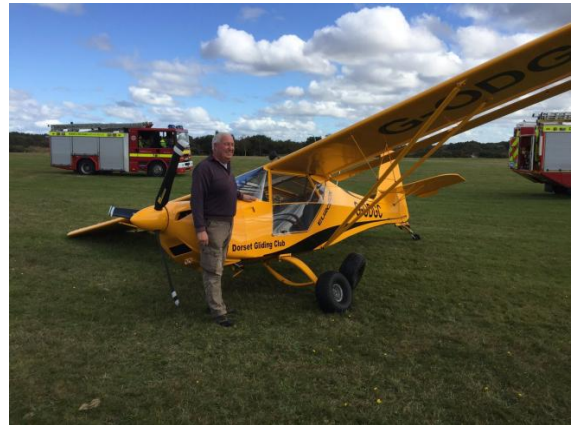
On a EuroFOX heavy use tail wheel glider tug aircraft with tundra tyres, the forward bolt failed on the undercarriage clamp bracket (containing 2 bolts M8 hex head 8.8 strength). The clamp bracket then swung away from the undercarriage leg just after take-off and the leg itself, being unrestrained, pivoted about its central fixing point in the middle and underside of the fuselage. A successful landing was made on one leg and the tail wheel, with minimal damage to the rest of the airframe (see Fig. 1.).

Fig. 1. The pilot of this Eurofox did a good job of getting the aircraft down without further damage after the undercarriage attachment bolt failed.

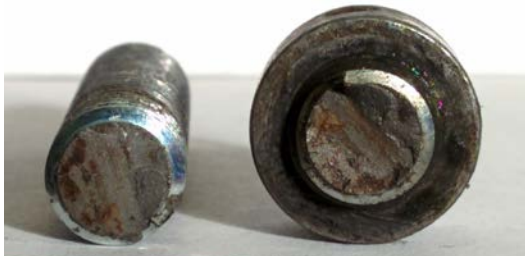
Fig. 2. Clear signs of fatigue in the failed bolts suggestive of looseness in service.

On the subsequent inspection, it became apparent that the bolt had failed in fatigue just under the bolt head (see Fig. 2.). The fatigue crack had been present for a while, but is not easy to find during normal inspections.

The earlier SB on this subject (SB2 2015) did not prevent this failure, therefore to minimise risk, it is required to change the assembly method and "life" of this bolt.

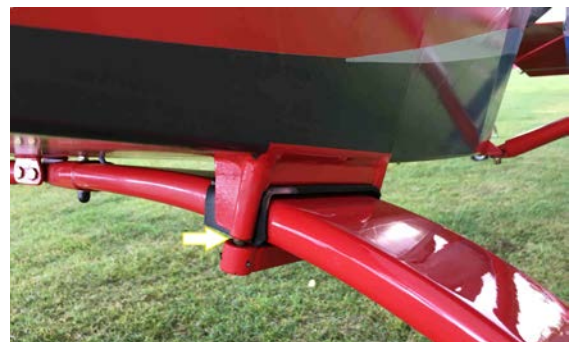
Fig. 3. The arrow marks the positions of spacing washers required so that the attachment bolt can be tightened more firmly.

The new fixing method, which includes spacing washers, will improve the load transfer within the assembly (see Fig. 3.).
