LAA/AWA/19/21  
6<sup>th</sup> November 2019

## Alpi Pioneer Aircraft (All Types)

### Inspection of Control Surface Hinge Attachment Cap-Bolts

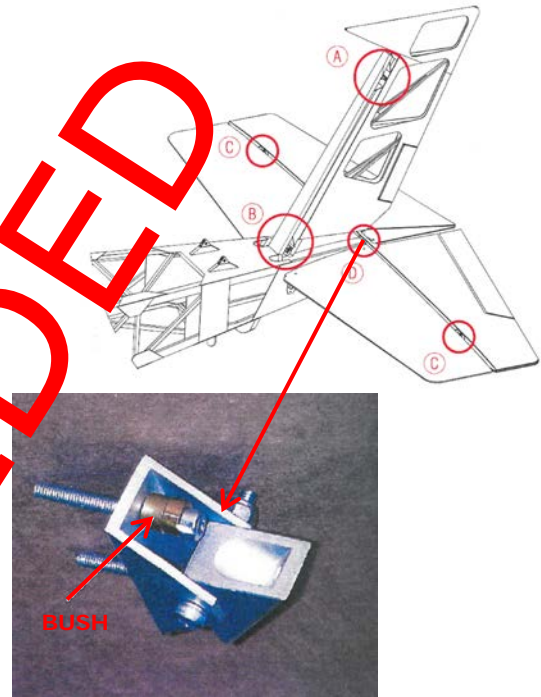
Fig 1. (Top) This sketch shows the inspection points within the empennage of all Pioneer types.

Fig 2. (Bottom) This shows the centre hinge assembly from a P.300. Note the Bushings (arrowed) which act as a primary control stop.

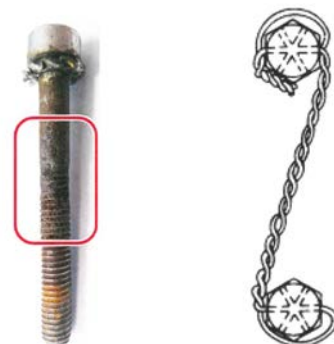
When an attachment bolt becomes loose, it can reduce the corresponding control surface's range of movement and, in the worst case, introduces a serious risk of the control surface becoming detached. When these loosened bolts were removed fully for inspection, some were found to be quite badly corroded.

Fig 3 (Left) Shows severe corrosion in a cap-bolt as removed from a Pioneer aircraft operating in a coastal environment, overseas.

Fig 4. (Right) Shows the correct wire locking method between pairs of bolts.
