LAA/AWA/20/01  
19<sup>th</sup> February 2020

## Groppo Trail & Groppo Trail Mk. 2 Lift Strut to Wing Attachment Swivel Bolts Implementation of Hours-Based Bolt Life

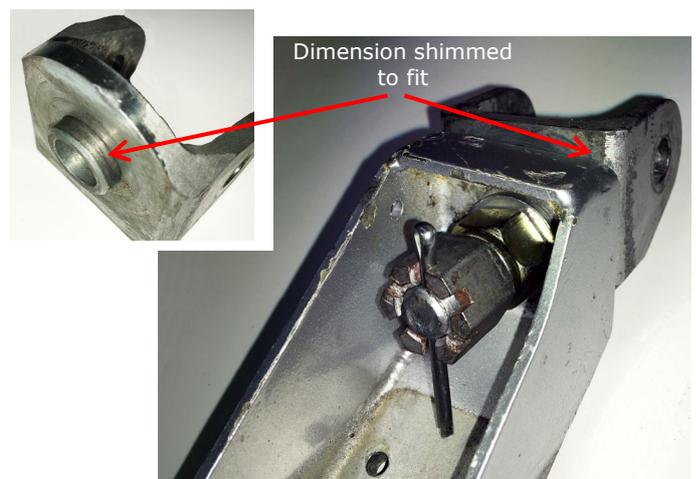
The second concern relates to one example where, during assembly, this connection was tightened such that the joint wasn't free to move. The explanation for this assembly error was a not well advertised manufacturer's change in the bushing sizes and a concurrent new requirement to shim the joint. Fitting instructions, new bushes and shim sets are available from the manufacturer or their UK agent.

Fig. 2 A picture of the three-dimensional swivel: Note that the designer requires this bolt to be secured with a nyloc nut and a split-pinned castle nut. When fitting the later bushes, it is essential that this joint is accurately shimmed during assembly to remove any angular play, but remains free to rotate.

To accomplish this change, an Airworthiness Information Leaflet (LAA/MOD/372/029 Issue 1) has been issued requiring bolt to be replaced each 200 flying hours.

Service experience has 'flagged-up' two areas of concern with regard to changing this bolt in the field. The first, a rather ubiquitous concern, is that some examples of bolts purchased commercially have been found not to meet the strength requirements specified by the manufacturer. It is essential that these critical bolts are replaced with bolts of known quality; the manufacturer specifies an M12 - 8.8 Grade - manufactured with a rolled thread. New bolts should always be sourced from the manufacturer or an approved manufacturer's agent.
