LAA/AWA/19/14
28th May 2019

Montgomerie-Bensen and Montgomerie-Merlin Gyroplanes

Inspection of Lap Strap/Airframe Attachment

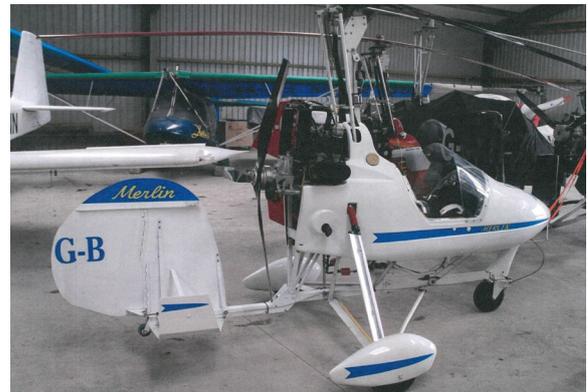
Fig 1. When first devised, single-seat gyroplanes were constructed with an open frame, sometimes a light fibreglass pod was used to protect the instruments and offer some protection to the pilot. This Montgomery derivative incorporated a wrap-round fairing which both offers better protection to the pilot and (arguably) improves the aircraft's look – though this come at the cost of restricting access to important inspection points.

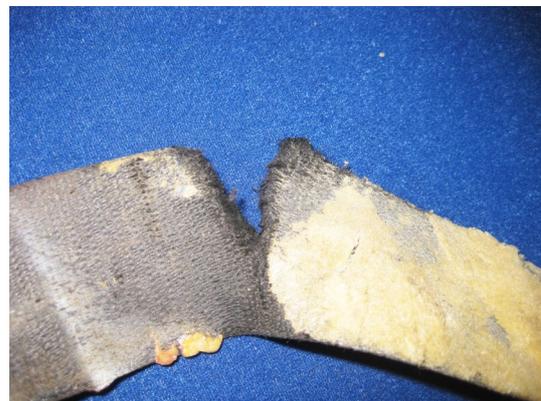
During the recent comprehensive refurbishment of a Montgomerie-Bensen B8MR gyroplane, the owner removed the fibreglass fairings and the fuel tank to gain access to the structural frame so it could be thoroughly inspected. With the fairing and the fuel tank removed it could be seen that the lap strap was badly damaged near its attachment to the main fuselage structure. Clearly, in the case of an abrupt stop, or perhaps even severe in-flight turbulence, this lap strap would very likely have failed.

Fig 2. The picture above shows the lap strap that led to the fleet inspection – no further comment is required!

LAA Engineering has recently issued an Airworthiness Information Leaflet (AIL) (LAA/MOD/G01A/003 Issue 1) requiring owners of the Montgomerie-Bensen and Montgomerie-Merlin single-seat gyroplanes to inspect the lap straps fully before further flight to ensure that they are in a satisfactory condition and not configured in a manner likely to cause 'chafe' damage in service, i.e. through contact with hard edges, or angled in a manner that prevents a direct 'pull'. For aircraft currently flying this inspection is required straight away and thereafter annually.
