LAA/AWA/19/10  
13<sup>th</sup> March 2019

## Murphy Rebel

### Inspection of Tailplane Strut End Fittings

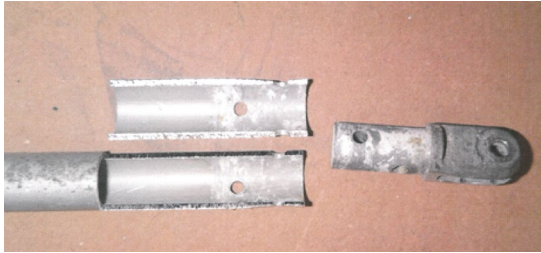
Fig. 1 A picture supplied by Murphy Aircraft showing the extent of the corrosion found in a recent inspection.

The SB describes how this report of a failure led them to inspect a 'local' aircraft and quite serious corrosion was found in the strut end fitting and the strut itself on this aircraft. The SB also explains that Murphy Aircraft will no longer be supplying this 'original design' end fitting, having upgraded the strut itself to a more robust strut system; they strongly recommend upgrading to this later strut design. Since 2011, aircraft operating under an LAA administered Permit to Fly have been required to dismantle and inspect this assembly annually.

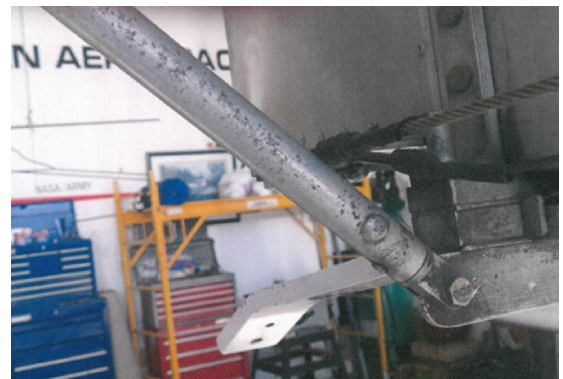
Fig. 3 This picture shows the 'original design' tailplane strut and end fitting – note the corrosion on the strut which should be considered unacceptable.

In the latest issue of the AIL (Issue 3), this annual inspection requirement remains in force for 'original design' struts but, by upgrading to the more robust strut, the annual strip inspection requirement is removed. LAA Engineering accept this upgraded strut as a factory option, so no formal application is required from owners should they wish to incorporate the upgrade onto their aircraft.

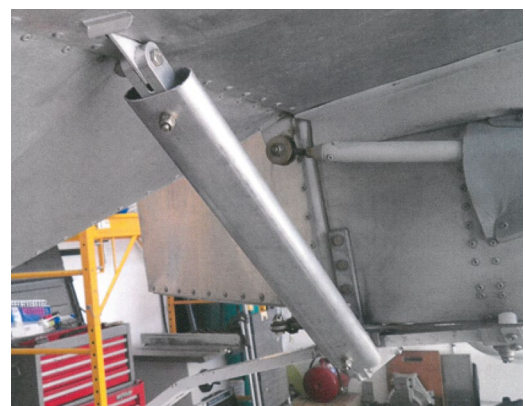
Fig. 4 The latest strut design – note that the end fitting is bolted rather than riveted in place.
