LAA/AWA/20/03
27th February 2020

Van's RV-12

Nose Undercarriage Leg Replacement (Van's SB 19-08-26)

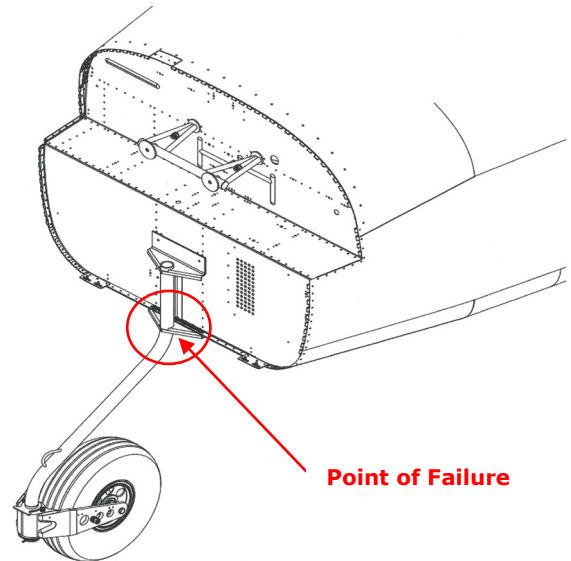
The reason given by the manufacturer for this recommendation is that a high-hour RV-12 aircraft, being used for training, suffered a nose undercarriage failure. The failure occurred where the leg itself meets the lower attachment bracket (see Fig. 1); engineers at Van's Aircraft believe this failure to have been caused by fatigue at this point.

The aircraft that suffered the nose undercarriage failure had accumulated over 1700 hours and, as a training machine, a very high number of landing and take-off cycles. Material failure due to fatigue is a function of the local stress in a material relative to the materials ultimate strength (load) and the number of applications of this local stress (cycles).

Fig. 1 (Top) Shows the general arrangement of the Van's RV-12 nose undercarriage and the point where the recent failure on a high-hour training aircraft occurred.

Because of this failure, we now know that this point in the RV-12 is subject to fatigue cracking and should be regularly inspected. LAA engineering wouldn't advise owners to change the nose undercarriage legs on their aircraft unless or until their aircraft have accumulated a significant number of hours, or are aware that the undercarriage leg on their aircraft has had to resist an unusually high number of cycles.

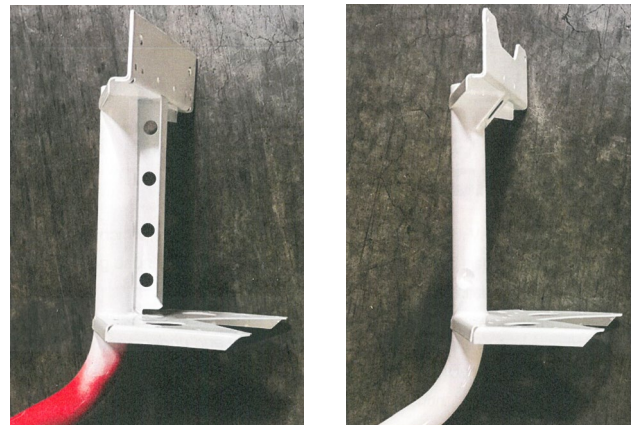
Fig. 2 (Bottom/left) Shows the firewall attachment point of the original (WD-1201) leg which Van's recommend should be changed.

Because of this failure, a reinforced leg is now available for purchase and, as previously stated, they strongly suggest that owners upgrade the nose undercarriages on their aircraft.

Fig. 3 (Bottom/right) Shows the reinforced leg (WD-1201-1-RTR) which is available for purchase from Van's Aircraft.
