LAA/AWA/19/09
6th March 2019

CZAW SportCruiser

Withdrawal of PS. Mk.1 Nose Undercarriage Assemblies

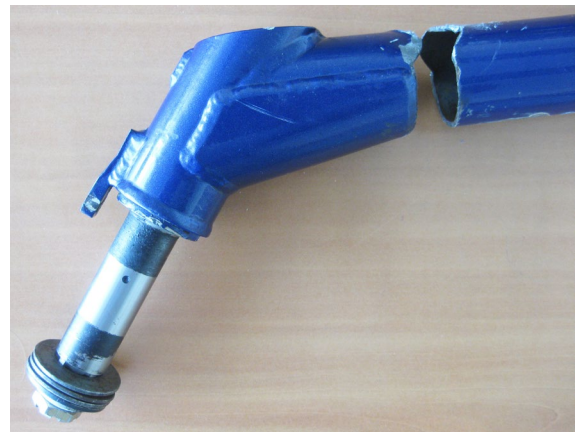
In May 2018, LAA Engineering published an Airworthiness Alert (LAA/AWA/18/03) giving notification to owners of CZAW SportCruiser aircraft that it will remove the approval to use the PiperSport (PS) Mk.1 noseleg. This withdrawal is felt necessary following an in-service failure of a PS. Mk.1 noseleg on an LAA aircraft, even though, up to the moment of the failure, it had been subject to regular and careful pre-flight inspections.

An increasing number of problems involving the welded connection between the spindle housing and the leg itself have bedogged the PS. Mk.1 legs worldwide and the manufacturers have now significantly strengthened the design. The latest version of the 'factory' undercarriage assembly has part number CSA NLG SG0300N. Use of this leg, which is acceptable to LAA Engineering, must be accompanied with the firewall strengthening kit as described in CSA SB-CR-032.

Fig. 1 This picture shows a failed PS. Mk. 1 undercarriage leg.

A copy of the Airworthiness Information Leaflet (AIL) (LAA/MOD/338/020 Issue 1) withdrawing the PS. Mk.1 leg from service can be downloaded [HERE](#).

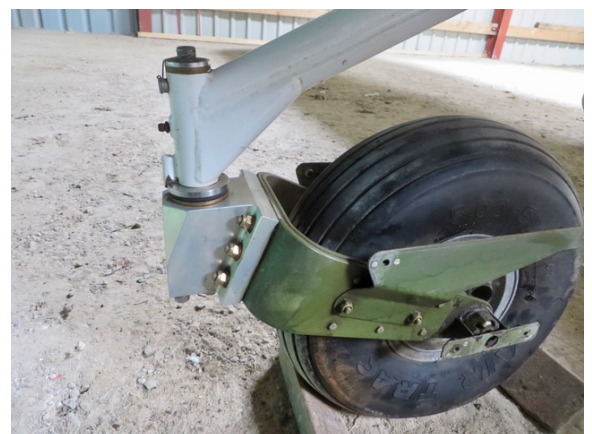
Fig. 2 The picture above shows the prototype spindle assembly attached to a strengthened CZAW undercarriage leg. Note that the spindle assembly is subject to an annual inspection requirement (see LAA/MOD/338/019 Issue 1) and the fork, here a two-leafed variant, is subject to inspections laid out in LAA/MOD/338/016 Issue 2.
