## Alpi Pioneer Aircraft (All Types) Inspection of Control Surface Hinge Attachment Cap Bolts

LAA/AWA/20/16  
9th June 2020  
Superseding LAA/AWA/19/23

### Extension of Compliance Time Due to the Corona Virus Outbreak

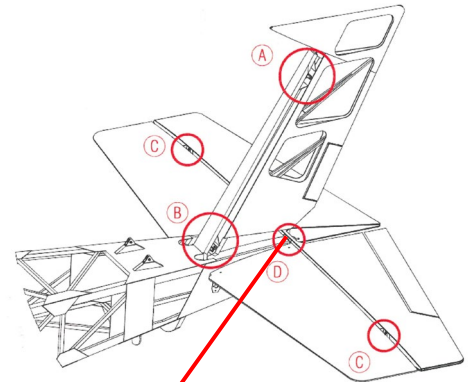
Fig 1. (Top) This sketch shows the inspection points within the empennage of all Pioneer types.

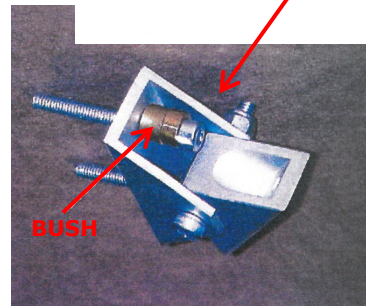
Fig 2. (Left) This Picture shows the centre hinge assembly from a P.300. Note the bushings (arrowed) which act as a primary control stop.

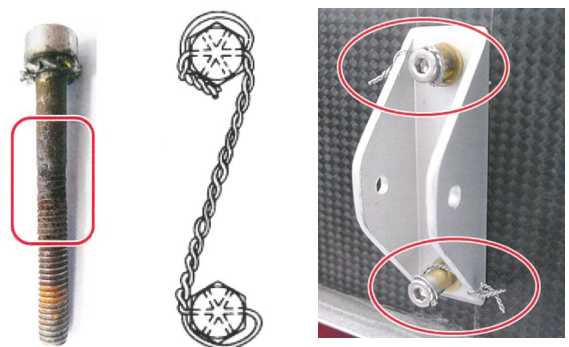
Fig 3 (Left) Shows severe corrosion in a cap-bolt as removed from a Pioneer aircraft operating in an overseas coastal environment.

Fig 4. (Centre) Shows a conventional method of wire-locking pairs of bolts.

Fig 5. (Right) Shows a suitable alternative method of wire-locking a pair of bolts where the wire-locking may interfere with correct hinge operation.
