Alpi Pioneer Aircraft (All Types)

Inspection of Control Surface Hinge Attachment Cap-Bolts

LAA/AWA/19/23
28th November 2019
Superseding LAA/AWA/19/21

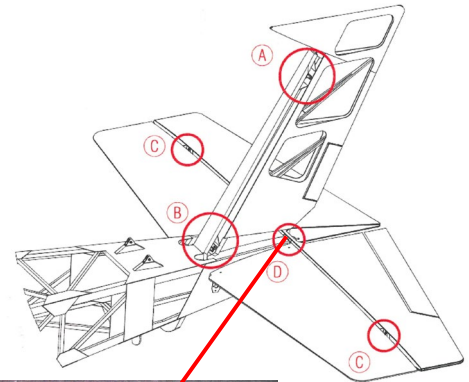
Fig 1. (Top) This sketch shows the inspection points within the empennage of all Pioneer types.

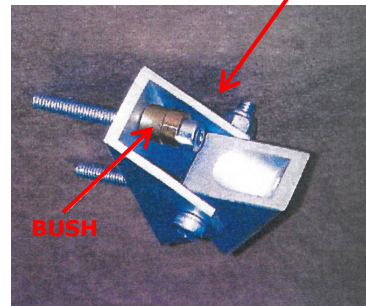
Fig 2. (Left) This Picture shows the centre hinge assembly from a P.300. Note the bushings (arrowed) which act as a primary control stop.

Following feedback from Pioneer aircraft owners and LAA Inspectors, LAA Engineering has reissued the AIL to allow more time before the full cap-bolt inspection and wire-locking process is completed; though the cap-bolts securing the centre elevator hinge (which support the control stop bushings) must still be inspected and wire-locked within five flying hours (or 28 days whichever occurred sooner).
