LAA/AWA/19/16
7th June 2019

Tri-R KIS Aircraft

Inspection/Reinforcement of Rudder Pedal Assembly

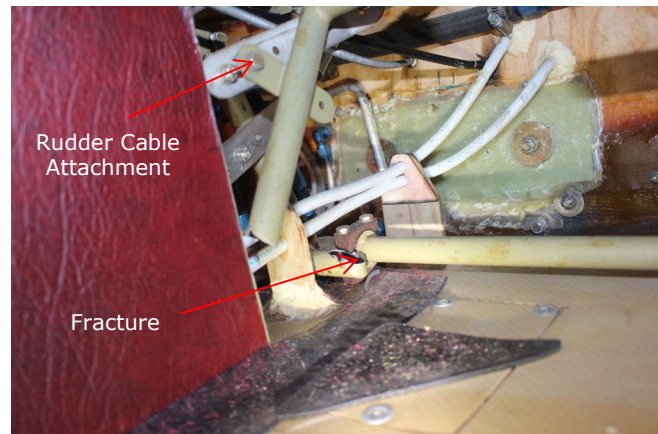
In this aircraft design, rudder movement is driven by two control cables, one of which is attached to the right-hand side left rudder pedal; the pilot therefore lost control of the rudder (though ground steering remained by using the differential brakes). Subsequent investigations revealed that the left pedal had detached itself from the horizontal torque tube because of a failure of the attaching weld.

Fig 1. This picture shows the point of failure; note the position of the rudder control cable attachment.

LAA Engineering has recently issued an Airworthiness Information Leaflet (AIL) (LAA/MOD/239/001 Issue 1) requiring operators of Tri-R KIS aircraft to carry out a 'before next flight' inspection of the rudder pedal assembly and include a repetitive inspection of the rudder pedal assembly into their maintenance regime each five flying hours until reinforced.
