LAA TYPE ACCEPTANCE DATA SHEET
TADS 242
CASA 1-131-E SERIES 1000, SERIES 2000,
JUNGMANN REPLICA

Issue 1	Initial Issue	Dated 19/12/17	JP
---------	---------------	----------------	----

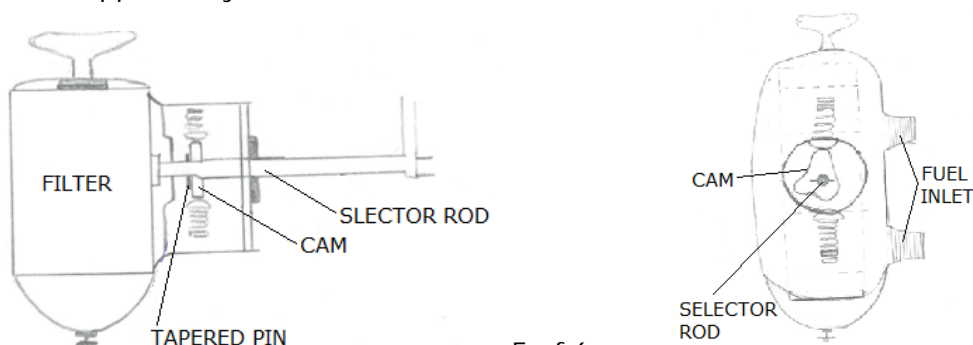
Fuel Cock Failure

The cause of in-flight engine failure and subsequently during ground testing was traced to a dislodged tapered pin that locks the operating cam to the selector rod inside the fuel selector valve assembly. The tapered pin was later found inside the fuel filter bowl.

The cam locates on a square section part of the fuel selector rod. The missing pin allowed the cam to move along the shaft and thus only partially open the mushroom headed valves. As a pre-flight check it should be impossible to operate the fuel wobble pump with fuel selector in any other position than reserve. It is not known why the tapered pin in this case became dislodged. It is recommended that the valve is disassembled and the tapered pin checked for condition and security at a suitably convenient opportunity.
