LAA TYPE ACCEPTANCE DATA SHEET  
TADS 854  
PIPER J3C-65

Issue 1	Initial issue	Dated 25/4/14	JV
---------	---------------	---------------	----

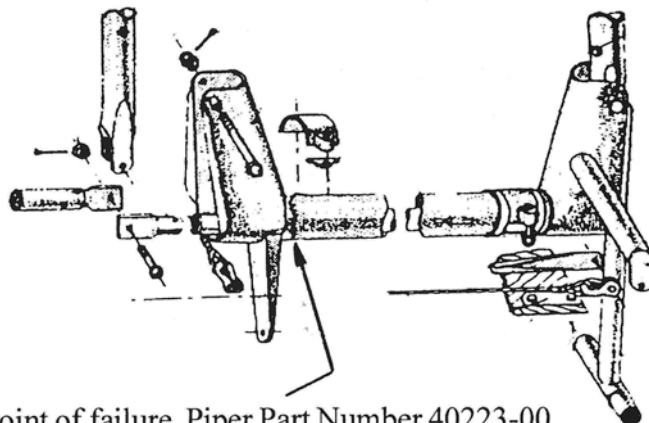
- In October 1995 an LAA Piper J3 aircraft was preparing for flight when, during pre-take off checks, the pilot found the controls had gone sloppy. It was later discovered that the torque tube shaft between front and rear control columns had sheared at a point adjacent to the weld connecting shaft to rear column. Front column had elevator control but no aileron. Rear column had no elevator control and only sloppy ailerons. The aircraft was built in 1946 and had flown around 1600 hours. It is not known what external causal factors might have existed. An inspection of this area for cracks is recommended. See diagram below.

Point of failure, Piper Part Number 40223-00.

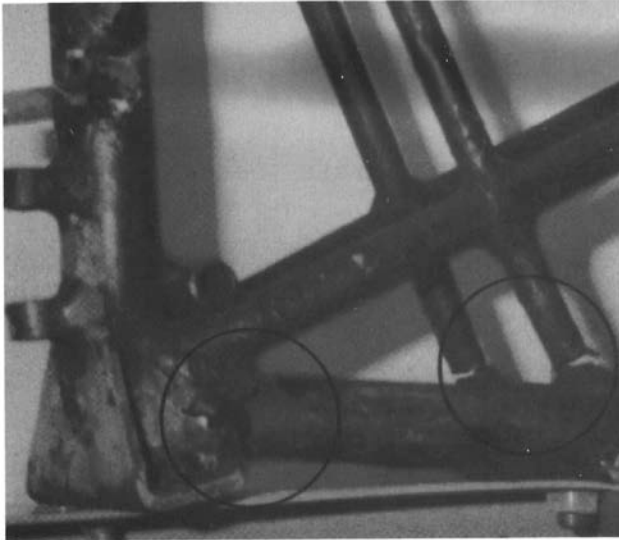
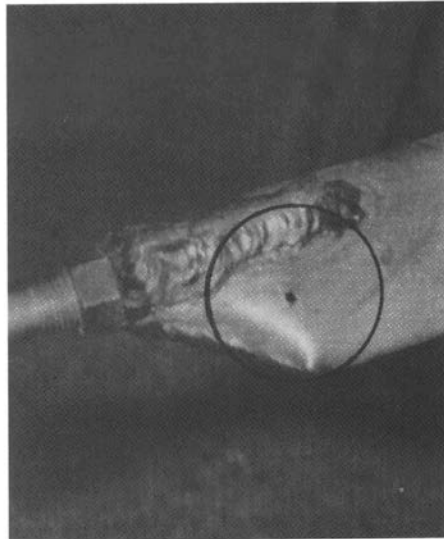
- Much of the LAA Piper fleet was built in the 40's and 50's and being largely constructed from steel tube, corrosion is a problem for owners and inspectors to be continuously alert for.

THESE PHOTOS SHOW ADVANCED CORROSION TO A VAGABOND FUSELAGE TAIL END, CORRODED & CRACKED RIGHT THROUGH IN THREE PLACES & THE SORT OF CORROSION AD 99.01.05 IS INTENDED TO DISCOVER (J3 WING STRUT).
