CFM Shadow, Streak Shadow & Star Streak Aircraft. Fuel Tank Inspection

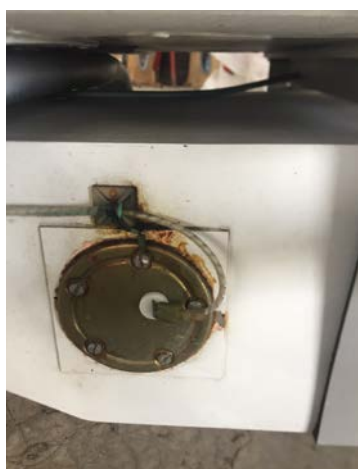
Fig 2. Access for internal inspection of the 'slipper' tank is gained by removing the fuel sender unit, though care is needed to ensure that the unit is completely resealed during refitting

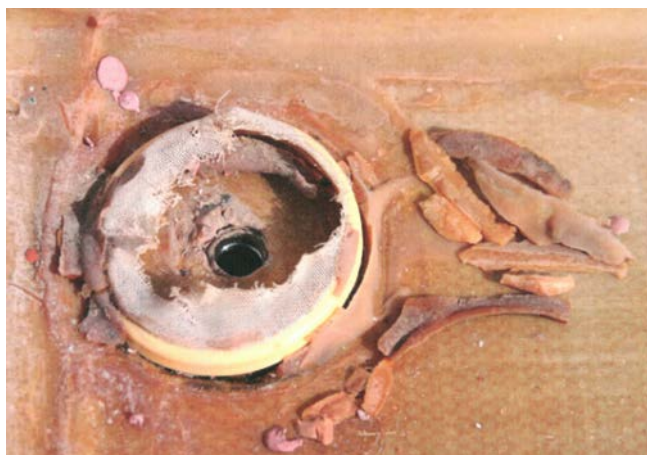
Fig 3. This picture shows an example of a failed fuel strainer. Note that the fine plastic gauze has disintegrated, most likely because of alcohol, now a normal component of mogas.

Both the LAA and the BMAA have received reports that this type of tank has developed leaks at the bonded edges and, in a number of cases, it has been found that debris had entered the fuel system because the fuel strainer had become dislodged over time. The type of material used to make this type of tank does not lend itself well to repair and many owners have changed their original composite tanks to approved aluminium equivalents.

LAA Engineering have recently issued an Airworthiness Information Leaflet (AIL) introducing a specific inspection of both the slipper and the main fuel tanks to ensure that the internal structure remains in good condition and that the fuel strainer remains securely positioned over the outlet. This AIL (LAA/MOD/206/007 issue 1) can be downloaded [HERE](#). The BMAA have published a Service Bulletin (BMAA SB 2336 issue 1) which gives further information on the subject; this SB can be downloaded [HERE](#).
