26th February 2019
LAA/AWA/19/06

CZAW SportCruiser Inspection for Cracks in Nosewheel Fork

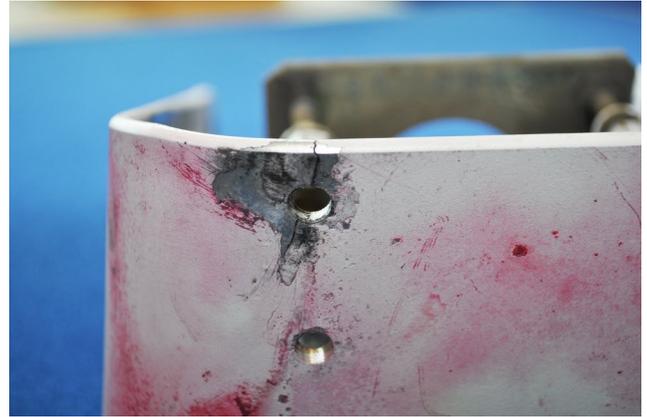
Fig 1. This close-up of the mating face of a two-leafed (original type) fork showing cracks radiating from an attachment bolt hole. These cracks cannot be seen until they reach the outside edge of the fork without the fork being dismantled from the assembly. This is particularly worrying with regard to the lower crack should it propagate unseen between the attaching bolt holes as it could lead to a sudden and unexpected failure of the fork.

LAA Engineering has recently reissued an Airworthiness Information Leaflet (AIL) (LAA/MOD/338/016 Issue 2) requiring owners of CZAW SportCruiser aircraft to carry out a close inspection of the nosewheel fork (at the attachment to the spindle block) at more regular intervals. This inspection requires the spat to be removed and the assembly to be dismantled.

The reason for this increased inspection requirement is that LAA Engineering has received many reports of cracking in the nosewheel fork on this type. Because of this cracking, a strengthened fork has been designed and is now a standard option for the CZAW SportCruiser (see Standard Mod. 13680) though, until more extensive service experience is gained, an annual close inspection of the fork has been applied.

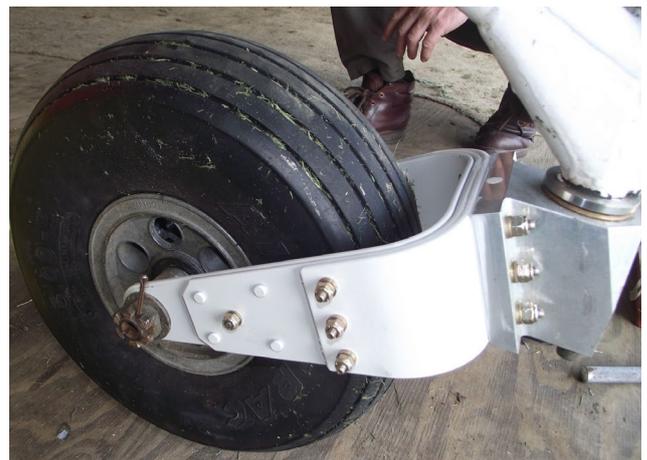
Fig 2. The picture above shows a strengthened (three-leaf) fork. This component is now available to CZAW SportCruiser owners and can be fitted under an LAA Standard Modification (SM 13680).
