LAA/AWA/19/07
28th February 2019

Ikarus C 42

Inspection of Nosewheel Steering Pushrods

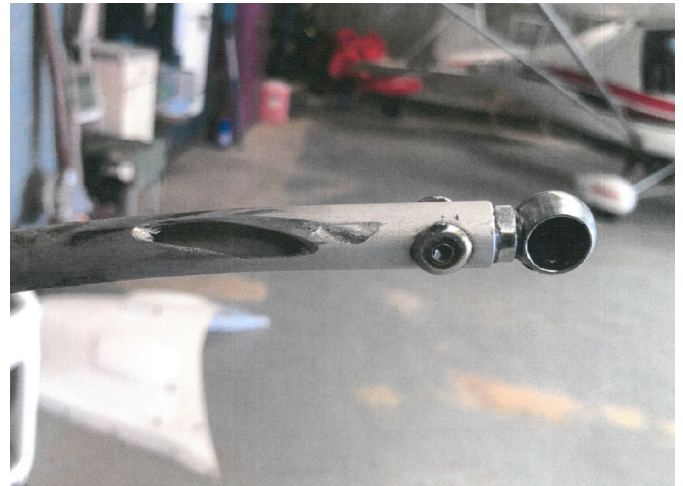
Fig 1. If a steering pushrod like this one actually failed during a take-off or landing it could lead to a loss of control accident or incident. Though not (in this case) part of the aircraft primary flying control system it does perform a critical role in the ground control system pathway and therefore deserves a regular and detailed inspection.

As you can hopefully see from the attached pictures, the wear-damage of this component has occurred because the part was rubbing against the wire-braced cabin heater hose. It's quite clear that this item had not been inspected before or the serious scuffing caused would have been spotted before any serious damage could have occurred.

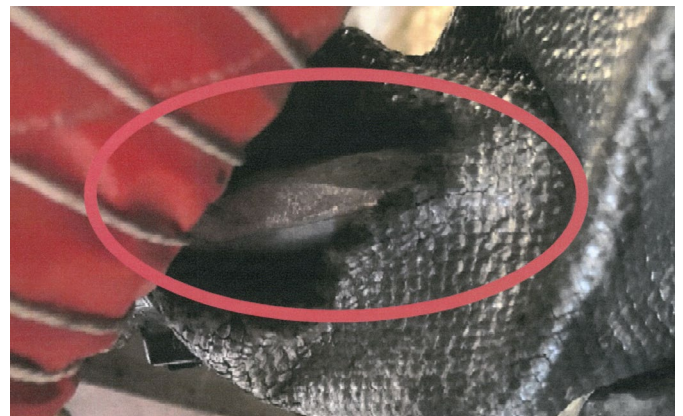
Fig 2. This steering control rod is, in service, hidden by a protective 'boot' in place to protect occupants from dangerous fumes in the engine compartment. It is essential that 'hidden' parts like this are subjected to a close inspection as part of the aircraft Tailored Maintenance Schedule (TMS).
