WHAT IS A REPORTABLE ACCIDENT?

JODEL D153 MASCARET FUEL FILTER BLOCKAGE

PIETENPOL AIR CAMPER OLD FUEL/NEW AIRCRAFT

GALVANIC CORROSION

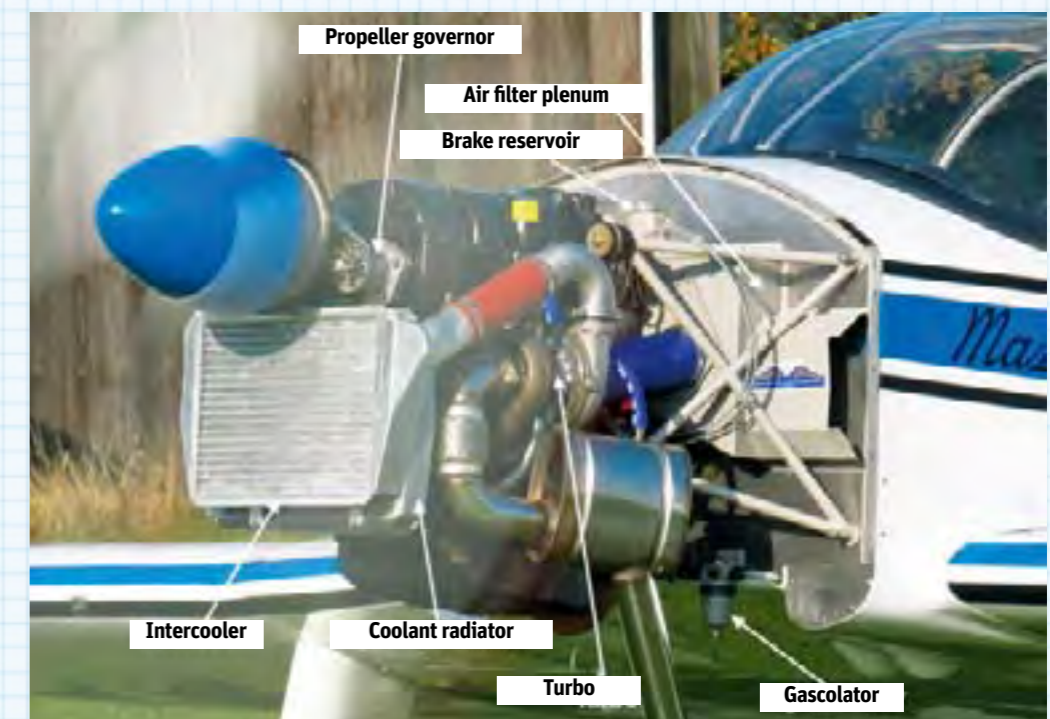
Here is a picture of Peter Fines' Wilksch WAM-120 engine installation. Diesel engines have taken some time to take off in the home-builder marketplace, perhaps because the miserly fuel consumption figures are offset by an increase in complexity. Hats off to Peter for this brilliant installation; this is a lot of engineering to squeeze under an engine cowl. In this picture the principle components in the induction system can be seen; exhaust gas drives a turbine which, in turn drives a compressor which boosts manifold pressure. Because this pressure rise is accompanied by a temperature increase an intercooler is required to cool the charge back down again to maximise the engine's thermal efficiency. The WAM-120 is still under development and its successor, the GEN II engine, is going through its final bench testing phase. (Photo: Peter Fines)

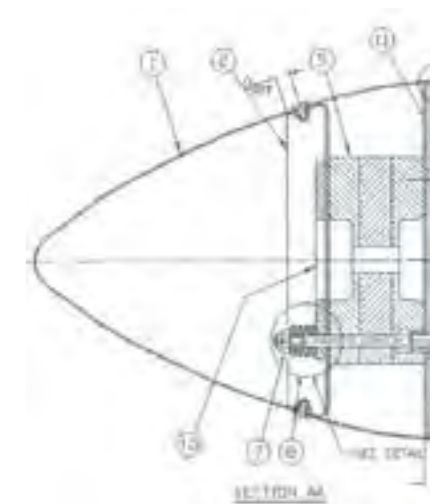
This general arrangement drawing of the propeller hub and spinner clearly shows the location of the drive lugs.
