With Malcolm McBride
Airworthiness Engineer

OF CORBETT, MOTHS, PUMPS, FIRE & EXHAUSTS

The latest LAA Engineering topics and investigations

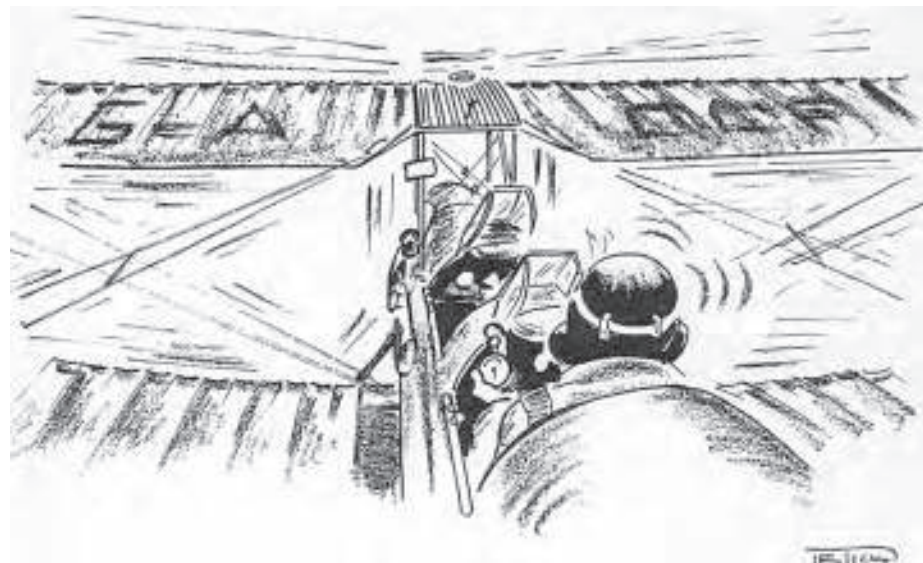
During a subsequent take-off, with the tail up and almost ready to lift off, the engine started vibrating and, of course, Malcolm's first thought was, "those bloody plugs! Will they clear or not?" A fraction of a second later, he thought better of the situation and abandoned the take-off. While taxiing back, the engine continued to run roughly and appeared to be missing on one cylinder.

(Above) 'With the tail up and almost ready to lift off... plugs again, better not.'
(Thanks to Stuart McKay)

They stopped the engine to investigate, making sure that the plug leads were still secure, etc, and then Paul pointed out that one of the valve push rods had come adrift. Closer investigation revealed that the rocker pedestal had cracked, allowing the push rod to disengage from its rocker. No valve operation equals no cylinder operation, over 25 per cent loss of 'oomph' and a gruff engine! Malcolm reflected that, if the failure had occurred thirty seconds or so later, he'd have been climbing out over the Solent at very low level.

As knowledge was gained, reinforcing gussets were added to the cylinder heads and there are now quite a few different designs of head to counter this problem. Malcolm submitted his head to Vintage Engine Technology, who repaired it and added gussets to the three other heads for good measure. If you run an early series Gipsy engine it's worth considering submitting the heads for a similar modification the next time you pull them for overhaul. I've experienced

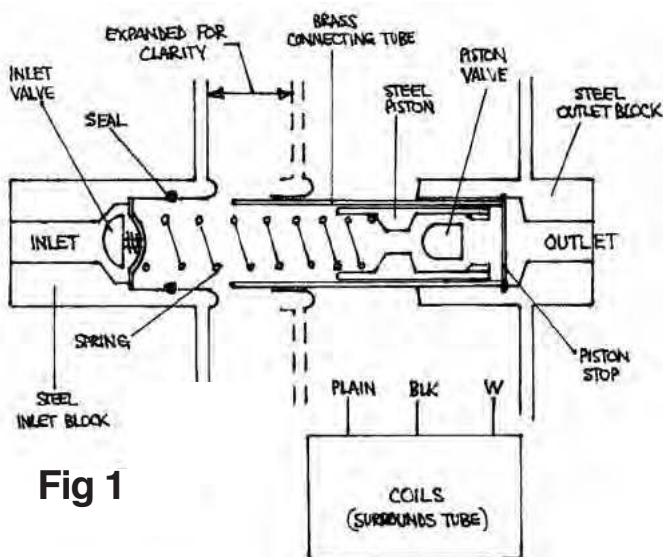
The diagram Fig 1 shows a section through the mechanical operating parts of the pump. On the left of the diagram, the hexagonal inlet block is shown, and on the right, the outlet block. The vertical lines from the blocks show the external casing. Linking these blocks is a brass tube in which a stand-alone piston has a sliding fit. The steel piston is hollow in the centre and contains a valve allowing fuel to flow to the outlet.

Fig 1 shows the basic layout of the Facet fuel pump, while Fig 2 is the reverse-engineered circuit diagram – read Bob's description of events through the pump's cycle in the main text. I got the gist of it after a couple of readings, though electronics has never been one of my strong suits.

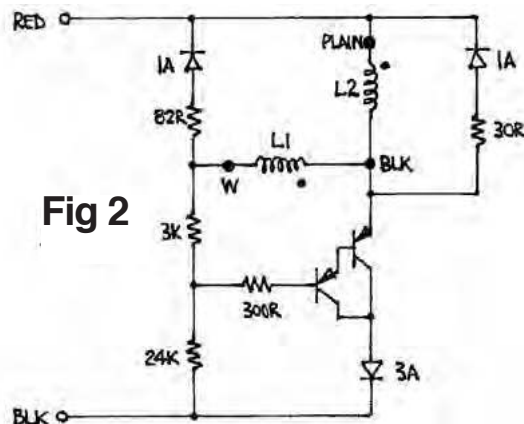
The diagram Fig 2 shows the circuit diagram for the electronics and will be used in the description of the operation of the pump.
