SUFFERING A DEFINITE DISCOMBOBULATION OF THE SPIRIT...

The latest LAA Engineering topics and investigations

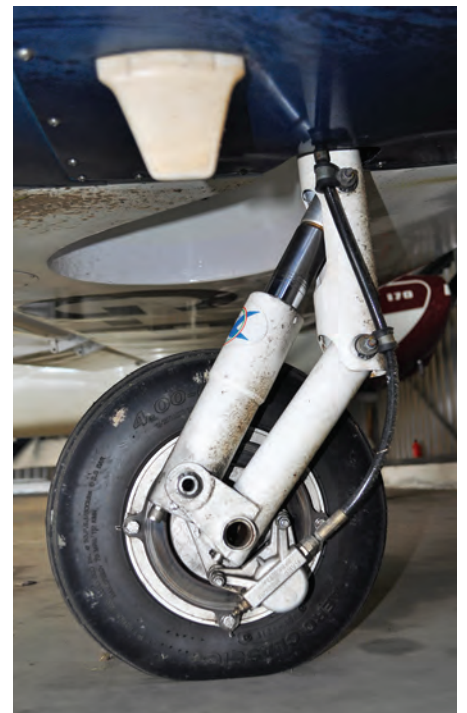
(Above) Here we show the general arrangement of the Pioneer P300 main undercarriage. This type of drag-link suspension is effective for absorbing impact loads applied roughly perpendicular to the lower swinging arm, but less so for those applied directly upwards. The geometry of this type of arrangement means it's especially important that the shock absorber is functioning correctly and not over-pressured. When we tested this leg, we found that shock-absorption wasn't that good during a drop test but was good with a fore and aft-loading case. Note the position of the brake disk attachment bolts, as discussed in the main feature. *(Photo: Malcolm McBride)*
