# Safety Spot

## Tailplane corrosion, creating a TMS, importance of following the 'drill' and nosewheel damage

### Luscombe 8E – Tailplane Corrosion

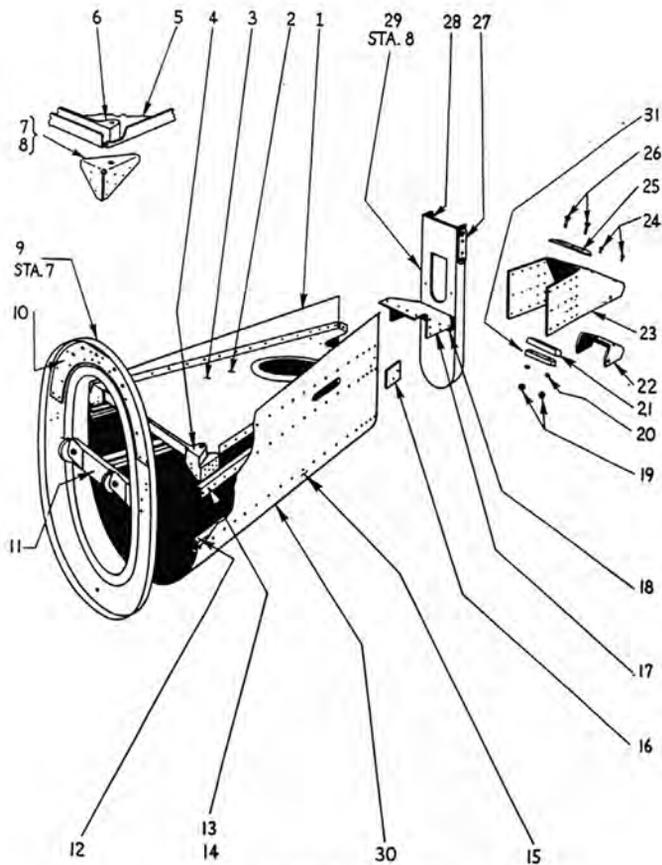
**FIGURE No. 9**  
FUSELAGE—STA. 7 TO 8

**Above** An exploded view of the Luscombe's empennage 'assembly'; during manufacture an earlier forward connection (items 5, 6, 7 & 8) was replaced with the cast forward tailplane attachment point (item 4). **Photo Luscombe Maintenance Manual**

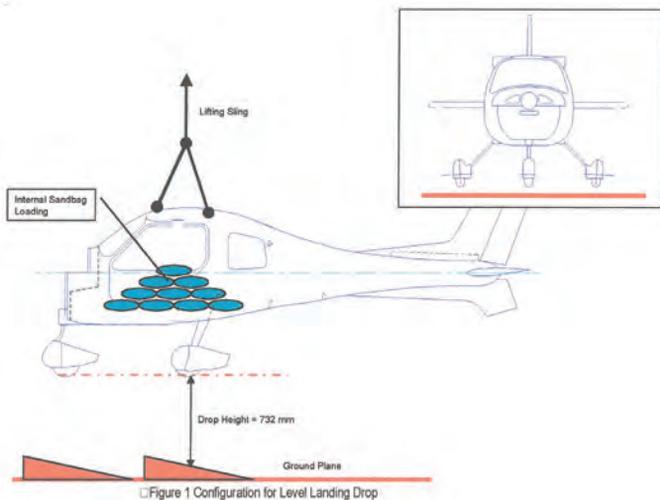
General View of the nose wheel and tyre deformation under the ultimate load conditions

**Top and Above** Part of the certification process for aircraft is demonstrating that the undercarriage is resilient enough to withstand quite heavy landings at maximum weight. There are a number of very demanding tests that need to be made and the pictures above show just two of them. The sketch shows the basic setup for a drop test, notice that, for the Jabiru SK, the aircraft's undercarriage (and associated airframe structure) needed to withstand a sudden drop of about 0.7 of a metre onto an inclined plane. The picture (top) show a more conventional strength check with the load being applied using a hydraulic press – notice the deformation in a normally inflated tyre during this ultimate load test. **Photo LAA Library**

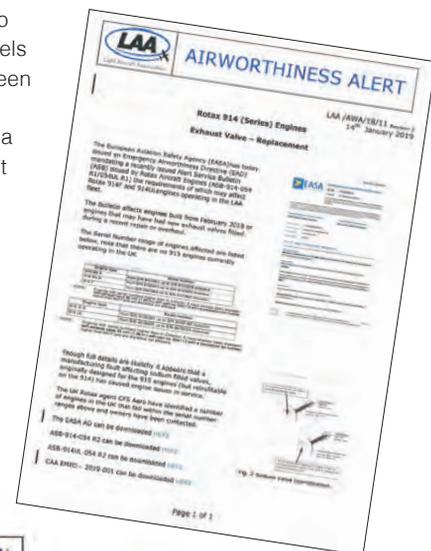
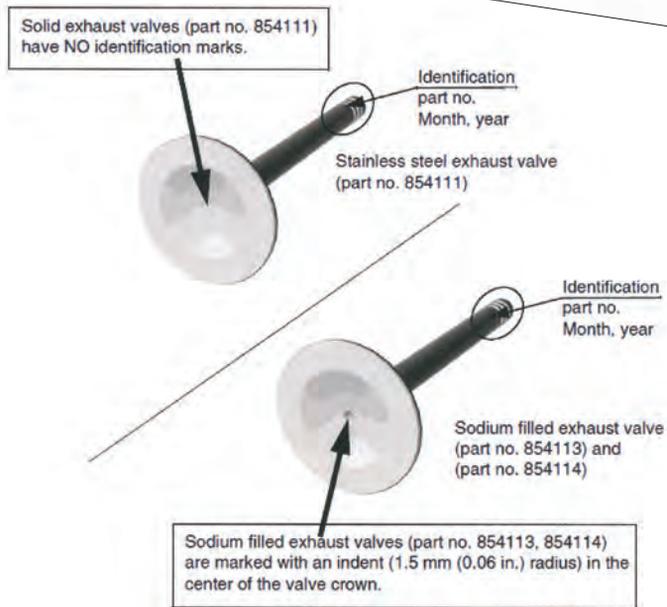
**Above** LAA Engineering always tries to promulgate important safety information to members; if the issue is type-specific and considered to be safety critical we'll normally write to affected owners directly. When we do this, we'll generally follow this up by issuing an Airworthiness Alert. LAA Airworthiness Alerts can be found in the Engineering section of our website and, if you're an aircraft owner, an LAA Inspector or just interested in the general technical goings-on then it's worth keeping an eye out for new additions. We recently issued this Alert because Rotax Engines discovered that there had been a manufacturing fault in a batch of sodium-filled valves designed for use in their new 915 engine – although also fitted, sometimes retrospectively, in the 914 turbo. This Alert (top) was actually released when Rotax first discovered the problem (December 2018) but EASA decided to mandate Rotax's Bulletin with an AD and then a CAA MPD was raised – all the associated documents can be downloaded via the Airworthiness Alert. **Photos LAA Library/Rotax Engines**
