LAA/AWA/21/09
5th November 2021

Eurofox Tricycle Undercarriage (3K version)

Fuselage Structure Under Seat Pan Weld Inspection

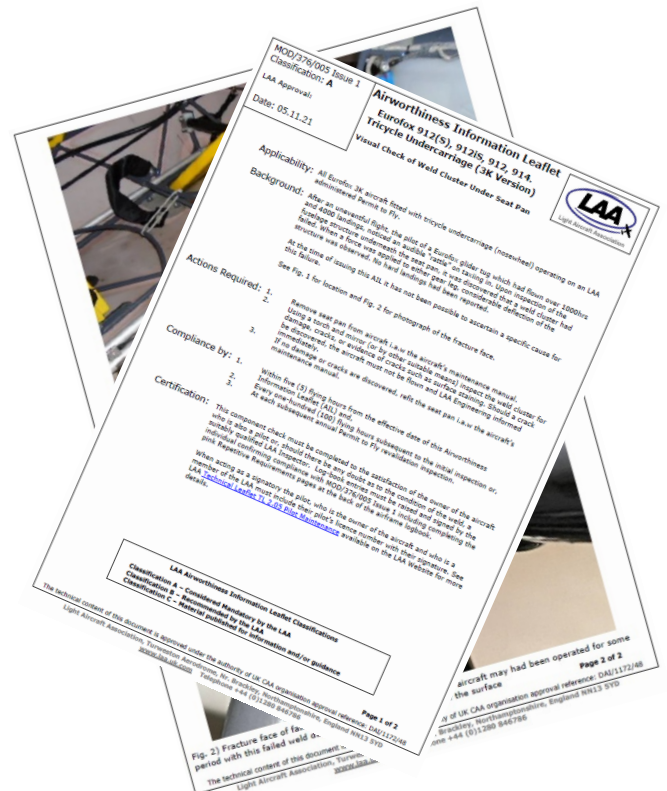
After an uneventful flight, the pilot of a Eurofox glider tug noticed an audible "rattle" on taxiing in. Upon inspection of the fuselage structure underneath the seat pan, it was discovered that a weld cluster had failed. When a force was applied to either gear leg, considerable deflection of the structure was observed. No hard landings had been reported. This aircraft had flown over 1000hrs and over 4000 landings.

At the time of issuing this alert, it has not been possible to ascertain a specific cause for this failure. However, if left unchecked, this could result in undercarriage collapse.

Location of failed weld cluster under seat pan.

Tricycle gear Eurofox owners are now required to inspect this weld cluster on their aircraft mandated by LAA Airworthiness Information Leaflet LAA/MOD/376/005 Issue 1.
