LAA/AWA/20/01  
19<sup>th</sup> February 2020

## Groppo Trail & Groppo Trail Mk. 2 Lift Strut to Wing Attachment Swivel Bolts Implementation of Hours-Based Bolt Life

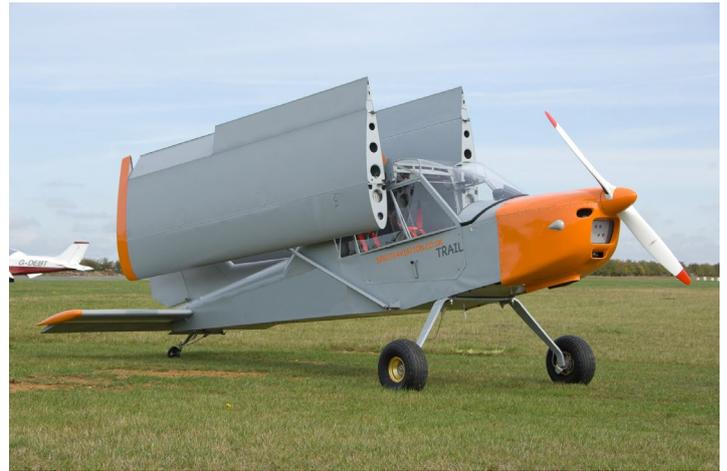
Fig. 1 An example of the Groppo Trail with the wings in the fold-back position; a huge advantage in hangars with limited space ... though introducing different continuing airworthiness issues, both from the perspective of the approving engineering team and LAA Inspectors carrying out their annual inspection.
