CFM Shadow, Streak Shadow & Star Streak Aircraft. Fuel Tank Inspection

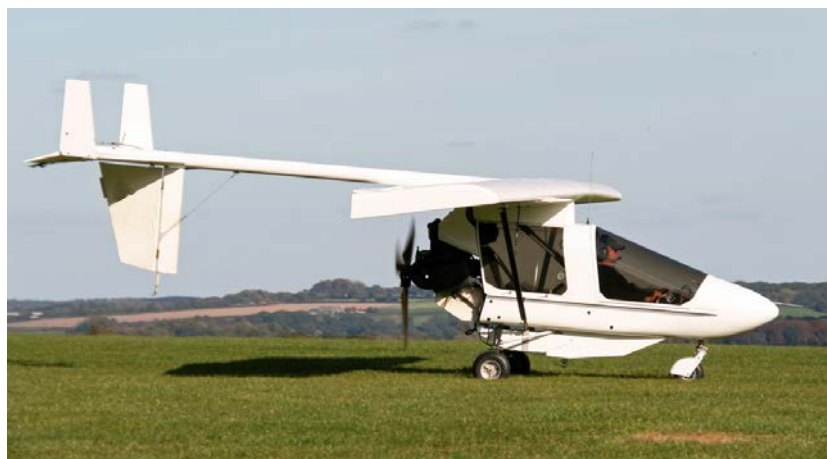
Fig 1. An example of an LAA Administered Streak Shadow aircraft; this picture shows clearly the main fuel tank attached below the engine and the 'slipper' tank attached between the mainwheels to the fuselage floor.
