With Malcolm McBride
Airworthiness Engineer

IDENTIFY, EVALUATE, PRIORITISE & MITIGATE – A BALANCED APPROACH TO RISK MANAGEMENT

This month's cautionary tales for pilots, builders and maintainers

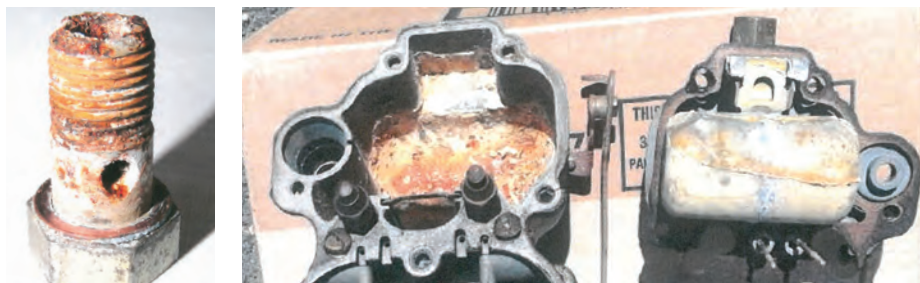
(Above) The use of forecourt motor fuel (mogas) in aircraft remains a theme here at LAA HQ, after a number of recent accidents and incidents.

The pictures above show the effect that water in fuel can have on components in a carburettor. In this case the water almost certainly entered the system because of the hygroscopic nature of ethanol. (Photos: Nigel Graham)

Therefore, after discussions with the Air Accident Investigations Branch (AAIB) at Farnborough, we agreed to remind our Association's flyers that, before an aircraft can legally use mogas, it must be checked whether it's eligible to be approved under the LAA's processes, and an LAA Inspector must carry out specified inspections and complete mandatory paperwork.

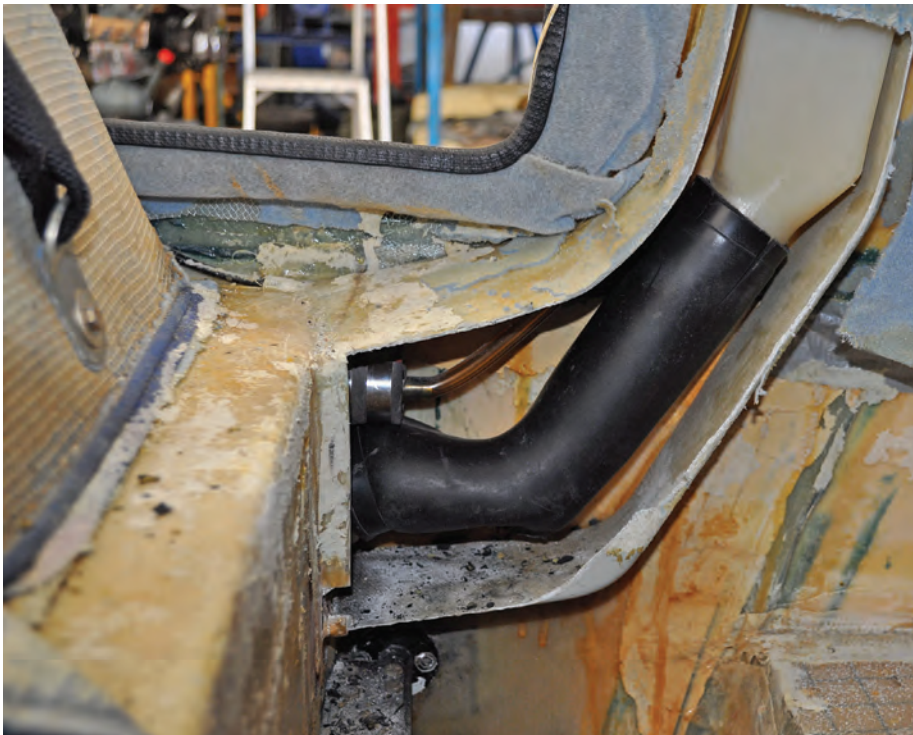
(Above) We showed this picture of a failed fuel inlet pipe in the December 2017 edition of *Safety Spot* and, as you may recall, the failure of this pipe has prompted the issue of an *Airworthiness Information Leaflet*, requiring checks on all Europa aircraft. (Photo: Malcolm McBride)

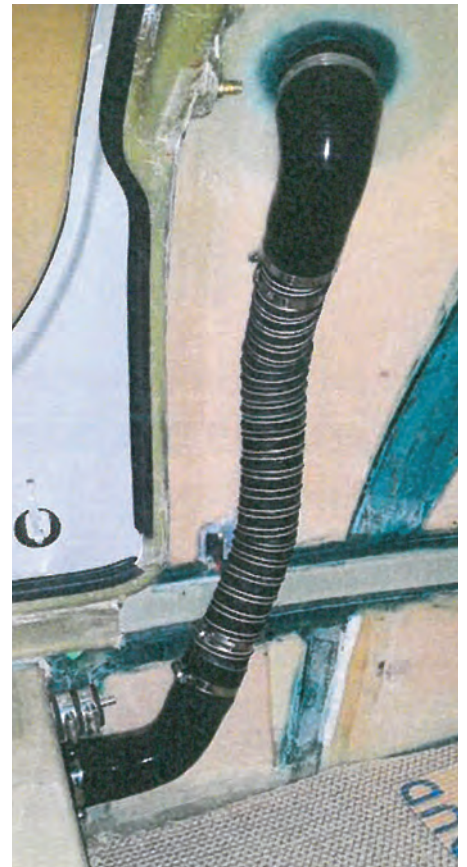
(Above) LAA Inspectors may come across this fuel inlet pipe design, which is an authorised Europa modification (MOD 79).

The reason that it had to be introduced was because the moulding company which supplied the formed plastic filler pipes, as shown in other photos, couldn't continue after the first batch.

Europa owners are reminded that the requirements to check the fuel inlet pipe applies to all types.

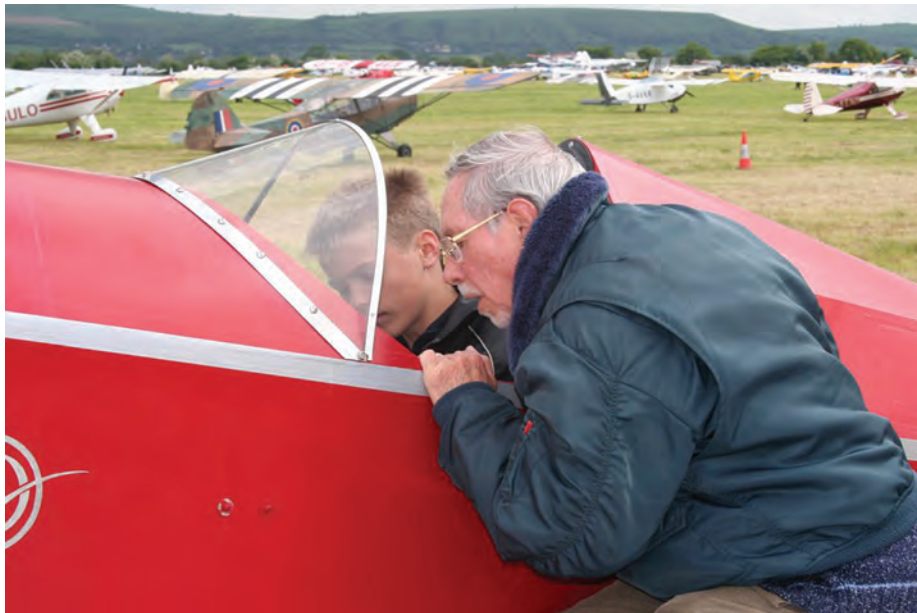
(Above) This picture shows LAA Inspector, Alan Hartfield, briefing his assistant, now Pilot Officer William Smith, on his role in the engine-starting process. Naturally, the 'gold standard' procedure when it comes to hand-starting involves two 'trained' people. Ideally, that's the pilot in the cockpit and the pilot/engineer as hand-swinger. However, as in this case, quite often pilots find themselves in positions where personnel choice is limited. A common misconception is that the pilot hands over the responsibility for starting the engine to the 'ground crew'. That may have been the case in the RFC, but these days the captain of the vessel remains in-charge at all times and is completely responsible for all aspects of the aircraft's starting. (Photo: Alan Hartfield)

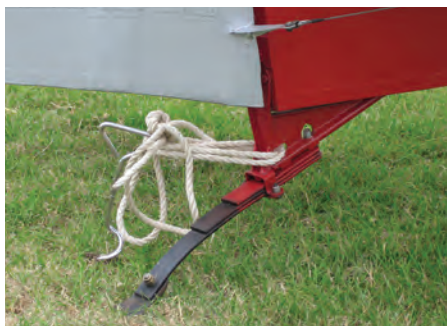
(Above) This picture shows the other end of the Dart Kitten II before the engine was hand-started by Alan, with a trainee in the cockpit. This 'belt and braces' approach to safety is absolutely essential, as risks increase when getting assistance from inexperienced hands. There's always a danger that the throttle could be wrongly set or moved accidentally when entering or leaving a cockpit. Watch out if you're using screw-in stakes as tie-downs, as they aren't always as secure as they may seem. (Photo: Alan Hartfield)

I expect that you've seen the lovely pictures of the Dart Kitten II, once owned and operated by Alan Hartfield. I really liked Alan's 'belt and braces' approach to engine starting. Although he was happy to go through a training routine with his young friend, he made sure that the aircraft was secured before actually starting the engine.

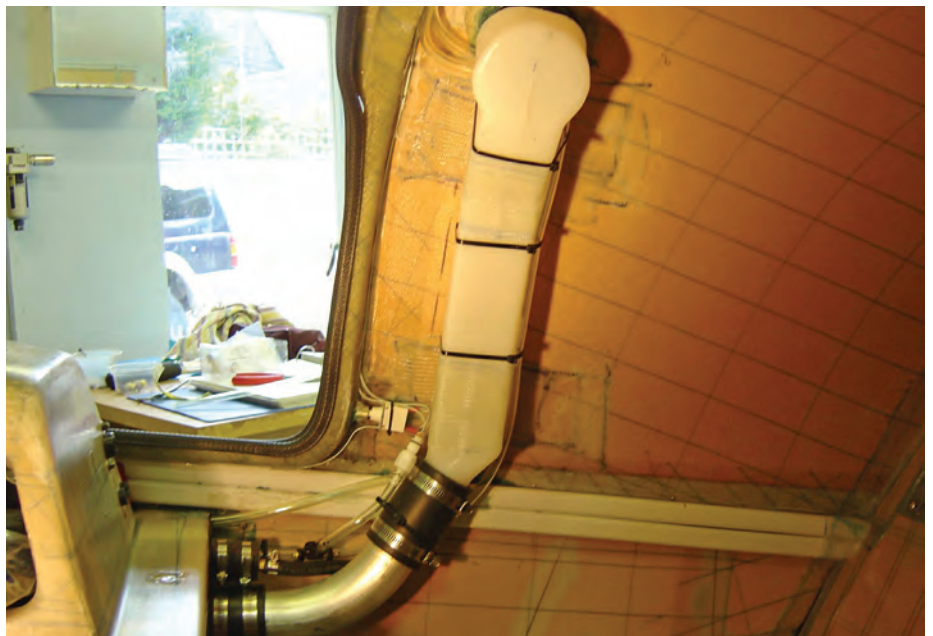
(Above) This picture links two distinctly separate issues discussed in this month's **Safety Spot**, quite by accident! The first issue relates to the changes some owners have made to the fuel filler pipes on their Europa aircraft. In this rather neat example, the rubber fuel pipe has been replaced by a preformed aluminium version – this particular one was sourced in New Zealand. One or two LAA members have done this and because this is such a neat solution, LAA Engineering is planning to issue a **Standard Modification** in the near future.

The second issue, well, have you spotted the microswitch attached to the door frame, which fires off a light on the instrument panel when the canopy is open? I did and thought, "What a cracking idea." (Photo: LAA Library)

If you haven't, take a gander at the picture showing the nicely-designed fuel filler pipe – look to the side of it and you'll see a little microswitch. When I first spotted that I realised immediately what it was for. Over the years, there have been several instances of Europas which have lost one of their gull-wing doors in flight, and it was concluded that the pilot hadn't

The microswitches are wired into a simple circuit which illuminates a light on the instrument panel if the door latch pins aren't fully home in their sockets. The owner of the aircraft in the picture pointed out, when I called to congratulate him for the design of this little safety feature, that even though there's a warning light, he still completes a physical check of the door to ensure it's fully secure before taking off. It's a bit awkward to do this in the Europa, as the rear catch, which, because of the way the door flexes, is the one with a history of the shoot-bolt missing its target socket, sits behind the crew's shoulders and can be difficult to see – extra effort is required!

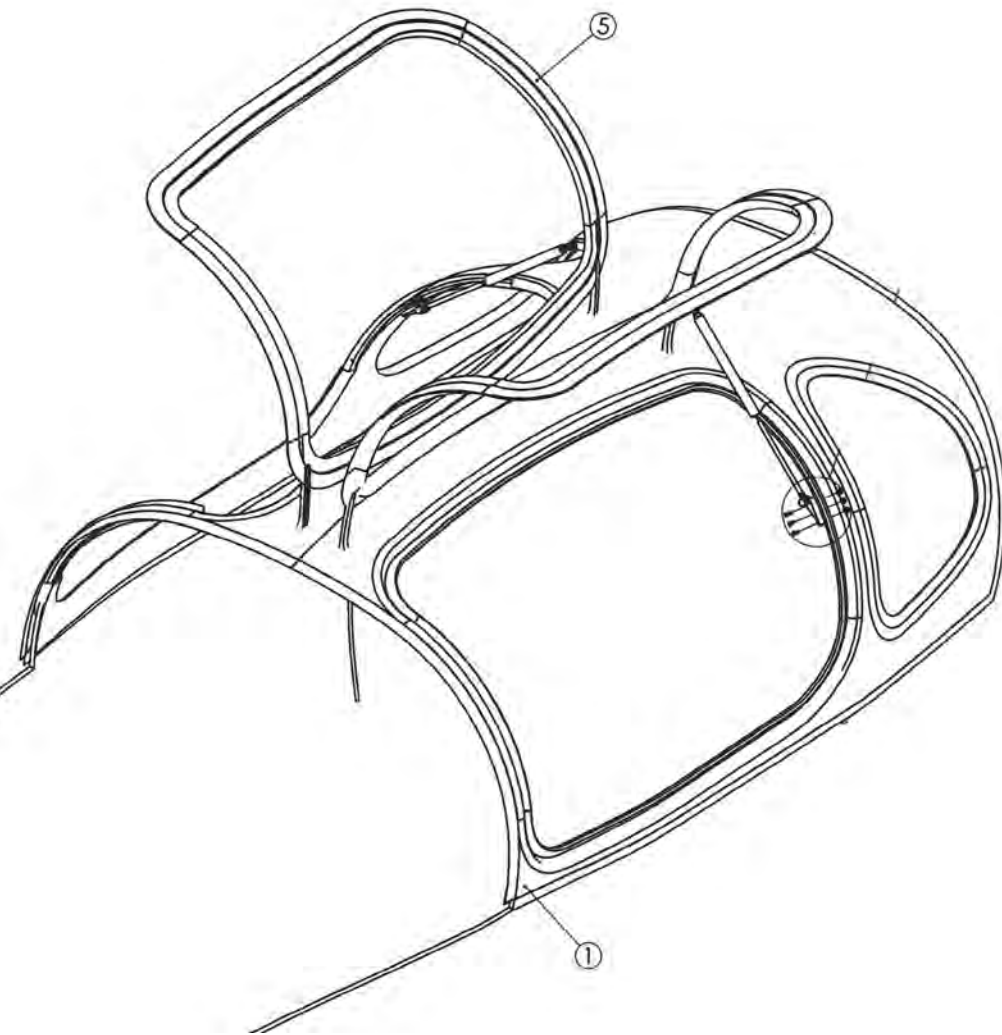
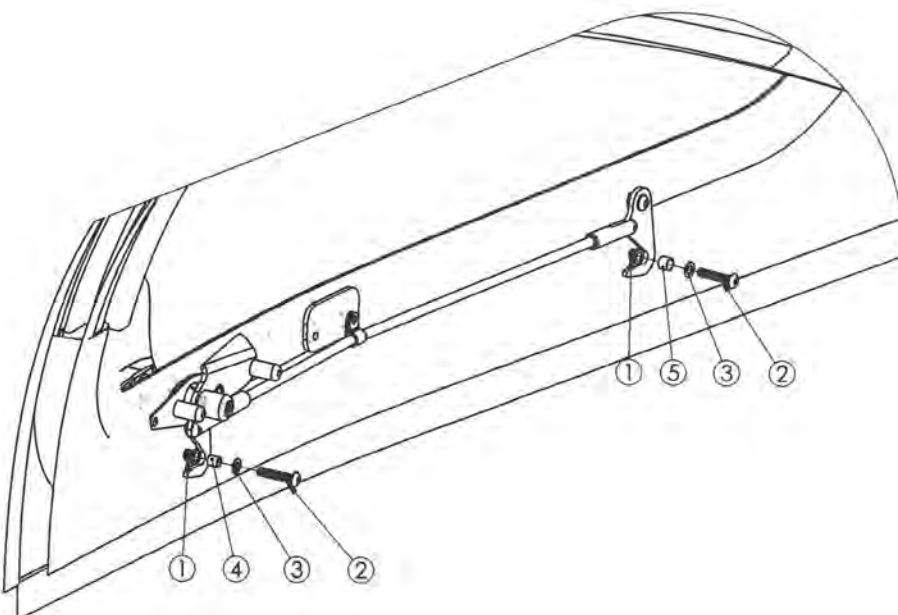
(Above & below) It isn't always a bad thing 'when the holes in the cheese line up'. The sketch above shows the general arrangement of the gull-wing doors on the Sling, which are very similar, in general arrangement terms, to those of the Europa.

Not wishing to be too Europa-centric, readers will remember that we've had a number of door losses due to them not being closed and latched correctly before take-off. Well, a similar thing has happened to a Sling aircraft so it's worth pressing the point that, regardless of latch design, it's essential for the pilot to physically check that the doors are closed and securely latched before take-off.

After discussions with the pilot, who was initially sure he'd checked that the door was completely secure before departure, we concluded it was likely that, although the door had been fully shut during the pre-flight check, the catch itself may not have gone completely home. It's another reminder, if one were needed, of the need to ensure that pre-flight checks are carried out calmly and thoroughly by the pilot before committing to aviation.

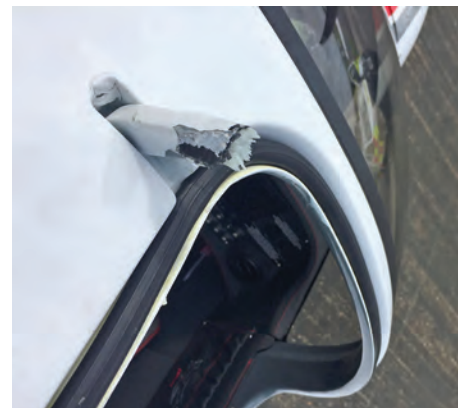
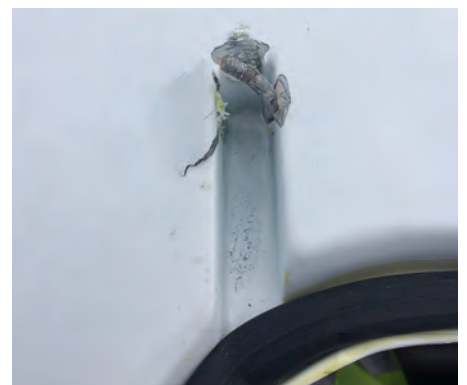
(Above) These two pictures show the details of the remaining parts of the broken door hinges on Lucien d'Sa's Sling, and offer a timeline for the probable sequence of events.

We think the front hinge (top photo) broke as the unlatched door slammed open, and was sucked upwards by the low-pressure area over the canopy. Held only by its rear corner, the door then flipped backwards in the slipstream, wrenching out the rear hinge bolt as it went (bottom photo). *(Photos: Lucien d'Sa)*

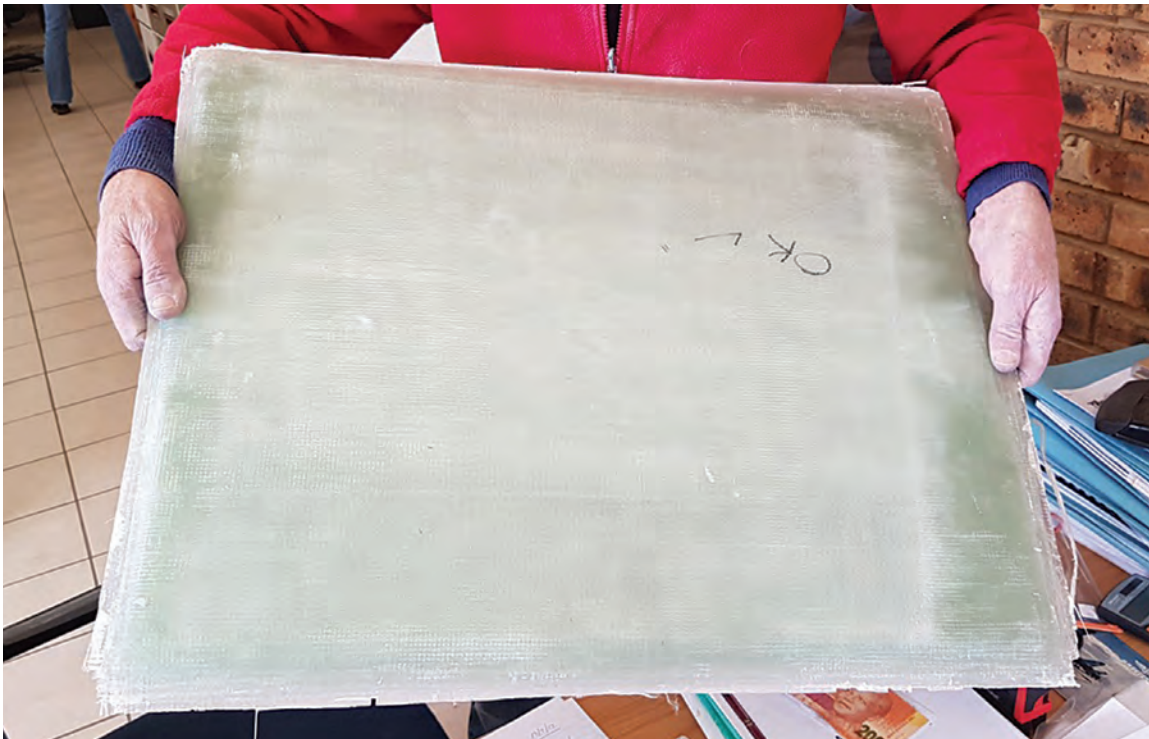
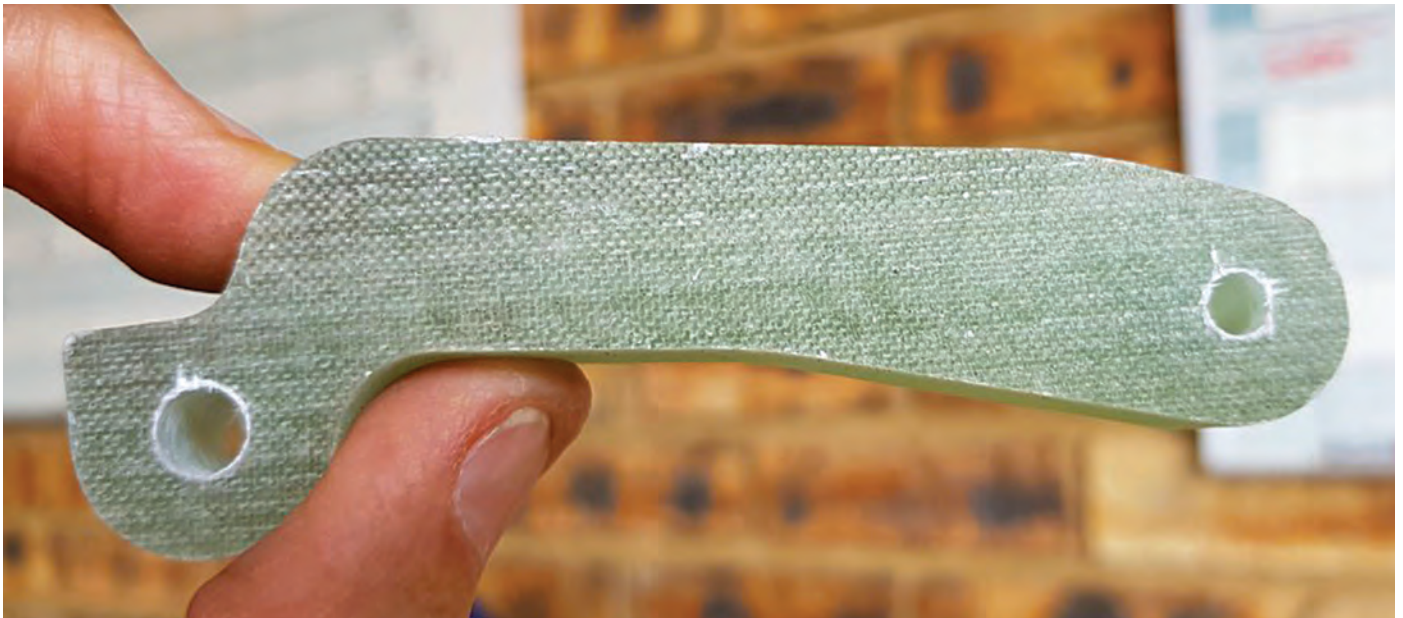
(Left & below)
When we first saw the pictures of the broken hinge we wondered whether the component itself mightn't have been made correctly. Originally, we presumed that the hinges themselves were individually laid up in moulds but, as you can see from the pictures, that isn't the case. For quality and manufacturing expediency reasons, the hinges are cut from a thick laminate composite material, which is especially laid-up for the purpose.
(Photos: The Airplane Factory)
