EuroFOX Aircraft

Checking of Elevator Trim Cable Assembly

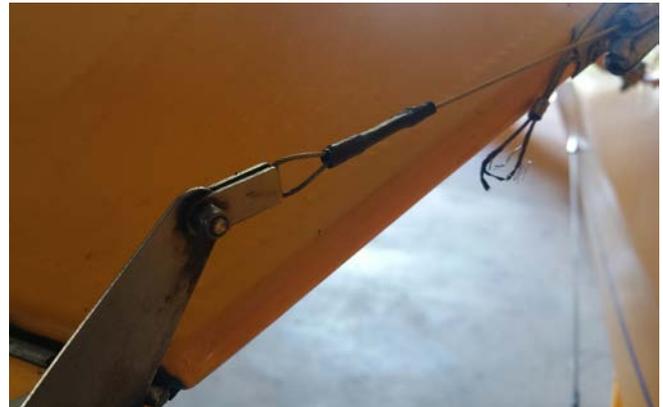
Fig. 1. This picture shows the detached bottom trim operating cable with the top cable still in place. Notice that the cable is forced around a sharp 90° angle: each operation requires the cable to go through an angular change causing fatigue in the individual strands.

This recent failure serves to remind us all of the need to include in an Aircraft's Tailored Maintenance Schedule a close visual inspection of all aircraft control cables and their connections.

To fully inspect a control cable may require removal of the cable from the airframe because the best way to check a cable for broken strands is to bend the cable into a loop between two hands and passing a cloth over the cable ... watch your fingers!

Though some wear along the length of a cable may be tolerated, especially if there's no blending between strands, cables must be replaced if it suffers a 'popped' core or any broken strands.

EuroFOX have issued a Service Bulletin (SB 04/2016) reminding owners of the need for regular checks in this cable connection: this Bulletin can be downloaded [HERE](#).

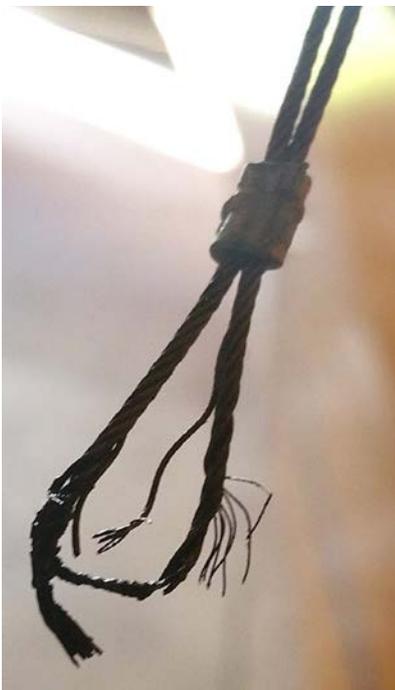
When the cable was detached from the 'U' channel by the engineer it was found that the cable had very nearly completely failed; had this cable failed in flight operational safety would have been compromised.

Fig. 2. This close up shows the extent of the damage found by the engineer when the cable was removed from the 'U' clamp. The point of bending is clear.

An exacerbating factor in this failure was that the 'U' channel itself wasn't lubricated and was therefore very tight and stiff to rotate; this increased the amount of bending that the cable was forced through during each operational cycle.
